**BIG CAJUN II  
COAL COMBUSTION RESIDUAL (CCR)  
ANNUAL INSPECTION REPORT**

*NRG Louisiana Generating, LLC (LaGen)  
NRG Energy, Inc.  
Baton Rouge, Louisiana*

*Project Number 1005494026*

*January 2016*

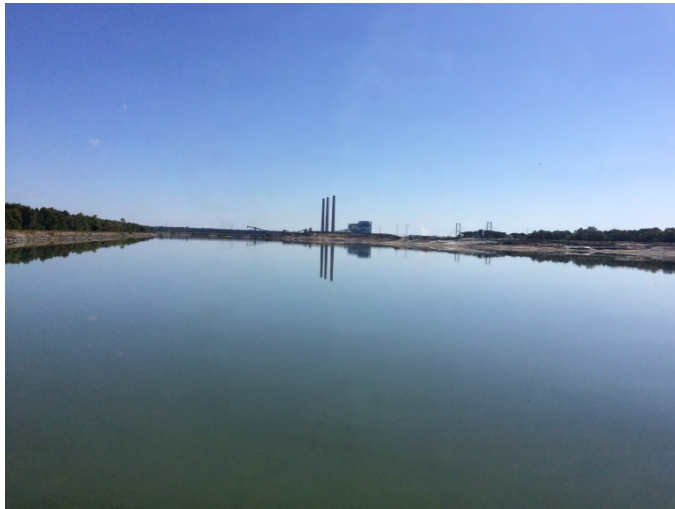
**Photo No:** 1                      **Picture Direction:** SE  
**Description:** Northwest corner of Fly Ash Unit looking east

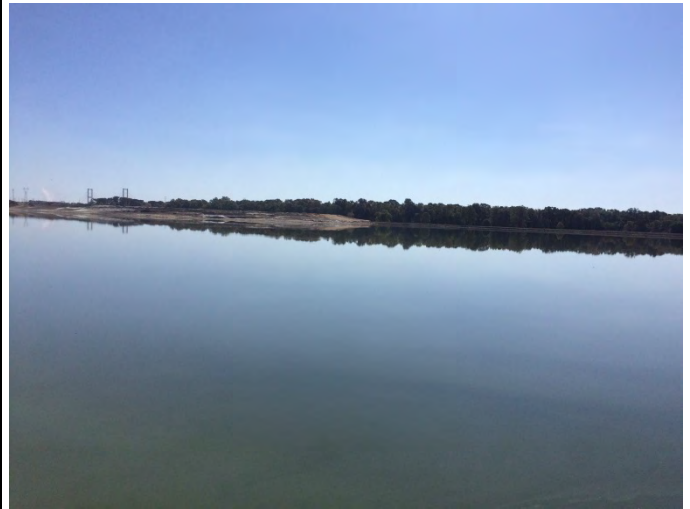
**Photo No:** 2                      **Picture Direction:** SE  
**Description:** Northwest corner of Fly Ash Unit looking east

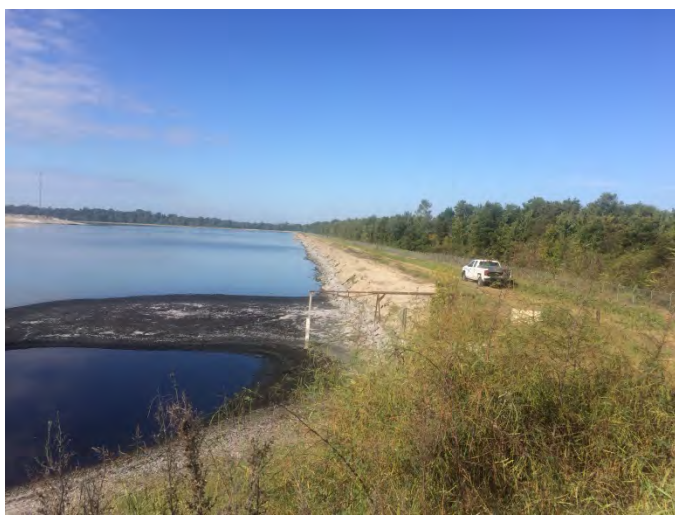
**Photo No:** 3                      **Picture Direction:** NE  
**Description:** Northeast corner of Fly Ash Unit looking west

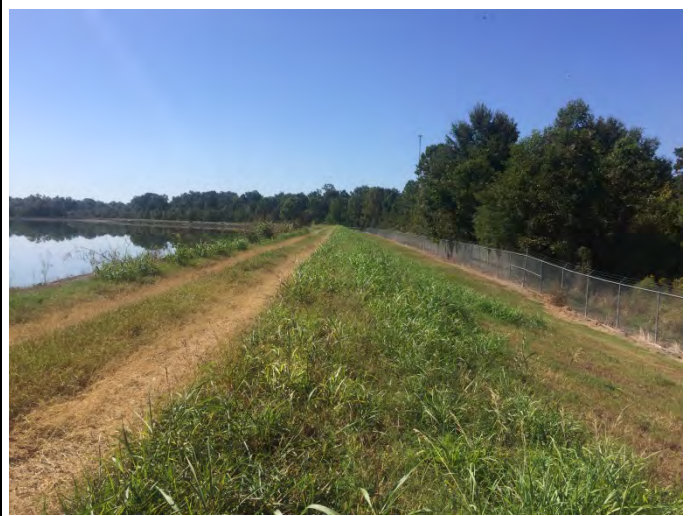
**Photo No:** 4                      **Picture Direction:** NE  
**Description:** Northeast corner of Fly Ash Unit looking west

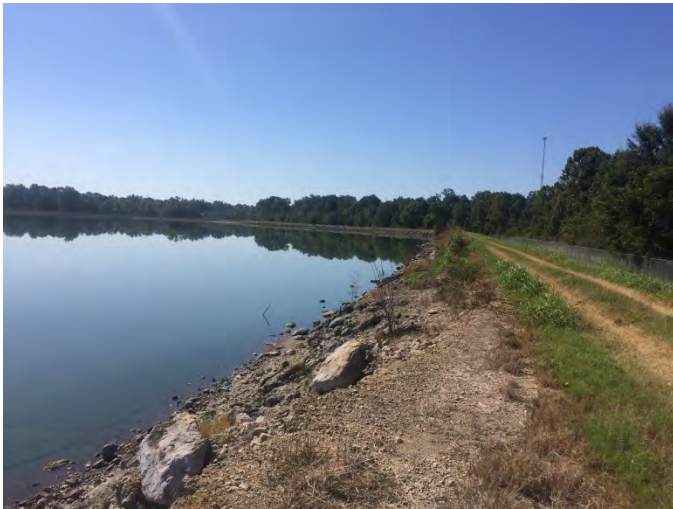
**Photo No:** 5                      **Picture Direction:** W

Observation of the inside of the levee showed the water level to be approximately 5 feet below the crest of the levee. Approximately 2/3 of the Fly Ash Unit is open water and fly ash that had been placed along the inside of the levee for erosion protection showed areas of erosion and undercutting of the fly ash, however, there was no evidence of erosion of the levee material.

**Description:** Fly Ash Unit, area of fly ash erosion protection

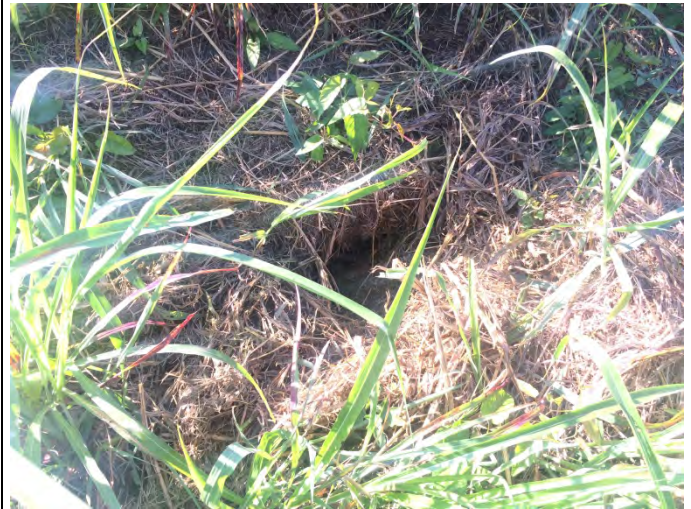
**Photo No:** 6                      **Picture Direction:** SW

At the time of the inspection, the grass was about 6-inches tall and allowed for adequate inspection. No woody vegetation was observed along the side slopes. A total of nine animal burrows were observed along the exterior side slope: five on the north exterior slope, two on the west exterior slope and two on the south exterior slope. The burrows were generally 3 to 4-inches in diameter and while most did not extend more than a few inches in depth, the depth of three burrows could not be determined. The burrows are believed to be dug by armadillos were observed in the area.

**Description:** Animal burrow 30° 43' 41.9" N, 91° 23' 21.9" W at toe of slop

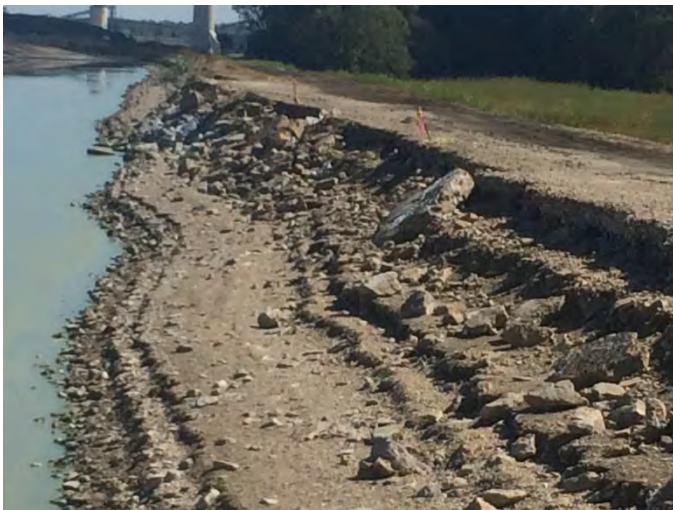
**Photo No:** 7                      **Picture Direction:** SE

**Description:** Fly Ash Unit, erosion of fly ash erosion protection areas

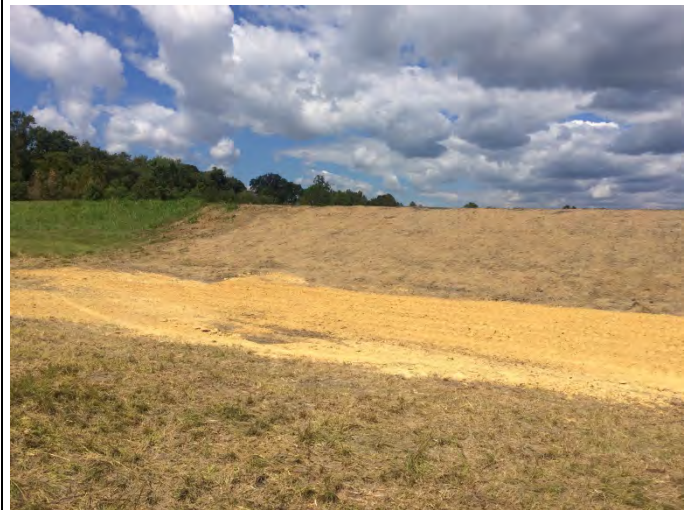
**Photo No:** 8                      **Picture Direction:** N

**Description:** Fly Ash Unit, south levee repair near MW-10H; 30° 43' 17.3" N, 91° 23' 37.6" W

- Removal of the failure slip-plane through excavation of the dike soil to behind and below the failure;
- Rebuilding of dike slope with geogrid-reinforced layers to resist the failure plane shear and increase slope stability; and
- Rebuilding of the outside half of the dike crest where it has settled.

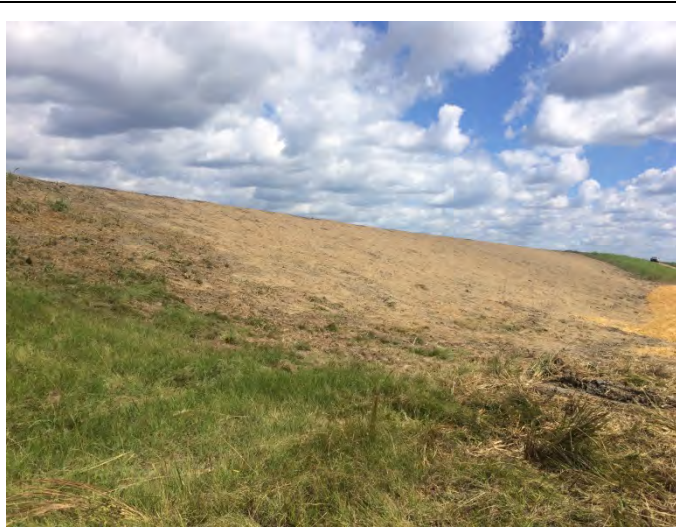
**Photo No:** 9                      **Picture Direction:** SE

**Description:** Fly Ash Unit, 2<sup>nd</sup> levee repair near MW-10H; 30° 43' 17.3" N, 91° 23' 37.6" W

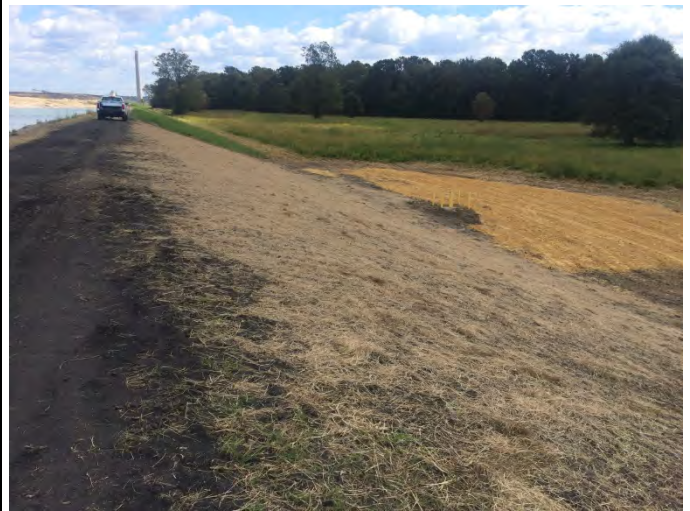
**Photo No:** 10                      **Picture Direction:** SE

**Description:** Fly Ash Unit, 2<sup>nd</sup> levee repair near MW-10H; 30° 43' 17.3" N, 91° 23' 37.6" W

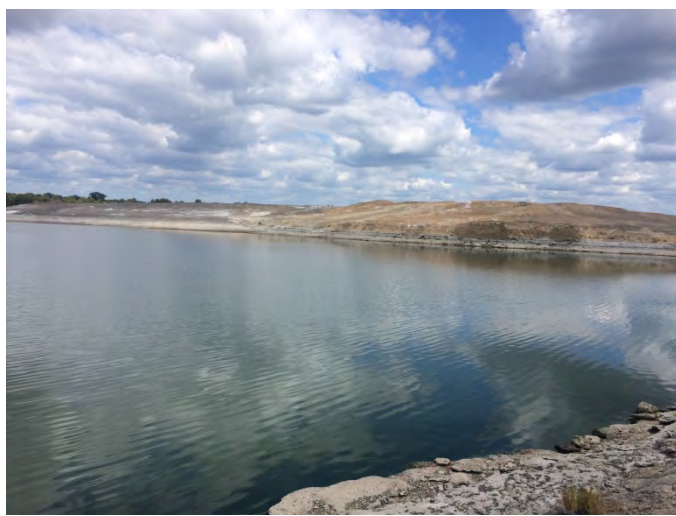
**Photo No:** 11                      **Picture Direction:** NE

**Description:** Southwest corner of Fly Ash Unit looking Northeast

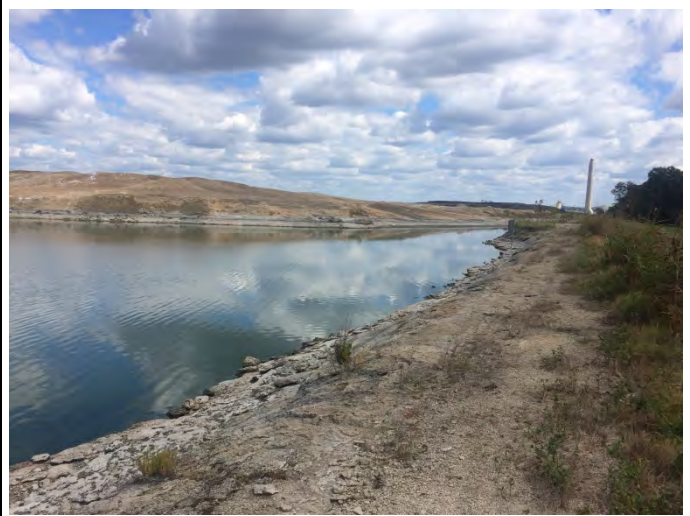
**Photo No:** 12                      **Picture Direction:** E

**Description:** Southwest corner of Fly Ash Unit looking Northeast

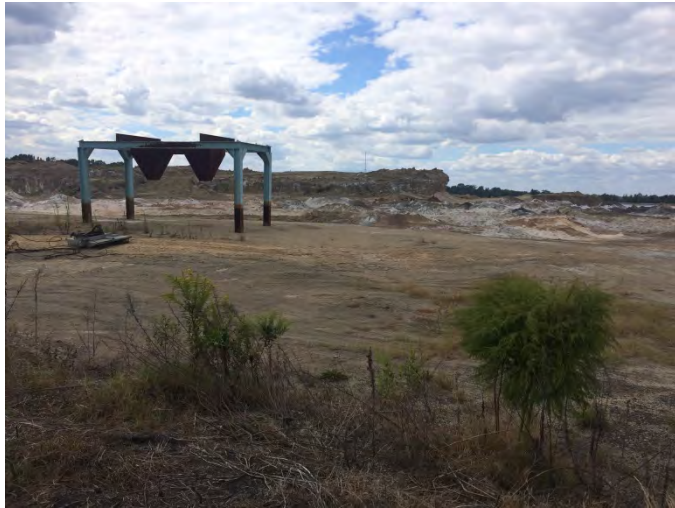
**Photo No:** 13                      **Picture Direction:** W  
**Description:** Levee between Fly Ash Unit and Bottom Ash Unit. Looking at stockpiles of bottom ash material within the Fly Ash Unit

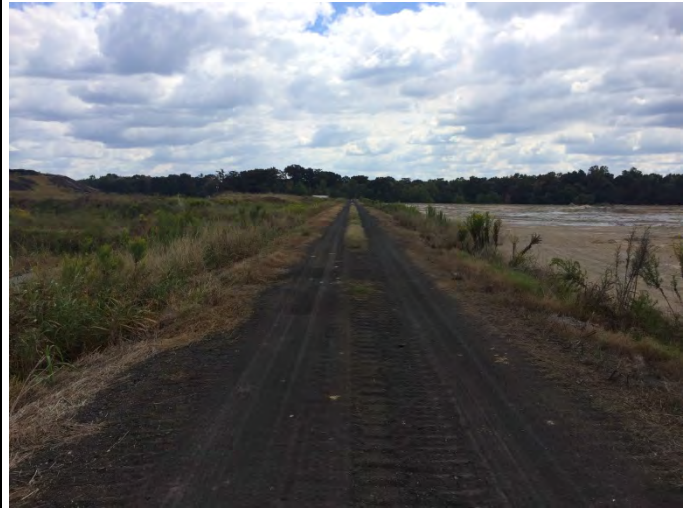
**Photo No:** 14                      **Picture Direction:** SW  
**Description:** Levee between the Bottom Ash Unit and Fly Ash Unit. Bottom Ash Unit on the left, Fly Ash Unit is on the right

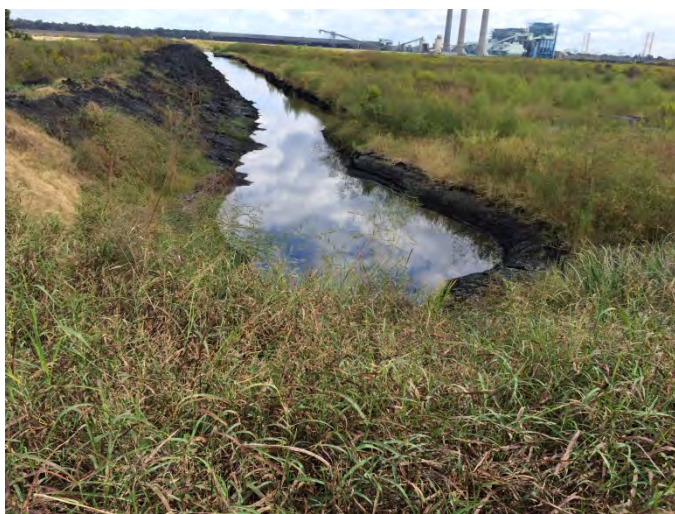
**Photo No:** 15                      **Picture Direction:** E  
**Description:** Drainage ditch within the Bottom Ash Unit, along north levee

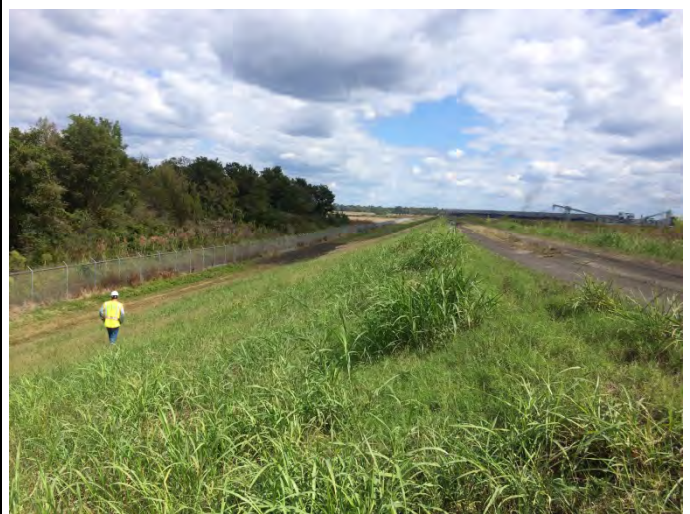
**Photo No:** 16                      **Picture Direction:** E  
**Description:** Bottom Ash Unit side slope

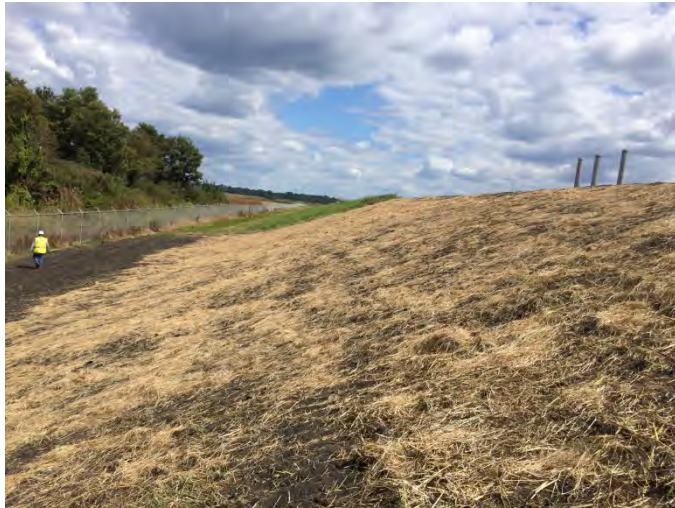
**Photo No:** 17                      **Picture Direction:** E

**Description:** Bottom Ash Unit, Northwest corner of Bottom Ash Unit showing levee repair

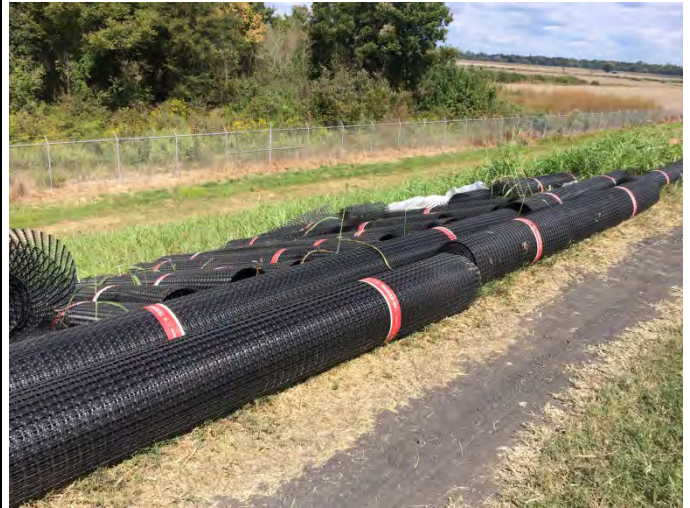
**Photo No:** 18                      **Picture Direction:** E

**Description:** Tensar geogrid material used as soil reinforcement to resist the failure plane shear and increased slope stability

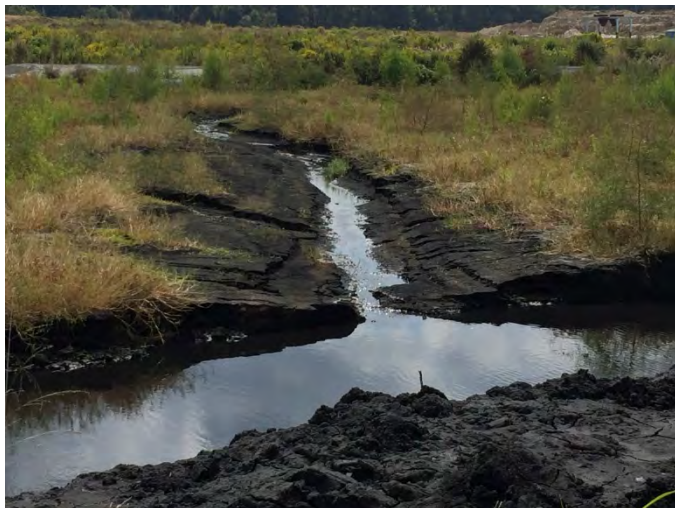
**Photo No:** 19                      **Picture Direction:** S

**Description:** Northern levee drainage ditch from the bottom ash

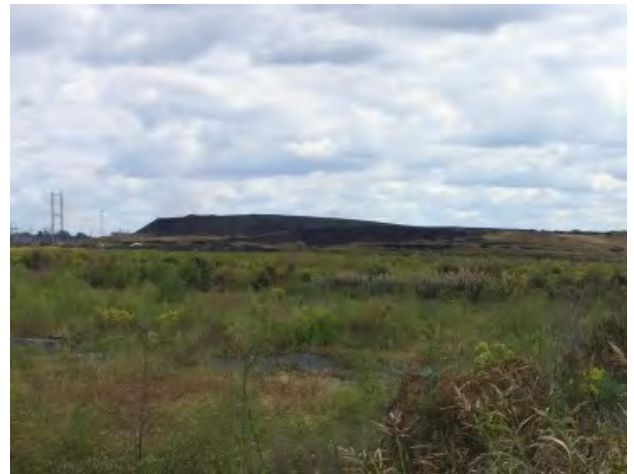
**Photo No:** 20                      **Picture Direction:** S

**Description:** Stockpile of bottom ash in the Bottom Ash Unit (approx. height 20ft)

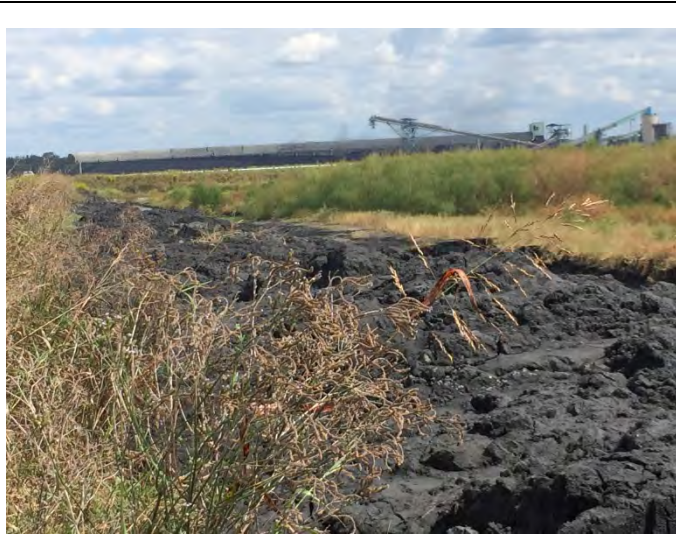
**Photo No:** 21                      **Picture Direction:** E

**Description:**  
 Bottom ash placement along the inside slope of the northern levee

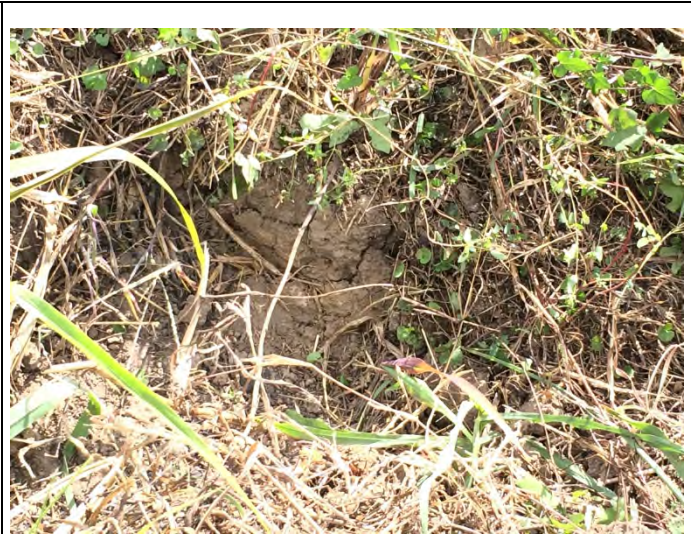
**Photo No:** 22                      **Picture Direction:**

Two small desiccation cracks (less than ½-inch wide and 5 to 10 feet long) were observed along the north exterior slope. No other desiccation cracks were observed in the Bottom Ash Unit levees.

**Description:** Small tensile cracking along north Bottom Ash Unit outside slope; 30° 43' 48.1" N, 91° 23' 01.5" W

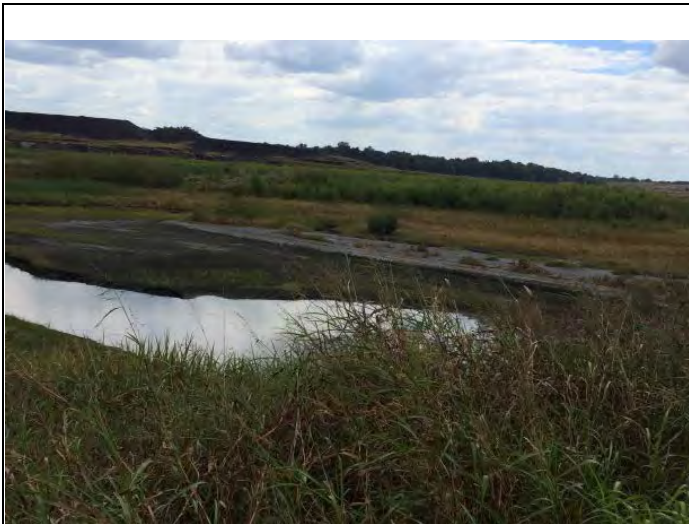
**Photo No:** 23                      **Picture Direction:** S

**Description:** Northeast corner of the Bottom Ash Unit, near underground pipe, geotube in the background barrier protects the outlet pipe from the Bottom Ash Unit

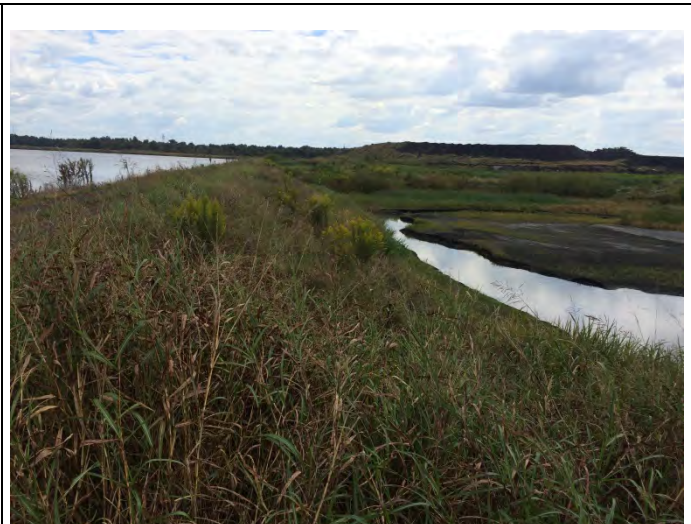
**Photo No:** 24                      **Picture Direction:** S

**Description:** Northeast corner of the Bottom Ash Unit looking South, Treatment Basins on the left and Bottom Ash Unit on right

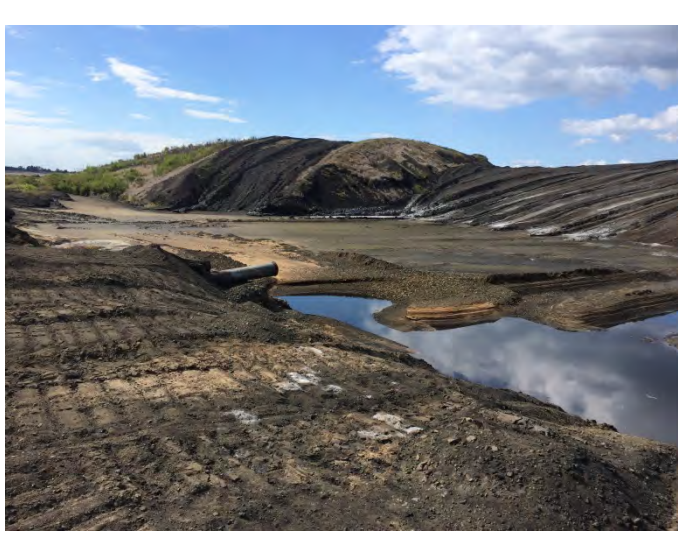
**Photo No:** 25                      **Picture Direction:** N  
**Description:** Southeast corner of the Bottom Ash Unit discharge slurry discharge point into the Bottom Ash Unit

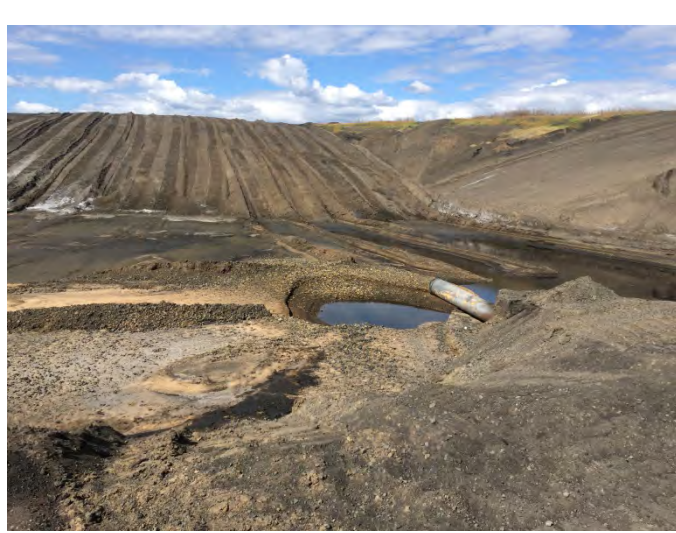
**Photo No:** 26                      **Picture Direction:** N  
**Description:** Southeast corner of the Bottom Ash Unit discharge slurry discharge point into the Bottom Ash Unit
