CCR SURFACE IMPOUNDMENT ANNUAL INSPECTION REPORT

Big Cajun II Power Plant

New Roads, Pointe Coupee Parish, Louisiana

January 2018

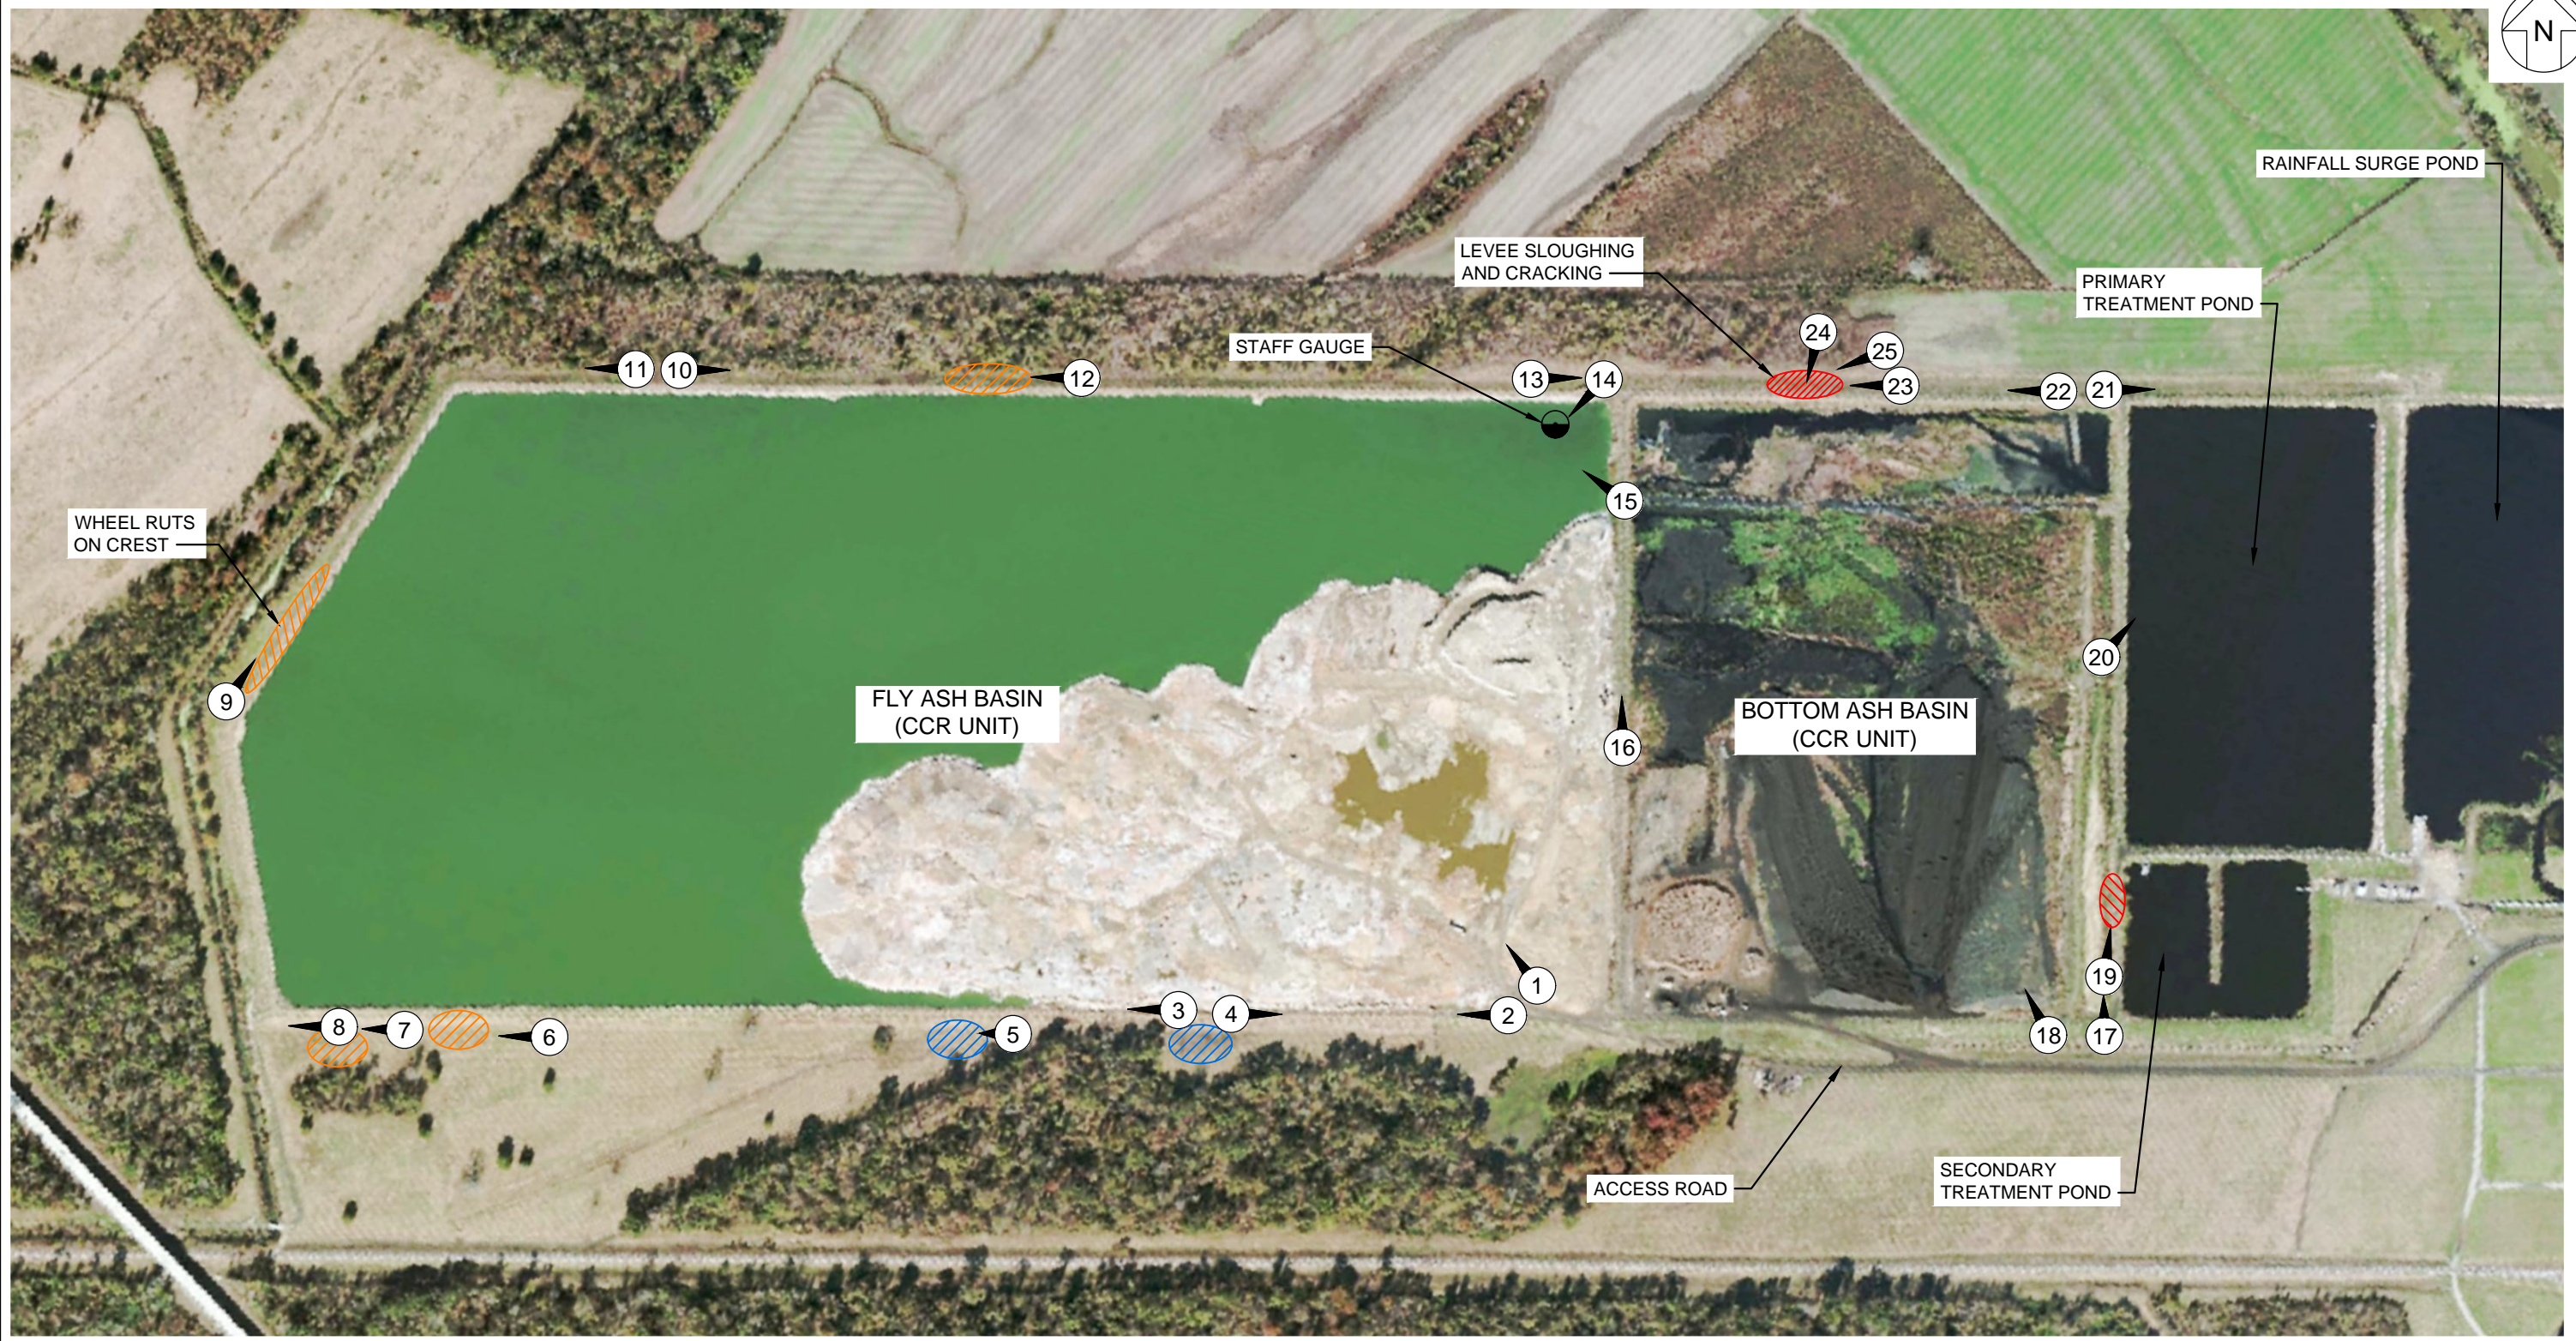
Figure 2: 10/25/2017 Inspection Map

- On the south side of the Fly Ash Basin, two areas about 1,300 feet west and 2,000 feet west from the eastern edge were observed to have standing water adjacent to the toe of slope of the perimeter dike (see Figure 2 and Photos 3 through 5). From the natural topography, it appears that these are low-lying areas where water tends to naturally accumulate. Based on this, along with the recent heavy rainfall at the site, the standing water did not appear to be attributed to seepage, and no signs of distress or malfunction in the adjacent dike were observed.
- An area of uneven ground surface was observed along the exterior dike along the south side of the Fly Ash Basin, about 250 feet east of the southwestern corner (see Figure 2 and Photo 8). In last year's annual inspection report, CB&I marked this area on the annual inspection figure as having potential sloughing/slope

- Another similar feature – area of uneven ground surface – was observed on the exterior dike along the north side of the Fly Ash Basin, approximately 1,400 ft east of the northwest corner (see Figure 2 and Photo 12). This area exhibited more significant equipment rutting which appears to be contributing to the uneven ground. At the time of Geosyntec's inspection, there was no evidence of movement or instability (it was not accompanied by observable escarpment, tension cracks, bulging/rotation, or seeps). However, it is being noted as a relevant observation due to the uneven and soft ground, which could be attributed to equipment rutting and the recent heavy rains, but also merits ongoing observation for changes or other signs of movement/weakness.

- A location of localized slope instability (area of surficial sloughing) was observed on the east-facing exterior dike slope approximately 250-ft north of the southeast corner of the basin (see Figure 2 and Photo 19). This location forms the interior

- A second location of localized slope instability (area of sloughing) was observed on the north-facing exterior dike slope of the Bottom Ash Basin, about 400 feet east from the northwestern corner (see Figure 2 and Photos 22 through 25). This area is approximately 70 to 90-ft long and exhibits an approximately 12-inch escarpment at the crest, along with signs of down-slope rotational movement. The area at the toe of movement is bulged and has softer soil that may indicate seepage exiting the slope. In last year's annual inspection report, CB&I marked this area on the annual inspection figure as having potential sloughing/slope instability. This also appears to match the same general area that experienced slope instability pre-2015 and was subsequently repaired. An interior drainage swale is located on the interior side of the dike, and it may be that the significant heavy rains caused water in this drainage swale to build up and seep through the dike and lead to the slope movement. At the time of the inspection, there was no CCR material or standing water being impounded on the Bottom Ash Basin-side of the dike in this area. Based on these factors this appears to be a localized issue needing repair, and not an issue that would impair the operation or safety of the CCR unit. However, given that this location coincides with previously-noted slope failures and repairs, it is evident that the magnitude of this condition and possible seepage-connection with water accumulating on the impoundment-side of the basin, this represents what is judged to be a potential structural weakness that should be carefully observed for changes and scheduled for repair.

1. **Corrective Measure – Repair.** The area of localized slope instability (area of sloughing) on the northern-facing exterior slope of the perimeter dike (near the northwest corner of the Bottom Ash Basin – see Figure 2) should be repaired to rehabilitate a potential structural weakness to the impoundment.

2. **Maintenance – Repair.** The area of localized surficial sloughing on the eastern-facing exterior dike slope of the Bottom Ash Basin (facing the Secondary Treatment Pond – see Figure 2), while not representing a structural weakness, should be repaired to prevent progressive worsening of conditions (e.g., erosion and continued sloughing of material).

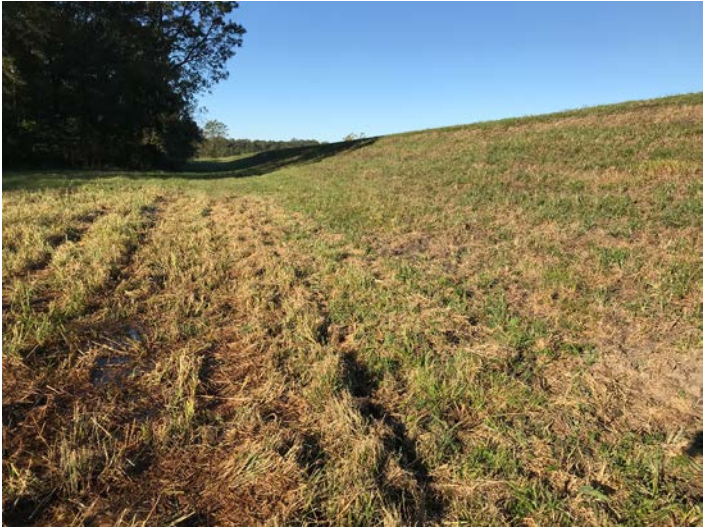
instability. This also is in the same area that experienced slope instability pre-2015 and was subsequently repaired. At the time of Geosyntec's inspection, there was no evidence of movement or instability (it was not accompanied by observable escarpment, tension cracks, bulging/rotation, or seeps). However, it is being noted as a relevant observation due to the uneven and soft ground, which could be attributed to equipment rutting and the recent heavy rains, but also merits ongoing observation for changes or other signs of movement/weakness.

<p>Photograph ID: 3</p> <hr/> <p>Date: 10/25/2017</p> <hr/> <p>Direction: W</p> <hr/> <p>Comments: Fly Ash Basin – south exterior slope, low-lying wet area</p>

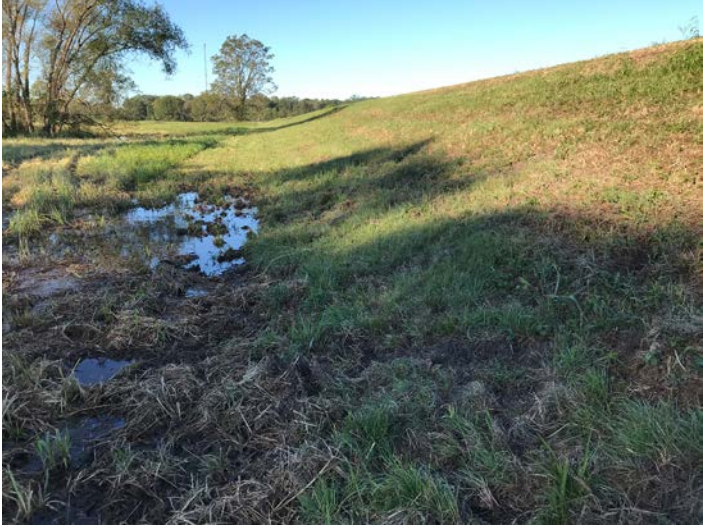
<p>Photograph ID: 5</p> <hr/> <p>Date: 10/25/2017</p> <hr/> <p>Direction: W</p> <hr/> <p>Comments: Fly Ash Basin – south exterior slope, low-lying wet area</p>

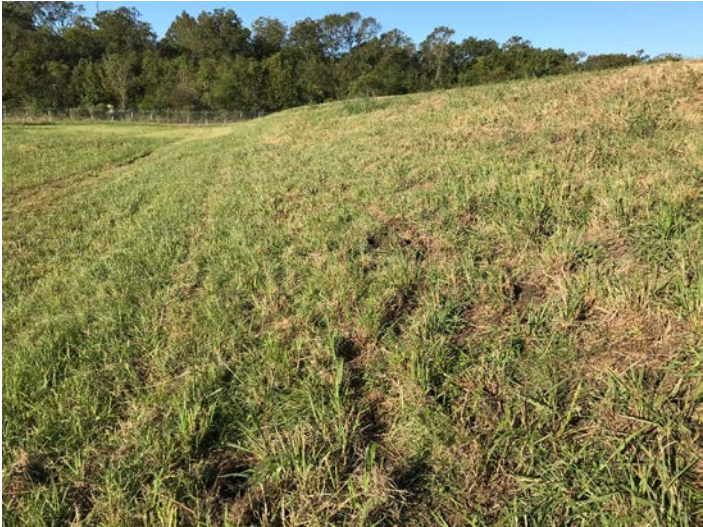
<p>Photograph ID: 8</p> <hr/> <p>Date: 10/25/2017</p> <hr/> <p>Direction: W</p> <hr/> <p>Comments: Fly Ash Basin – south exterior slope with minor signs of uneven slope with some wetness along ground surface</p>

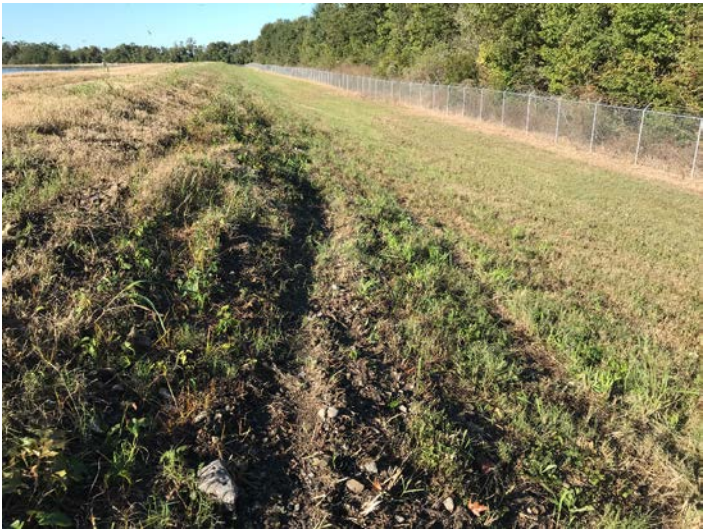
<p>Photograph ID: 12</p> <hr/> <p>Date: 10/25/2017</p> <hr/> <p>Direction: W</p> <hr/> <p>Comments: Fly Ash Basin – north exterior slope with moderate signs of uneven slopes and soft ground showing equipment ruts</p>

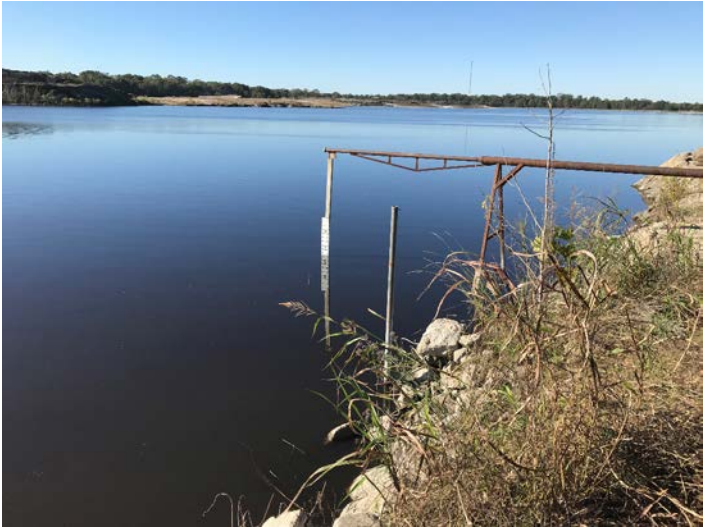
- The staff gauge located at the northeast corner of the Fly Ash Basin was functional, with a depth reading of 2.75-ft (see Figure 2 and Photo 14). Based on discussions with the facility environmental coordinator, this water level was slightly higher than normal due to the significant heavy rains, and was in the process of being gradually lowered by gravity discharge.
- Near the staff gauge location, the discharge pipe between the Fly Ash Basin and Bottom Ash Basin was functioning, and there was no observed erosion, scour, or seepage at or adjacent to the pipe penetration.
- The hydraulic structures associated with the CCR unit appeared to be functional; no issues that would impact the structural integrity or continued safe and reliable operation of the hydraulic structures were observed.

The site has one staff gauge installed located in the northeastern corner of the Fly Ash Basin (photo 14). On the date of the annual inspection (25 October 2017) the observed staff gauge level was 2.75-ft, indicating a freeboard of approximately >4-ft above the crest of the perimeter dike. The staff gauge is observed weekly during the inspections by a qualified person. Readings have indicated that >2-ft of freeboard has been maintained in the Fly Ash Basin since the last annual inspection report.

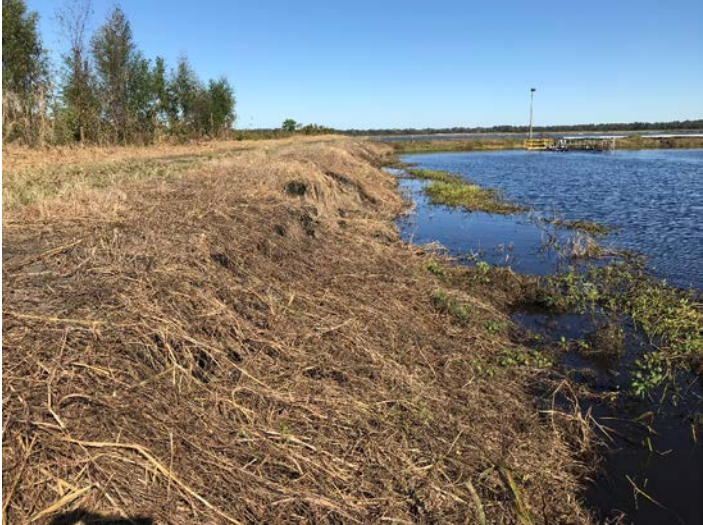
sideslope of the Secondary Treatment Pond. The sloughing was occurring on the upper portion of the slope, with a scarp at the crest and signs of movement down to the waterline of the Secondary Treatment Pond. It is noted that the bottom ash placement adjacent to this area is set-back approximately 150-ft from the dike to make room for an interior drainage swale. Thus, there is no CCR material or standing water being impounded on the Bottom Ash Basin-side of the dike in this area. It was further observed that the top-width of the dike was wider along this area, and the slough may not be part of the Bottom Ash Basin dike per se. Based on these factors this appears to be a localized issue needing repair, and not an issue that would impair the operation or safety of the CCR unit, or otherwise present an indication of a global slope stability concern.

<p>Photograph ID: 19</p> <hr/> <p>Date: 10/25/2017</p> <hr/> <p>Direction: N</p> <hr/> <p>Comments: Bottom Ash Basin – looking north at interior slope of Secondary Treatment Pond</p>

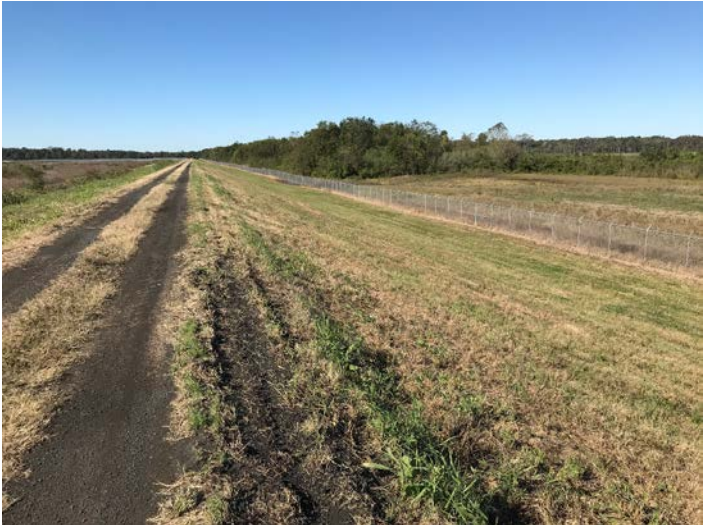
<p>Photograph ID: 22</p> <hr/> <p>Date: 10/25/2017</p> <hr/> <p>Direction: W</p> <hr/> <p>Comments: Bottom Ash Basin – north slope</p>

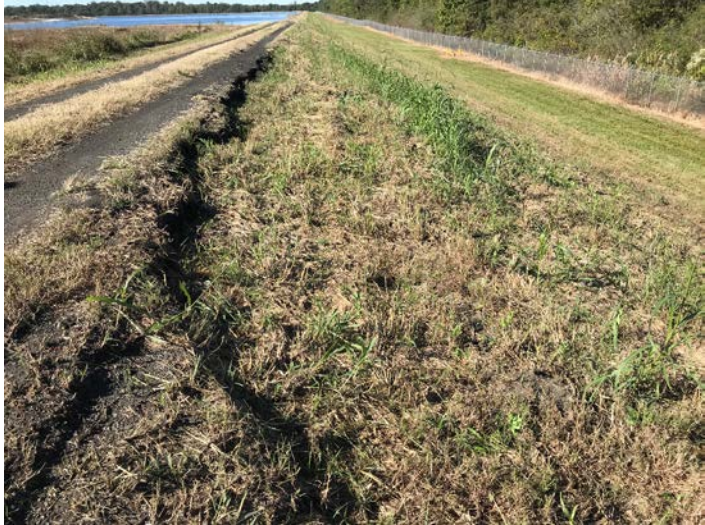
<p>Photograph ID: 23</p> <hr/> <p>Date: 10/25/2017</p> <hr/> <p>Direction: W</p> <hr/> <p>Comments: Bottom Ash Basin – sloughing and slope cracking/movement on north slope</p>

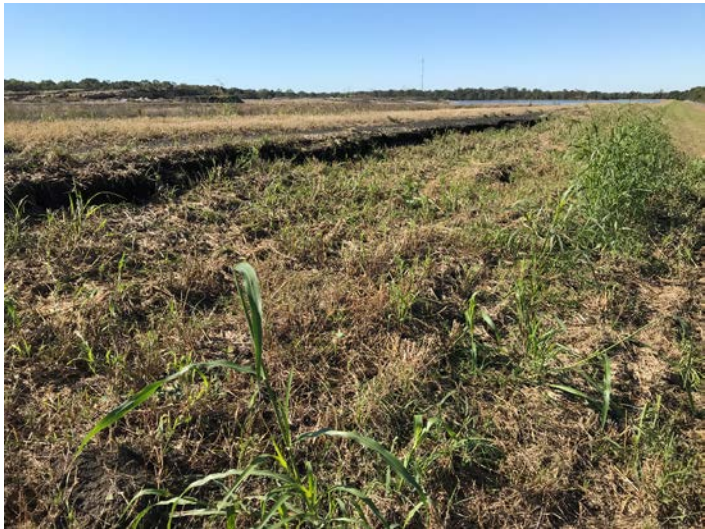
<p>Photograph ID: 24</p> <hr/> <p>Date: 10/25/2017</p> <hr/> <p>Direction: S</p> <hr/> <p>Comments: Bottom Ash Basin – sloughing and slope cracking/movement on north slope</p>

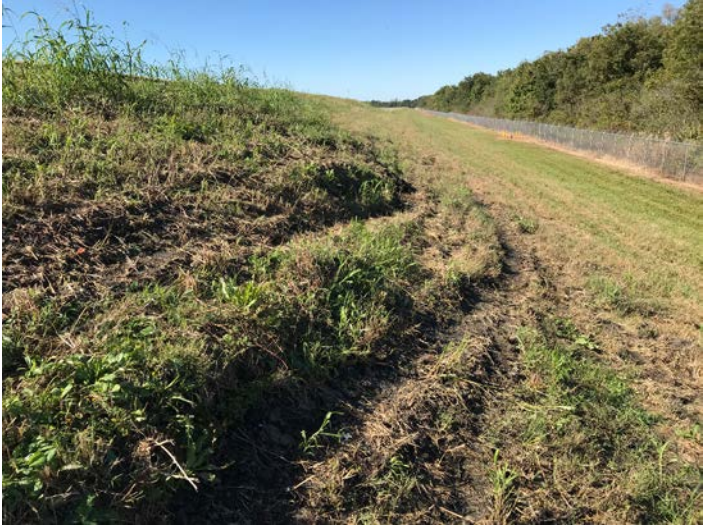
Photograph ID: 25

Date: 10/25/2017	
Direction: W	
Comments: Bottom Ash Basin – sloughing and slope movement at toe of area on north slope
