CLECO POWER LLC

DOLET HILLS POWER STATION

CCR ANNUAL INSPECTION

ASH BASIN NO. 2

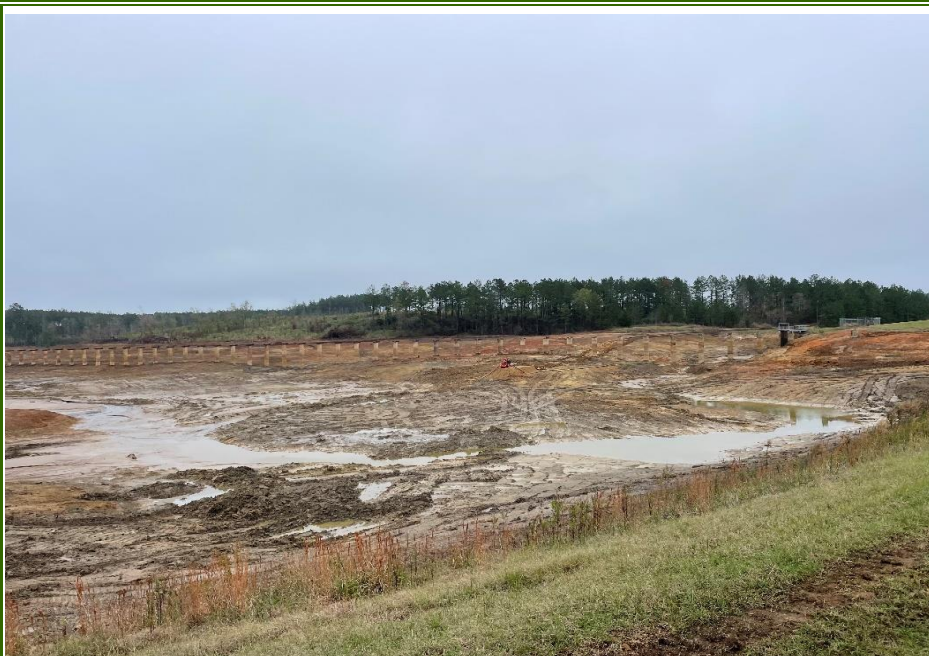
Ash Basin No. 2

Ash Basin looking at remains of sluice structure and ash removal.

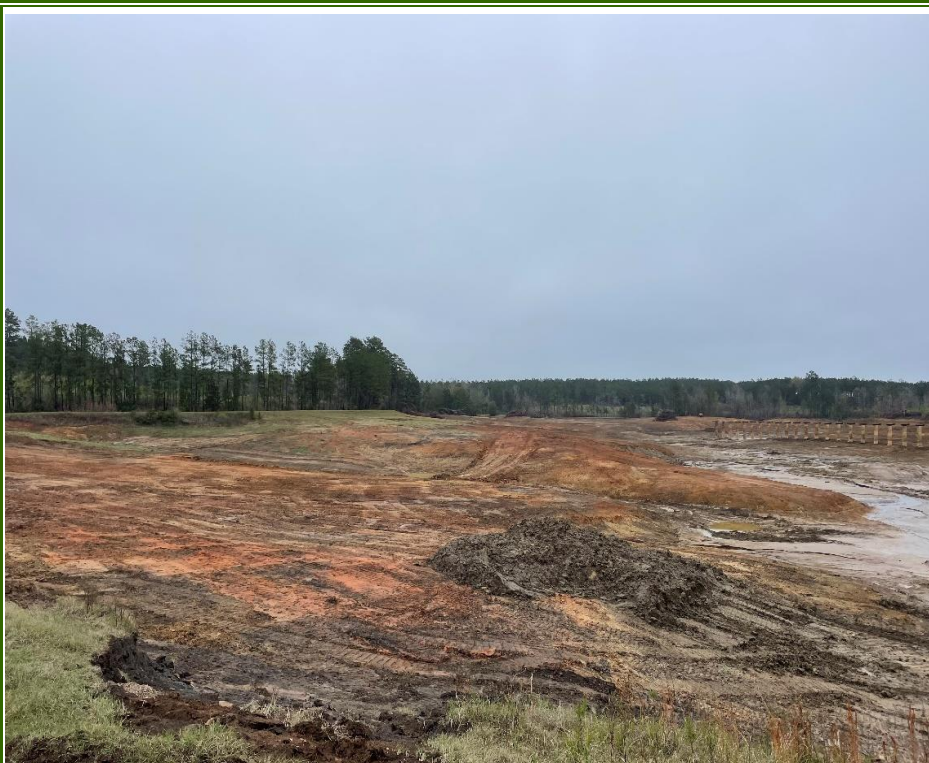
Ash Basin No. 2

Northern side of Ash Basin—ash material removed.

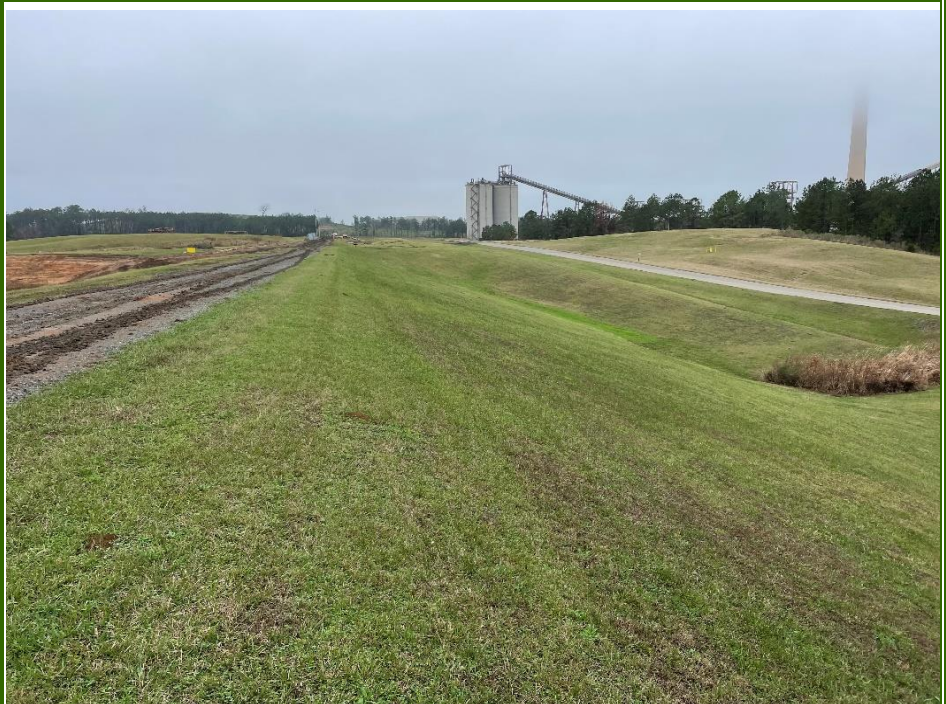
Ash Basin No. 2

| 6.0 SLOPE PROTECTION – EXTERIOR SLOPES: | |
|---|--|
| Findings: | The exterior slope was inspected and appeared to be in satisfactory condition. No corrective actions are required at this time. |

Exterior slope of western levee.

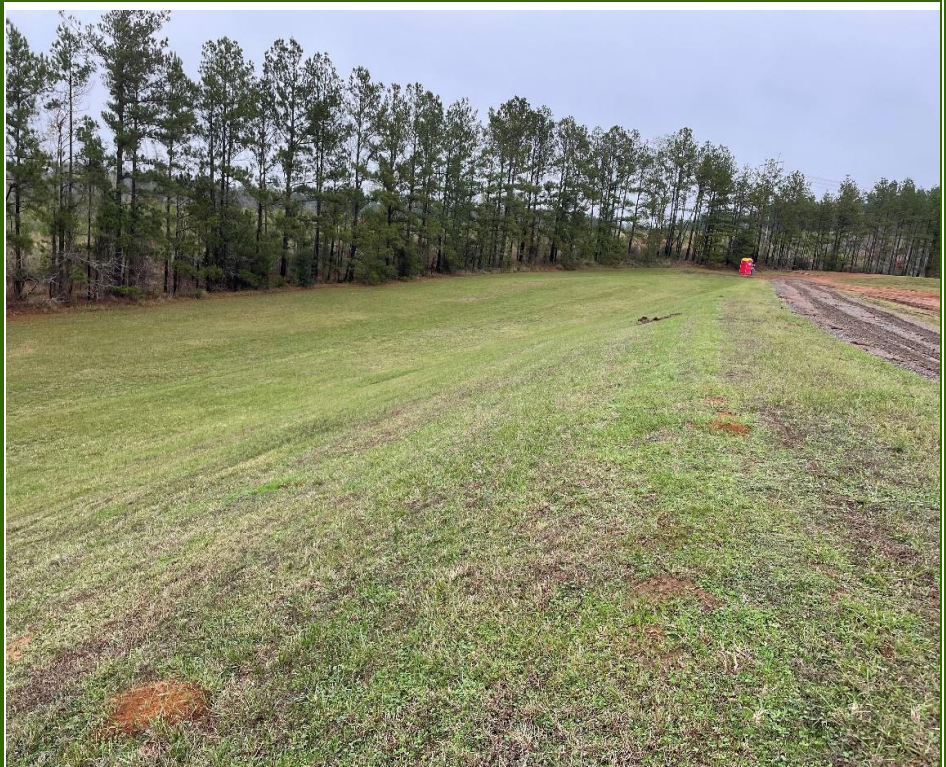
Ash Basin No. 2

Exterior slope of western levee.
