| <b>ANNUAL CCR LANDFILL INSPECTION:</b> | | | |
| <b>Facility Name:</b> | | Cleco Dolet Hills Power Station | |
| <b>Landfill Name :</b> | Dolet Hills Landfill | <b>Owner:</b> | Cleco Power LLC |
| <b>Date of Inspection:</b> | | 12/12/2017 | |

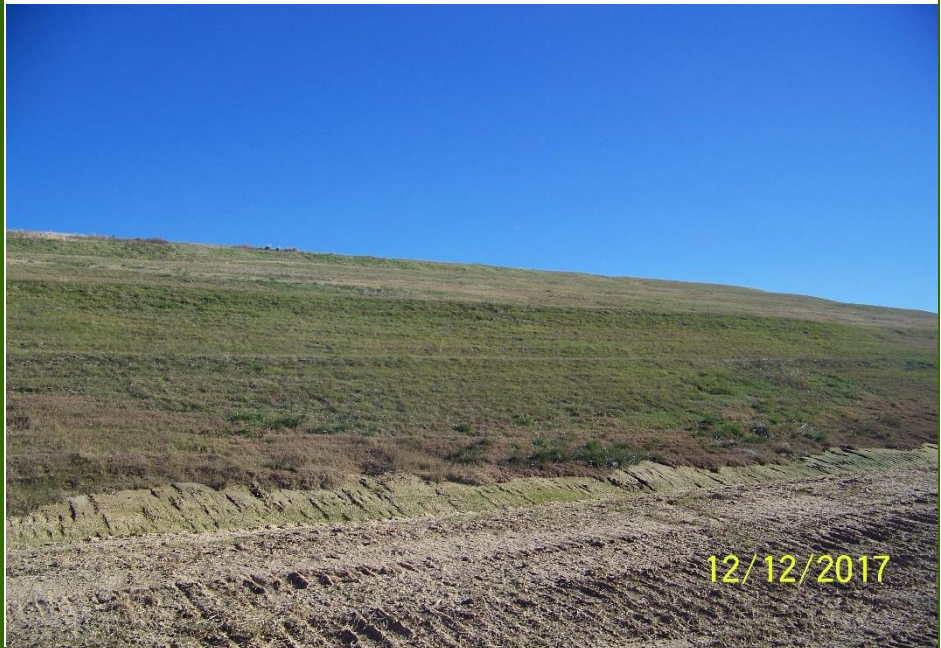
Western side slope.

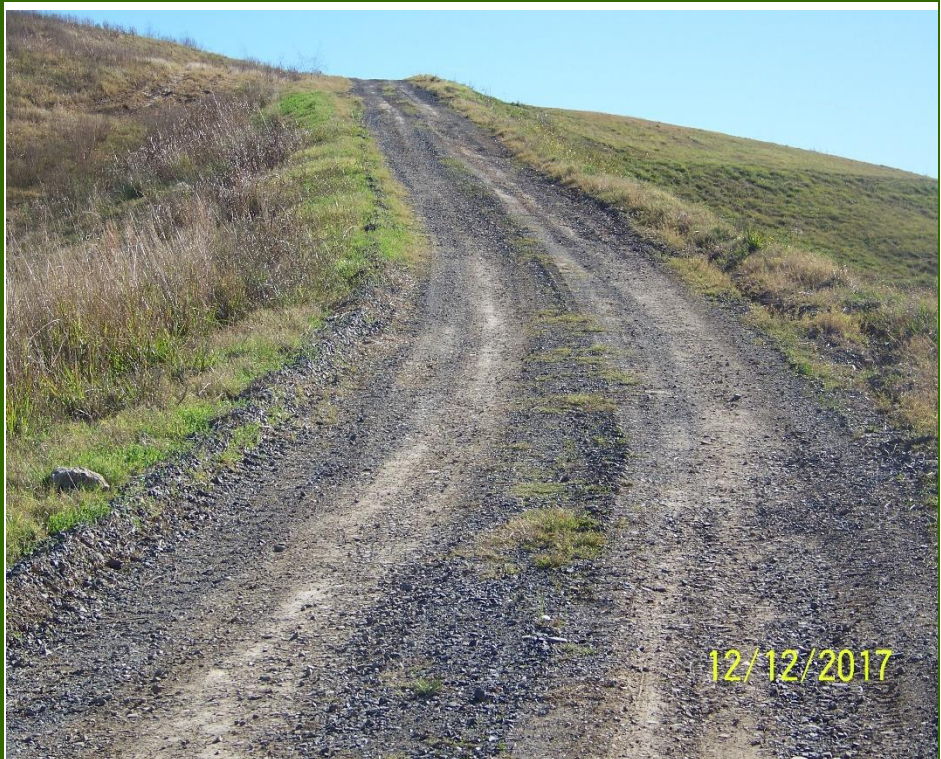
Access ramp.

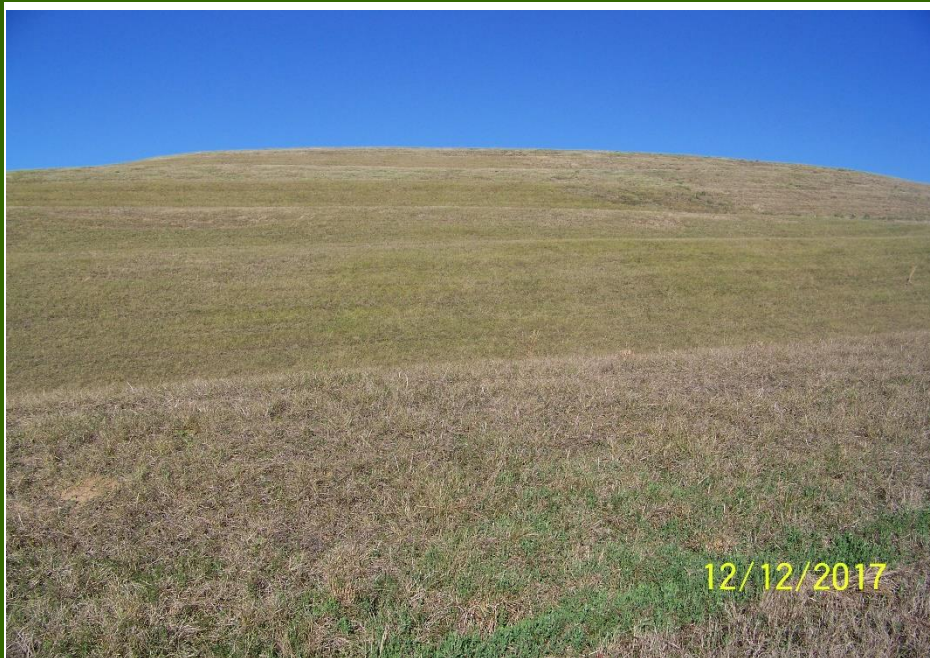
Southern slope showing terraces.

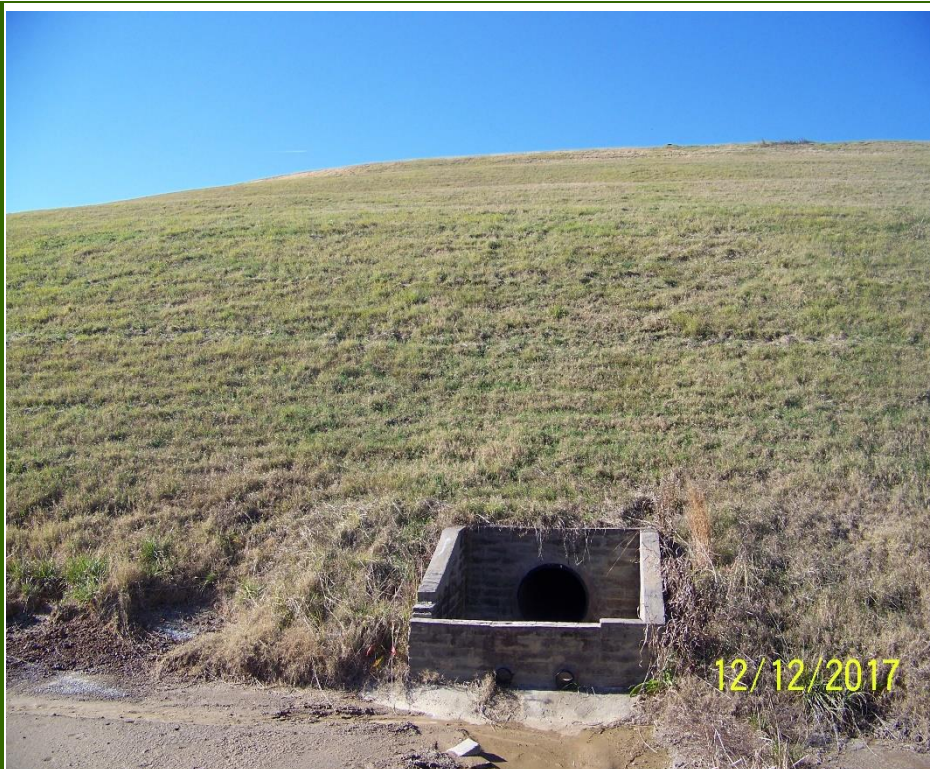
Eastern exterior slope showing discharge opening for upper elevation inlet piping.

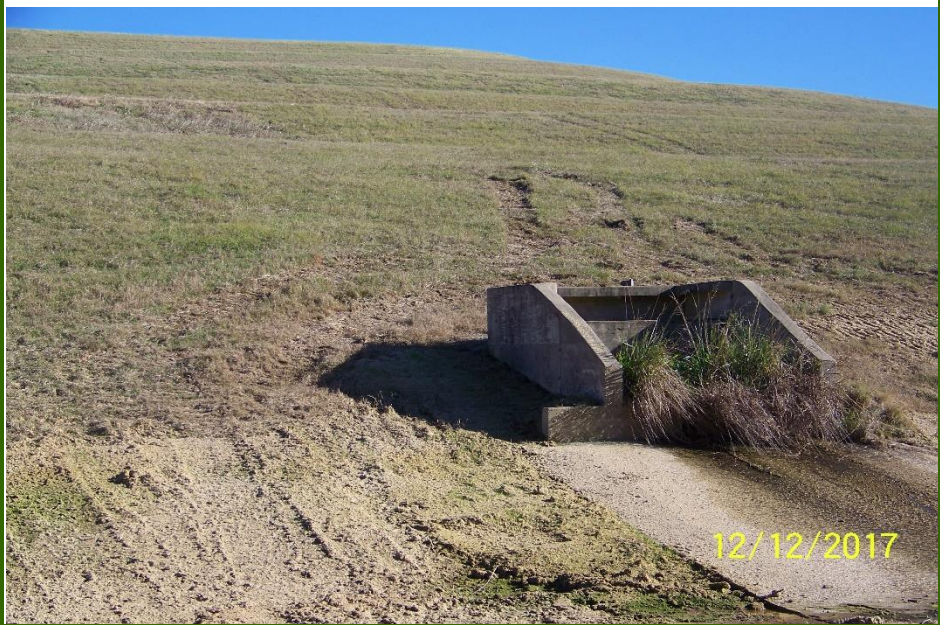
Western exterior slope showing discharge opening for upper elevation inlet piping.

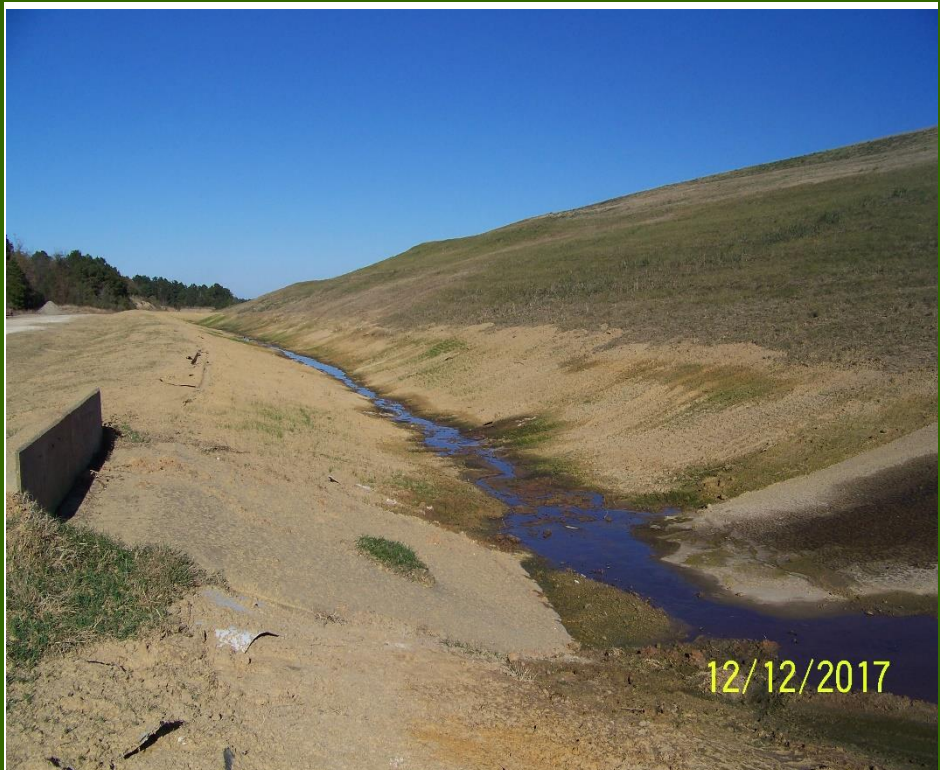
Western exterior slope showing recently hydroseeded storm water drainage ditch.

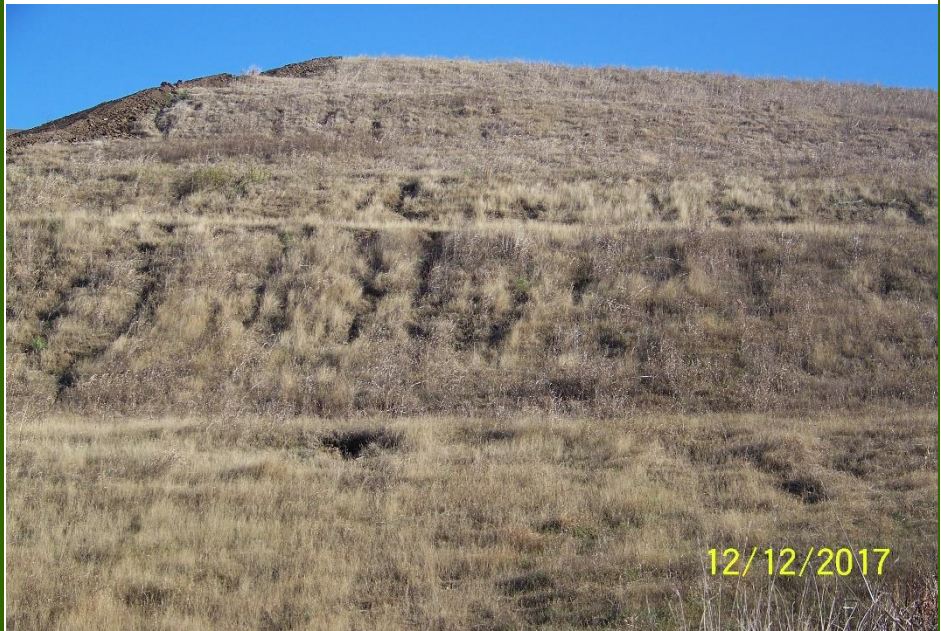
| SLOPE PROTECTION – EXTERIOR SLOPES: | |
|--|--|
| If yes, describe (size of area, location, severity, etc.) | Rills along approximately 1 acre on closed cap area on the west side slope. |

Rills on the western slope to be corrected.

| SLOPE PROTECTION – EXTERIOR SLOPES: | |
|--|--|
| <b>Findings:</b> | The exterior slopes were inspected and appeared to be in fair condition. The rills on approximately 1 acre of the closed cap on the west side slope must be filled and reseeded. |

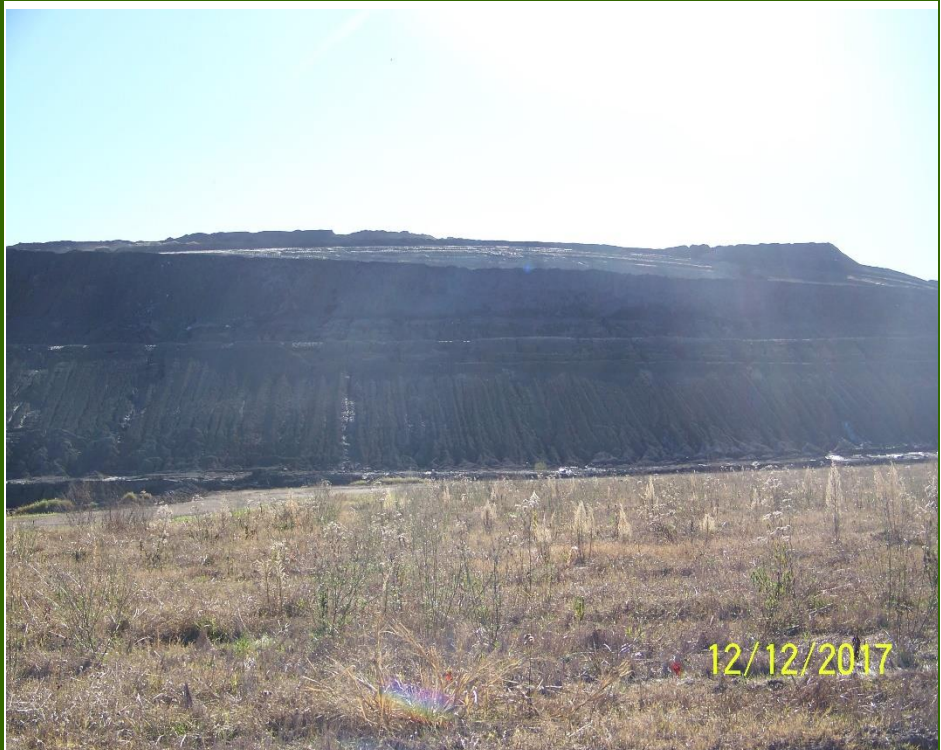
Working face of the landfill.

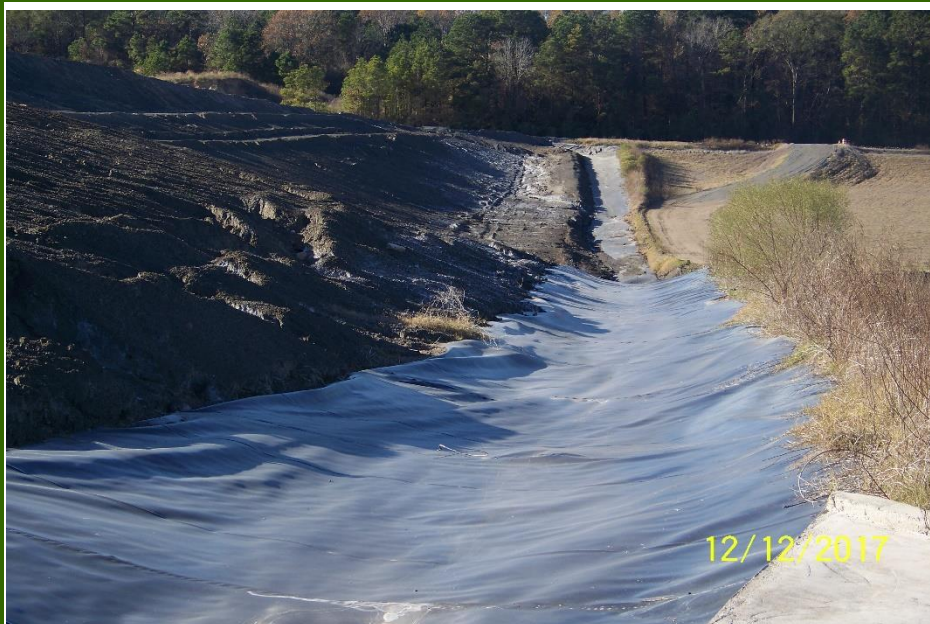
Storm water drainage ditch on edge of working face of landfill that drains to the landfill runoff pond.

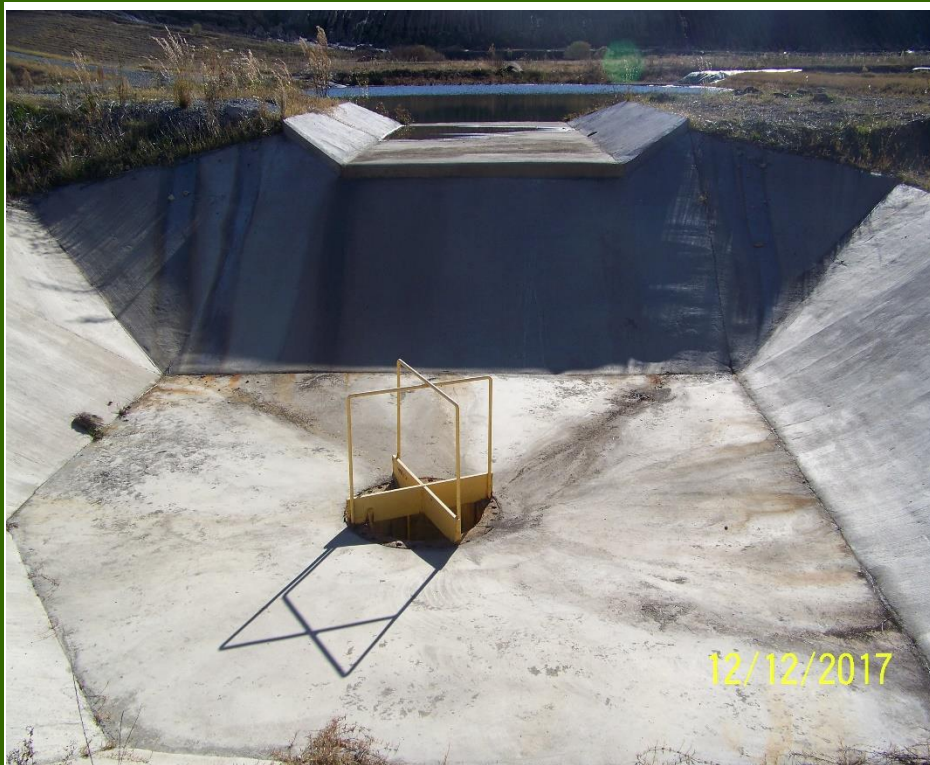
Storm water overflow inlet that drains to the landfill runoff pond.

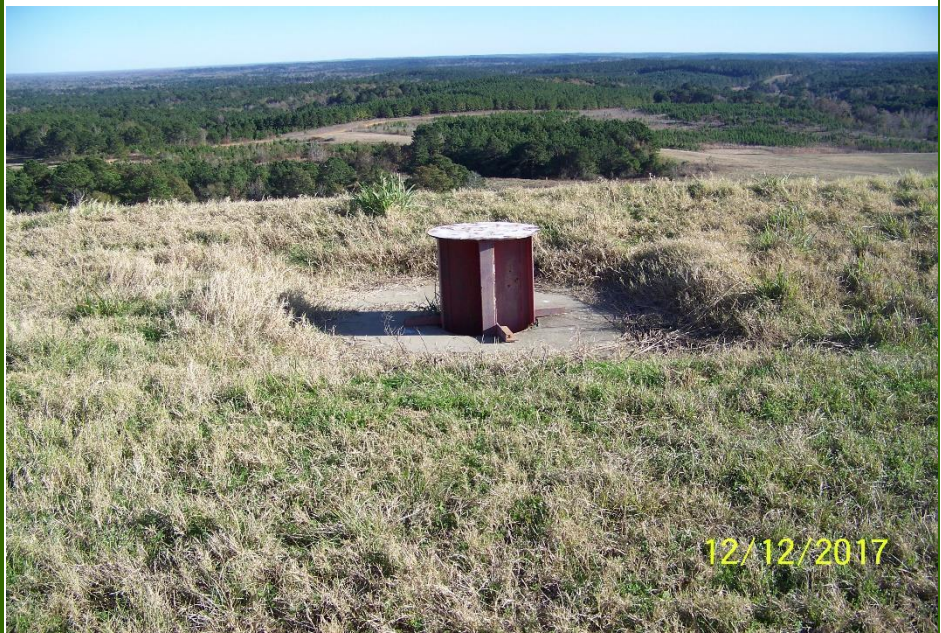
Drop inlet structure on crown of landfill cap.

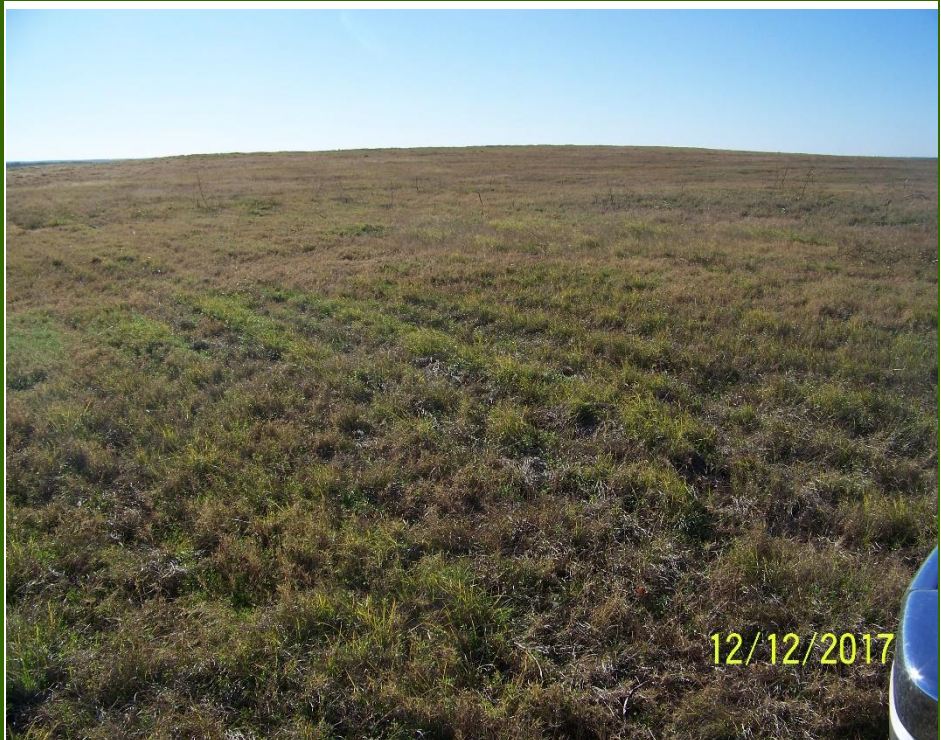
Upper elevation flat crown area.
