# **CLECO POWER LLC**

## **BRAME ENERGY CENTER**

### **CCR ANNUAL INSPECTION**

### **FLY ASH POND**

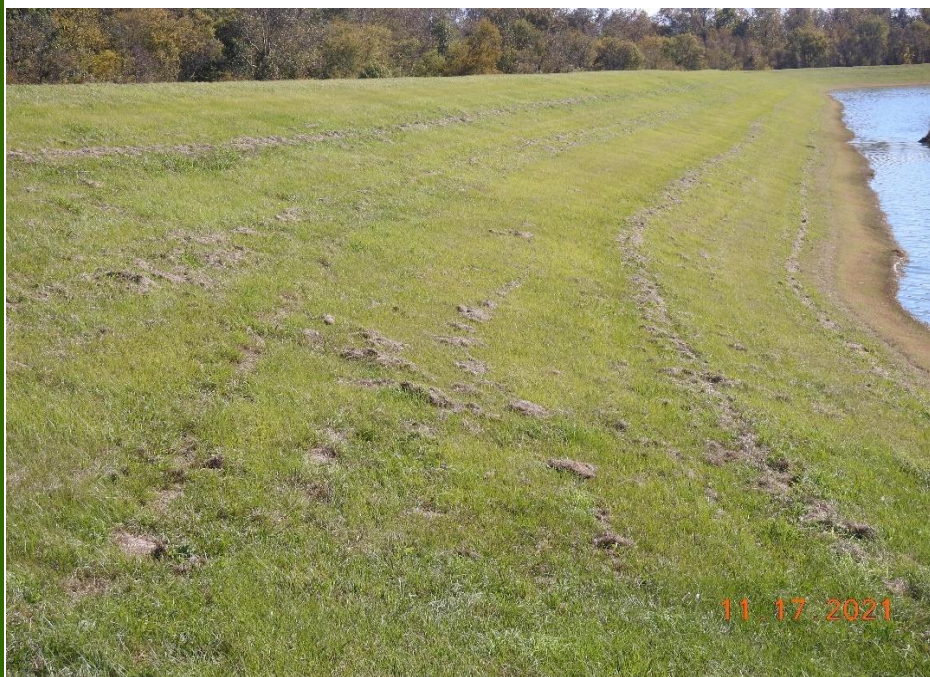
If yes, describe (size of area, location, severity, etc.)	
<b>Findings:</b>	The interior slope was inspected and appeared to be in satisfactory condition.
<b>Other observations on the interior slopes:</b>	None

Interior slope of northern levee.

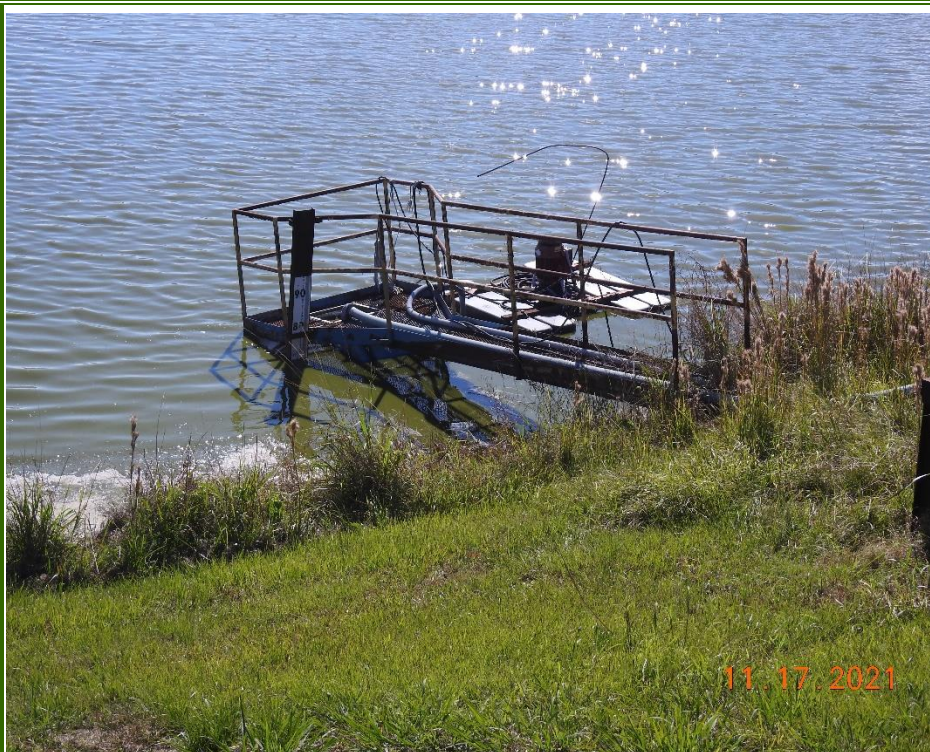
If no, describe ( type of debris, reason for obstruction, etc.)	
<b>Describe the quality of discharge from the hydraulic structure (turbidity, depth, etc.)</b>	The Fly Ash Pond was not discharging into the Bottom Ash Pond at the time of inspection.
<b>Findings:</b>	The outlet works were inspected and appeared to be in satisfactory condition. No corrective actions are required at this time.
<b>Other observations on the outlet works:</b>	None

Pump system in Fly Ash Pond that pumps discharge water into the Bottom Ash Pond.

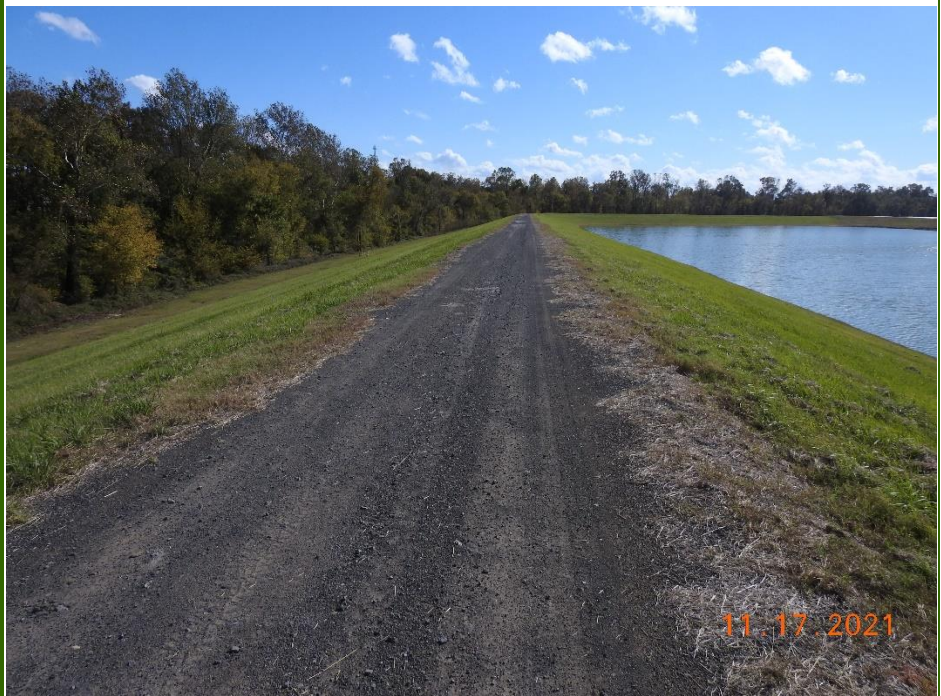
If yes, describe (size, location, etc.)	
<b>Are there any sinkholes?</b>	<input type="checkbox"/> Yes <input checked="" type="checkbox"/> No
If yes, describe (size, location, etc.)	
<b>Findings:</b>	The crest was inspected and appeared to be in satisfactory condition. No corrective actions are required at this time.
<b>Other observations on the crest:</b>	None

Crest along the northern levee.

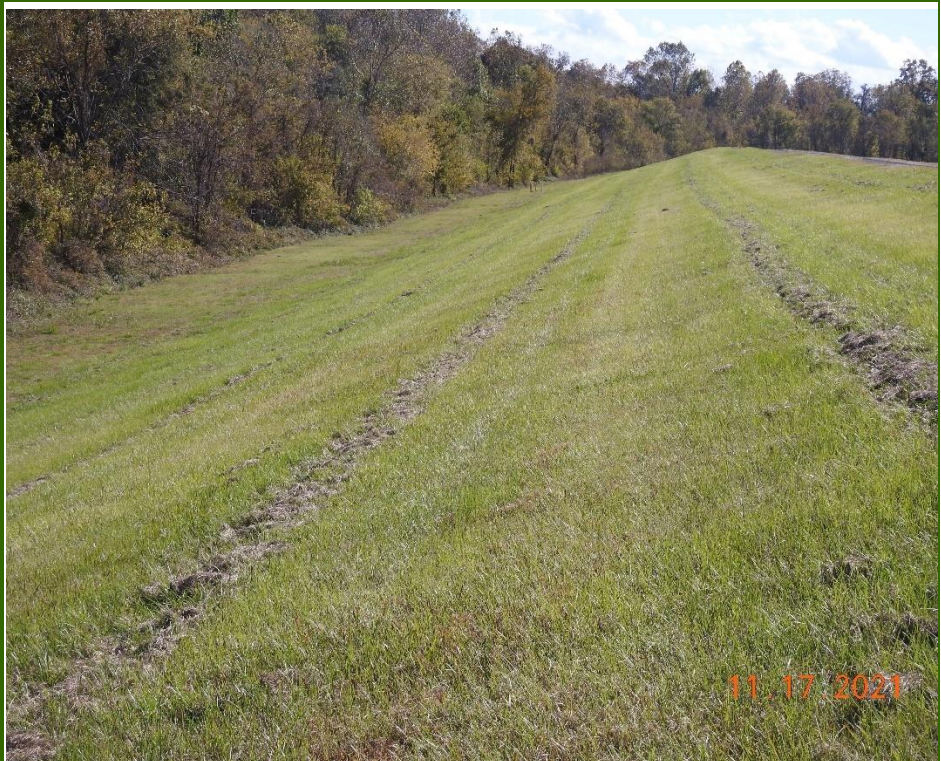
If yes, describe (size of area, location, severity, etc.)	
<b>Are there any trees on the slopes?</b>	<input type="checkbox"/> Yes <input checked="" type="checkbox"/> No
If yes, describe (type of vegetation, size, location, etc.)	
<b>Findings:</b>	The exterior slope was inspected and appeared to be in satisfactory condition.
<b>Other observations on the exterior slopes:</b>	None

Northern exterior levee slope.

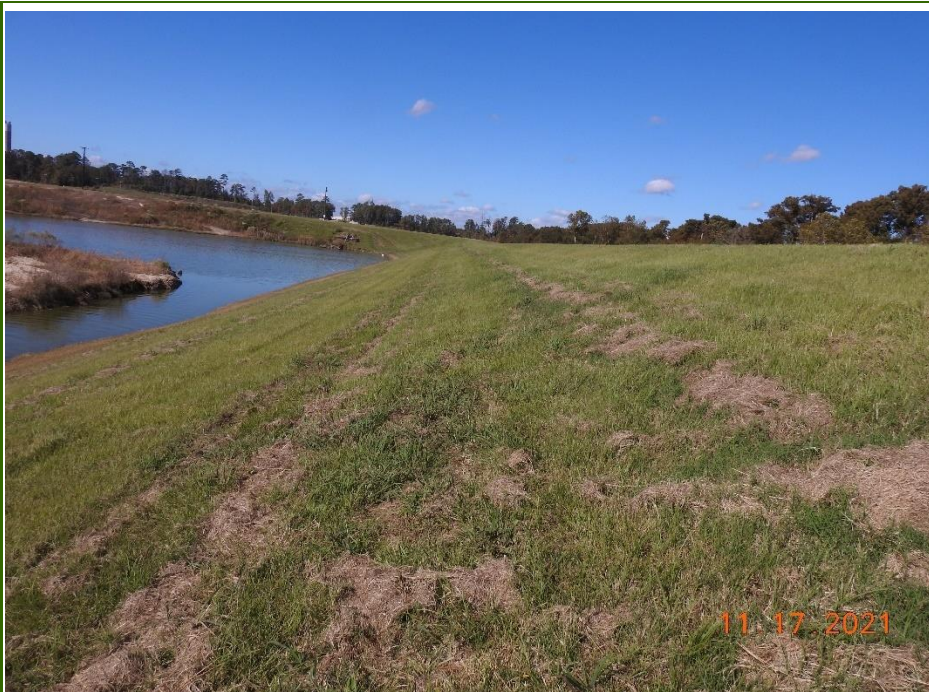
Interior slope of northern levee.

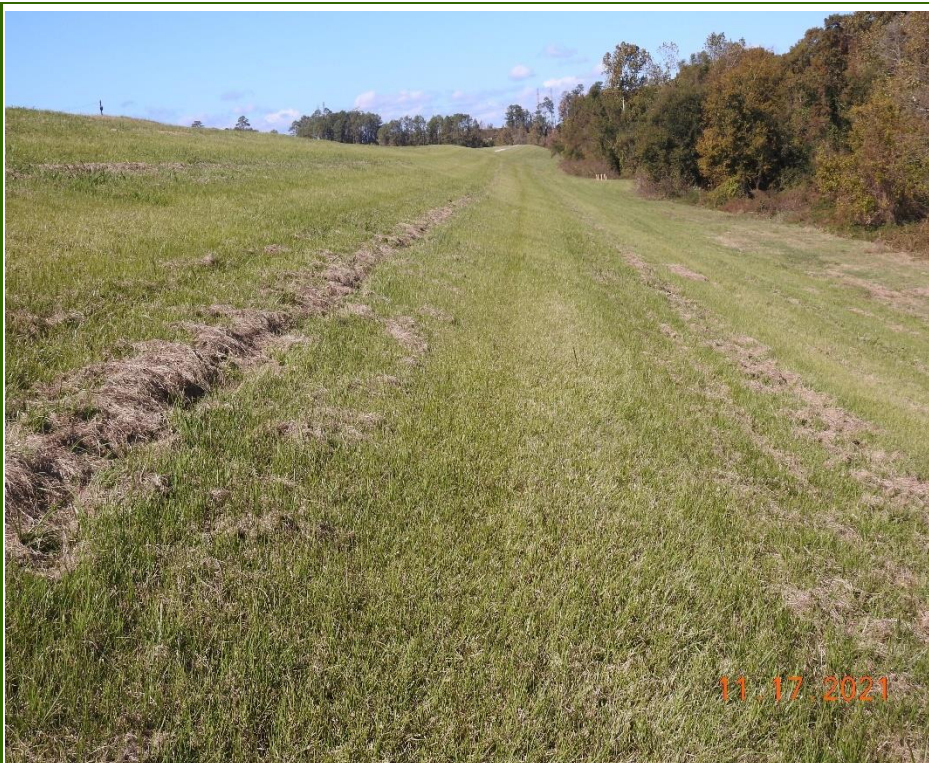
Exterior slope of northern levee.

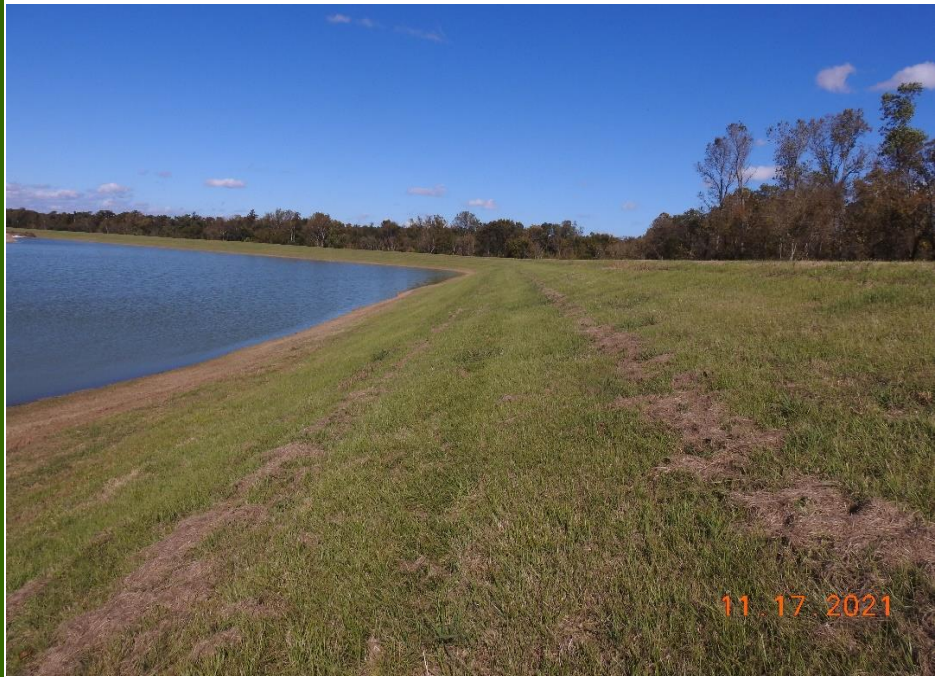
Interior slope of eastern levee.

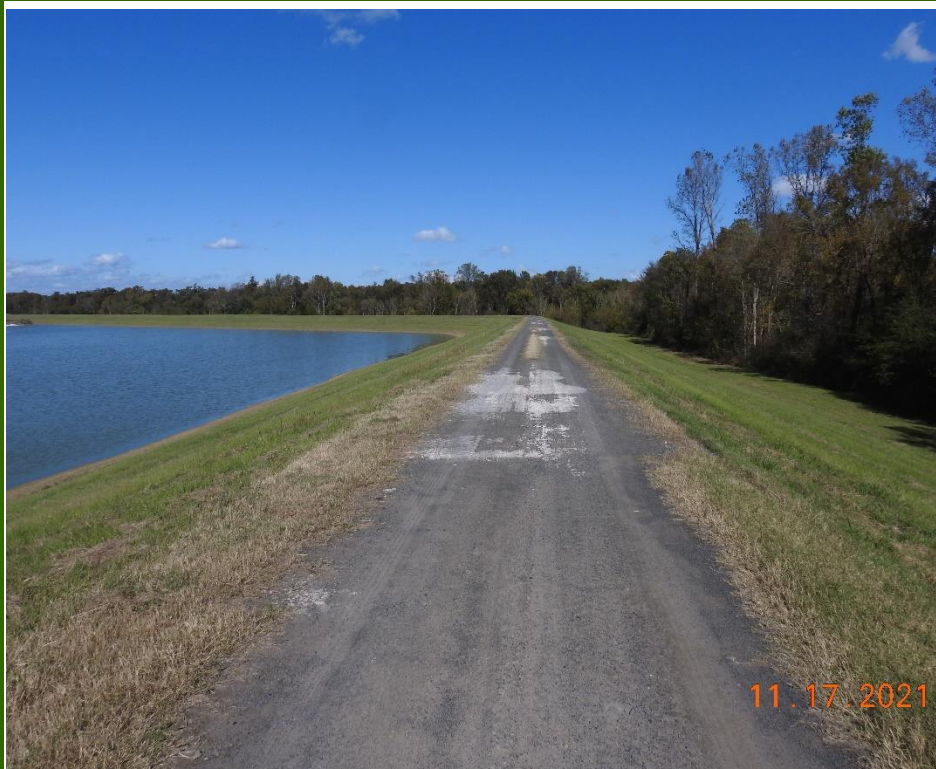
Crest along eastern levee.

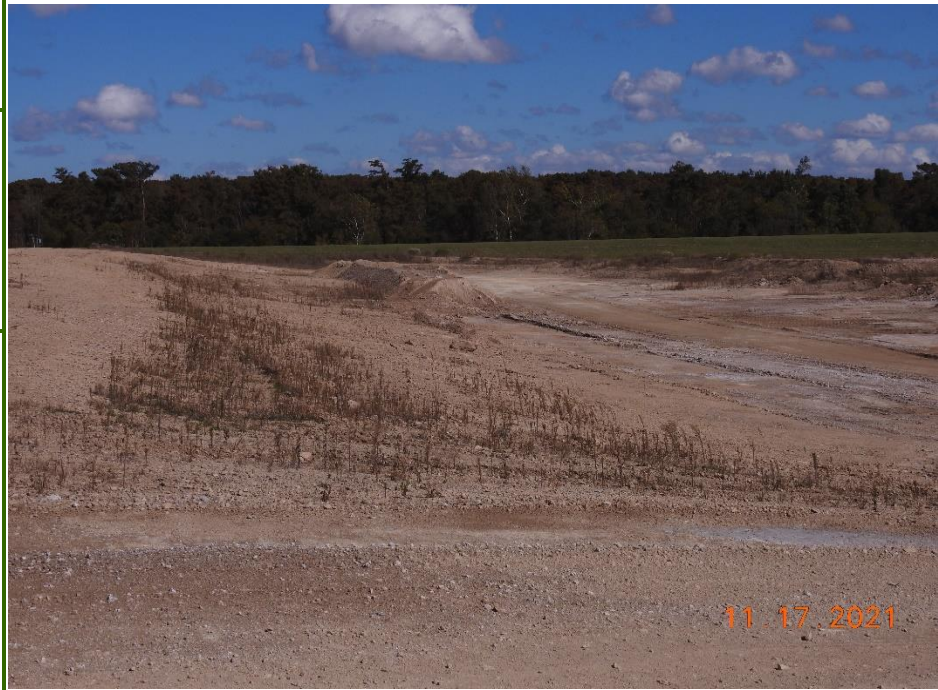
**Comments:**  
Fly ash in the Fly Ash Pond.

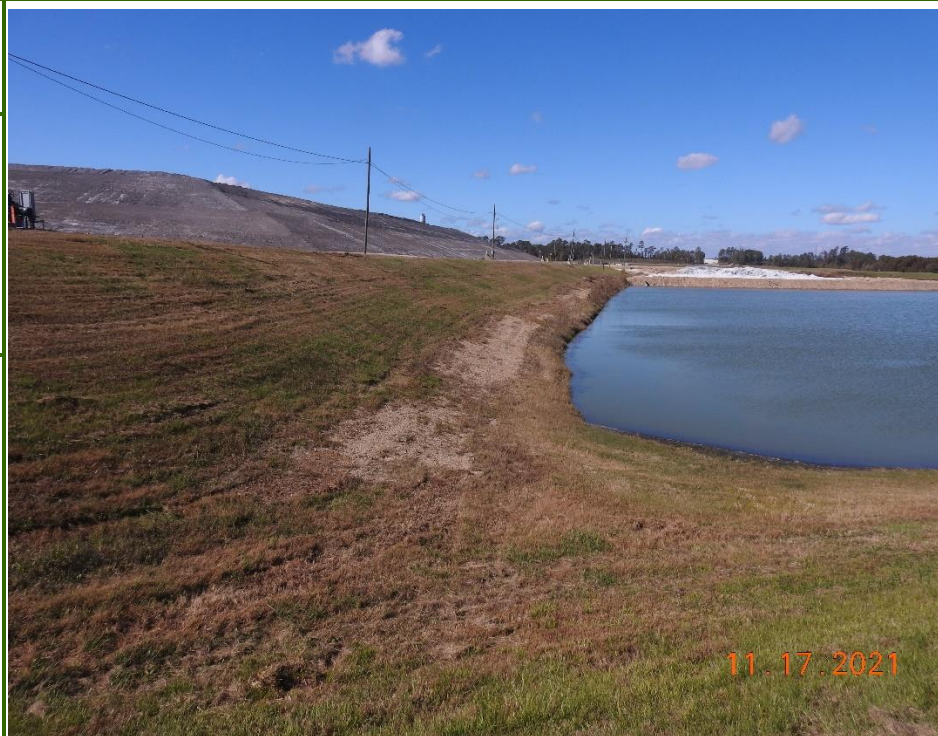
**Comments:**  
Interior slope on southern levee.
