BRAME ENERGY CENTER

CCR ANNUAL INSPECTION

BOTTOM ASH POND

JANUARY 2023

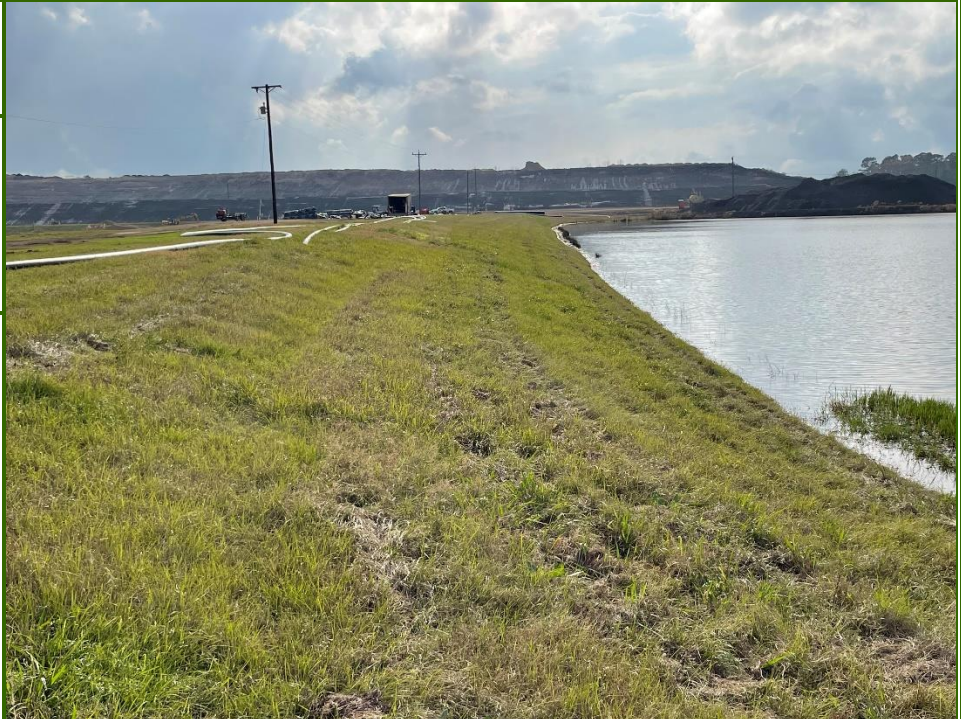
Bottom Ash Pond

Interior slope of eastern levee.

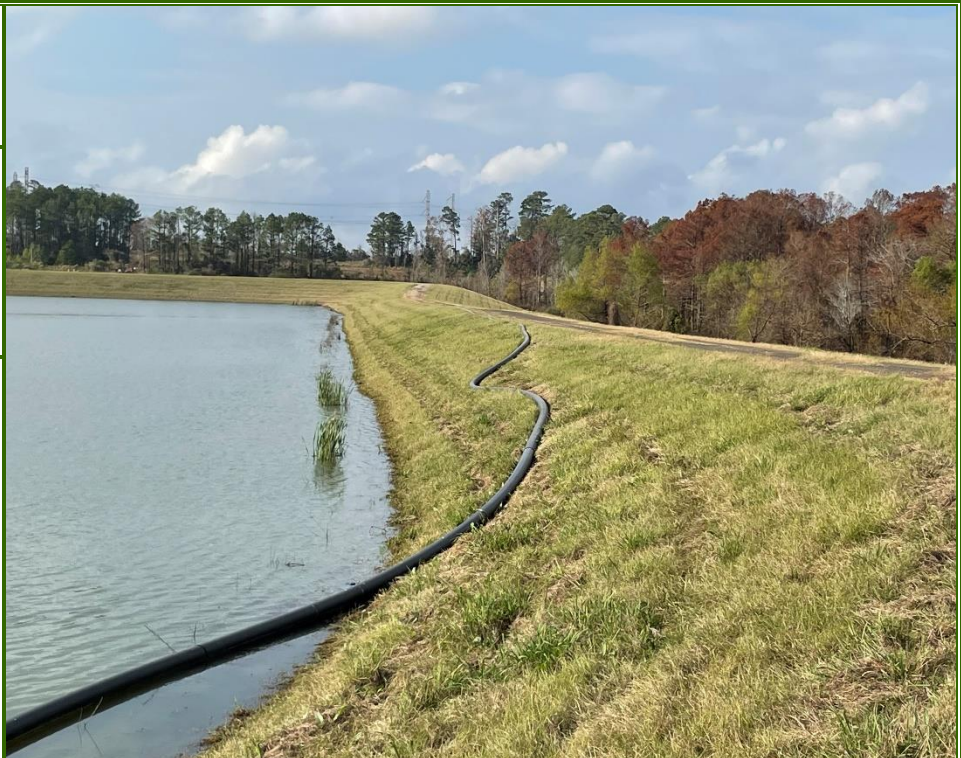
Interior slope of northern levee.

HDPE pipe not part of Bottom Ash Pond Operations.

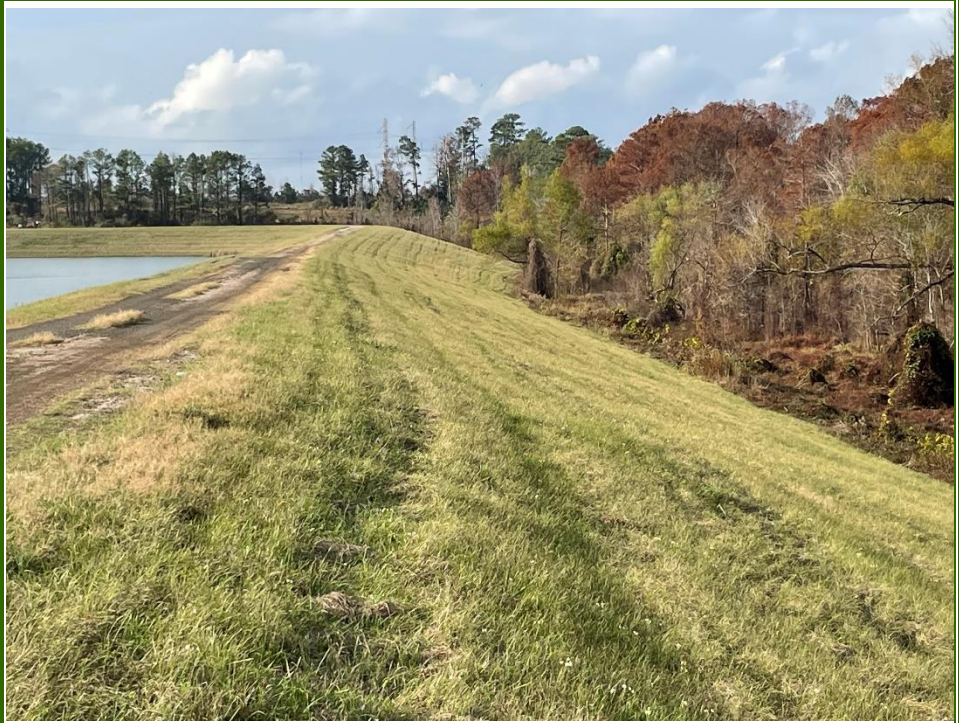
Bottom Ash Pond

Exterior slope of northern levee.

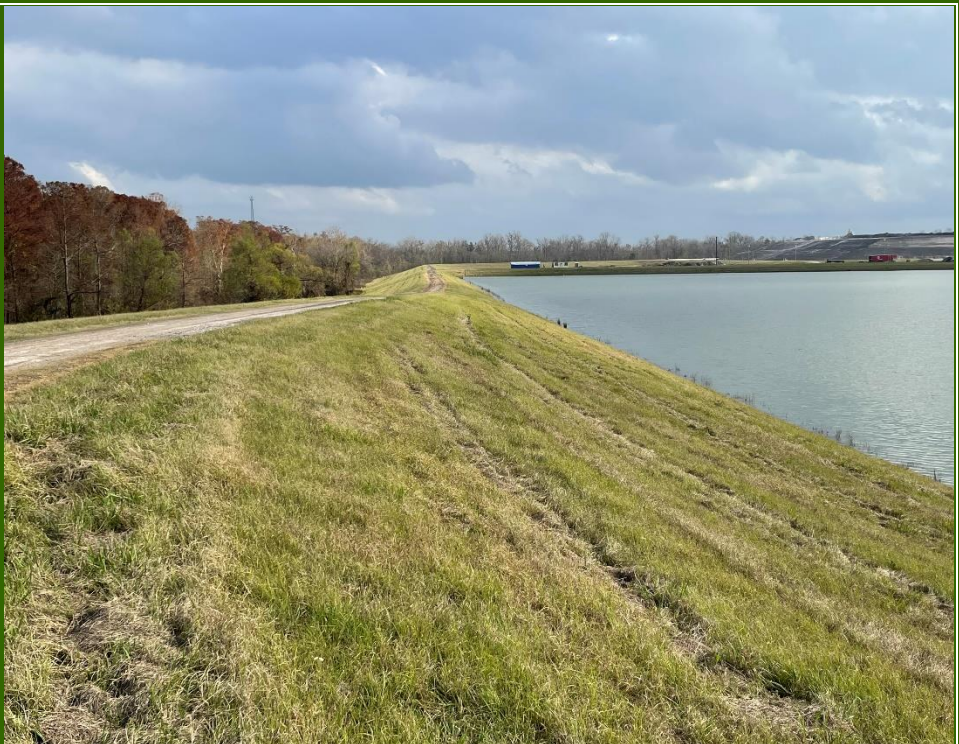
Bottom Ash Pond

Interior slope of northern levee.

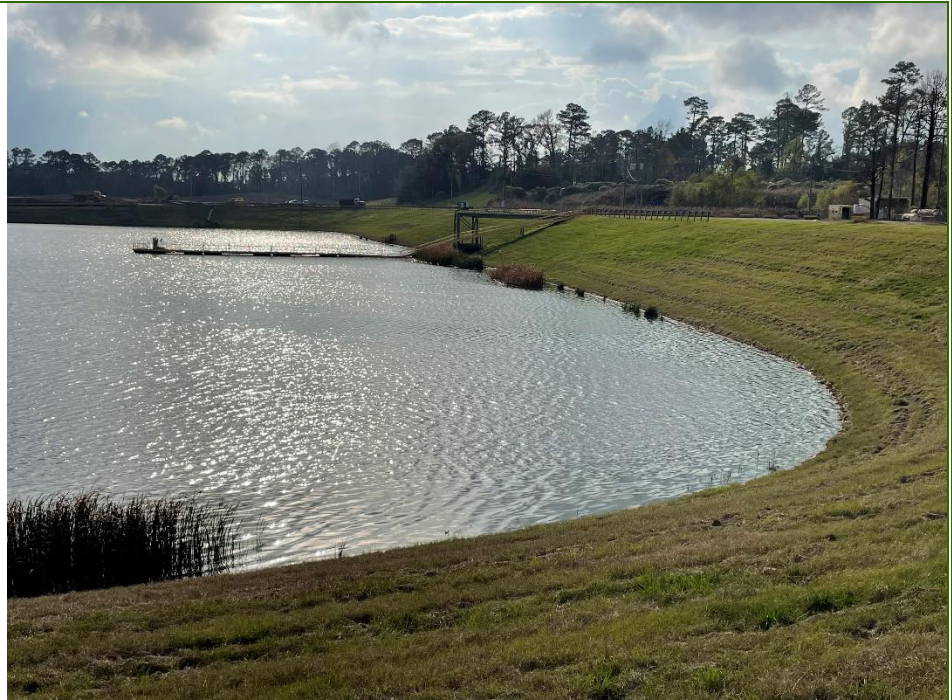
Bottom Ash Pond

Interior slope of western levee.

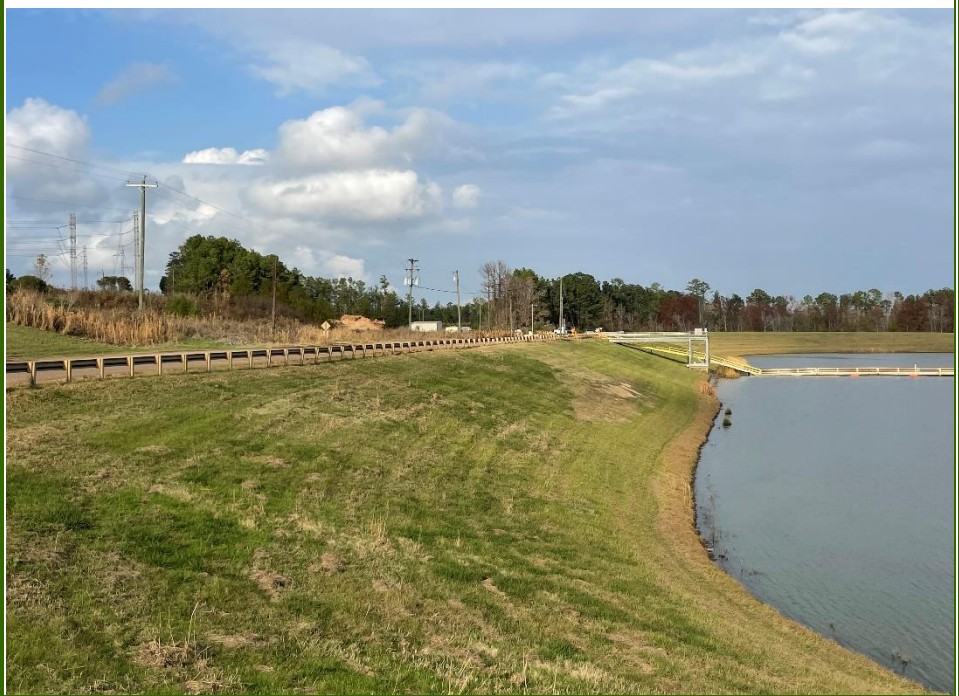
Bottom Ash Pond

Interior slope of western levee.

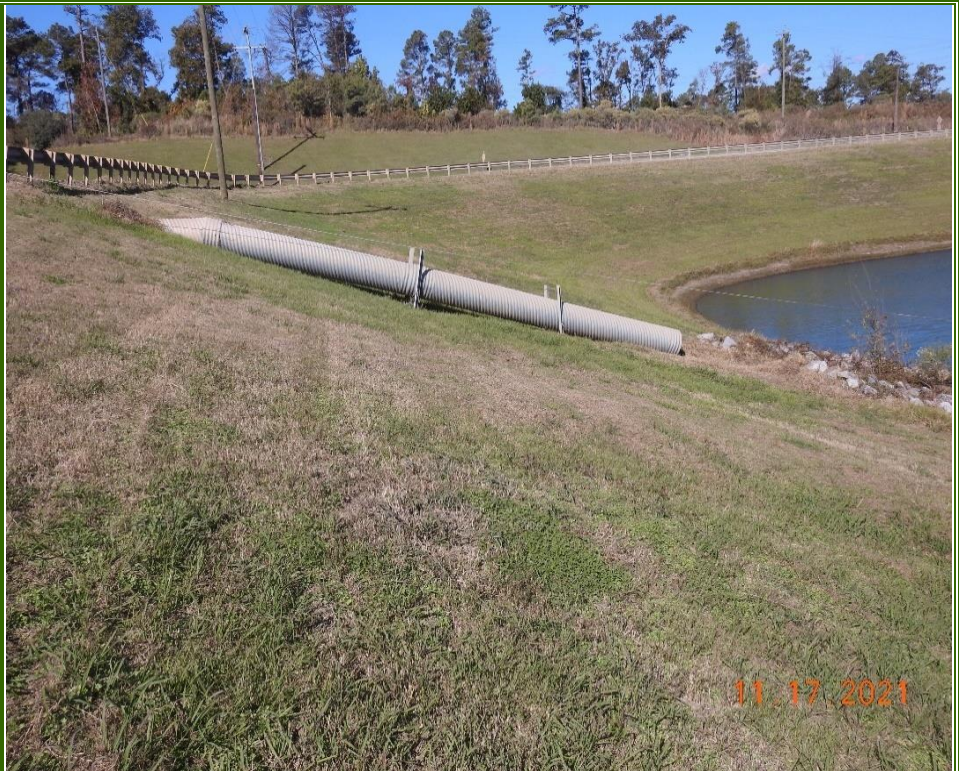
Bottom Ash Pond

Interior slope of southern levee.
