CLECO POWER LLC BRAME ENERGY CENTER

CCR ANNUAL INSPECTION

BOTTOM ASH POND

JANUARY 2024

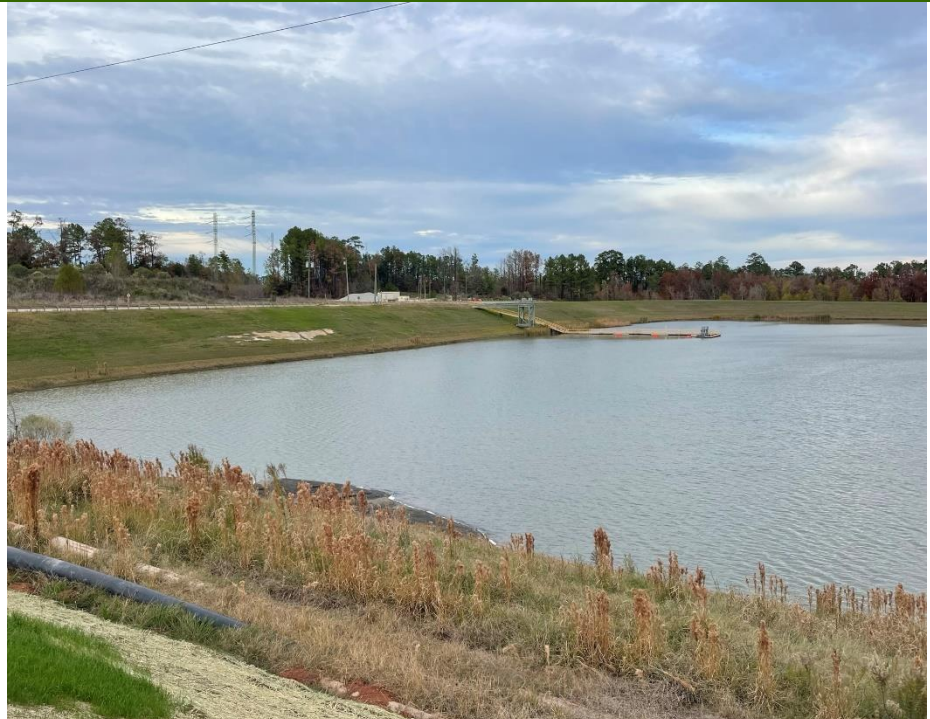
Northern portion of Bottom Ash Pond

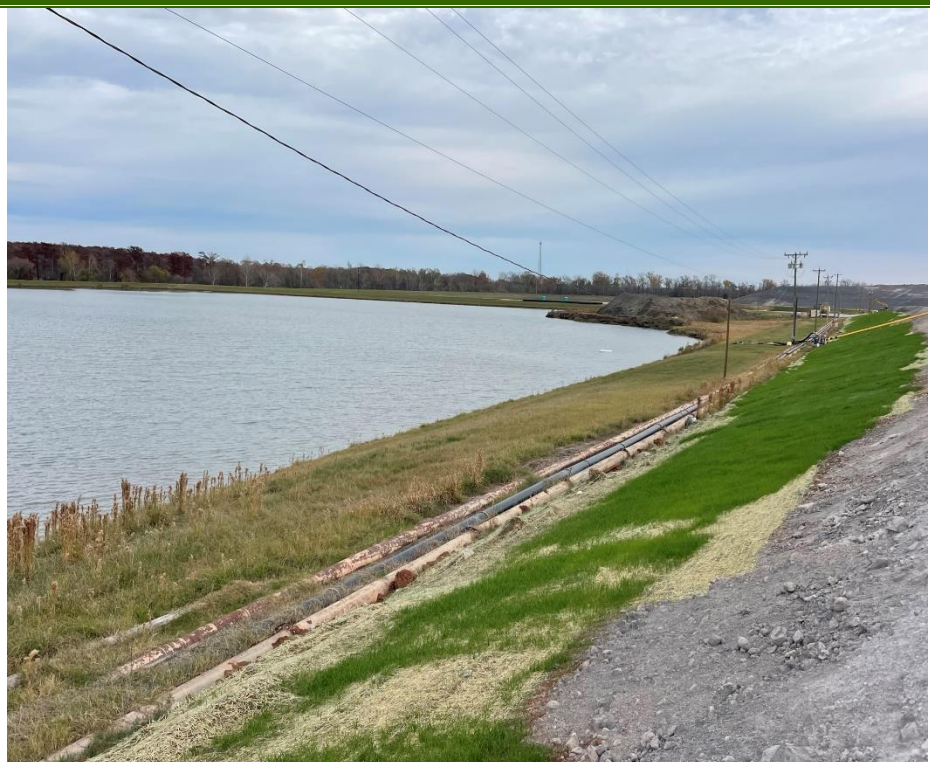
Western portion of Bottom Ash Pond

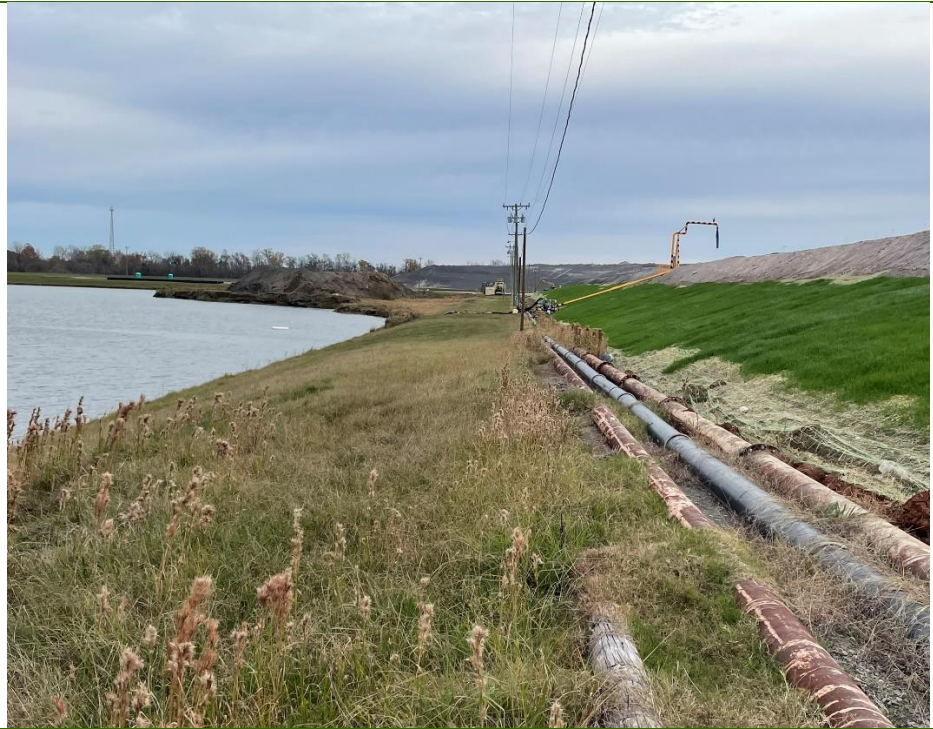
If yes, describe (size of area, location, severity, etc.)	
Findings:	The interior slope was inspected and appeared to be in satisfactory condition. Some excessive vegetation on the interior of the west slope adjacent to Cell 4 of the landfill.
Other observations on the interior slopes:	None.

Vegetation on western slope

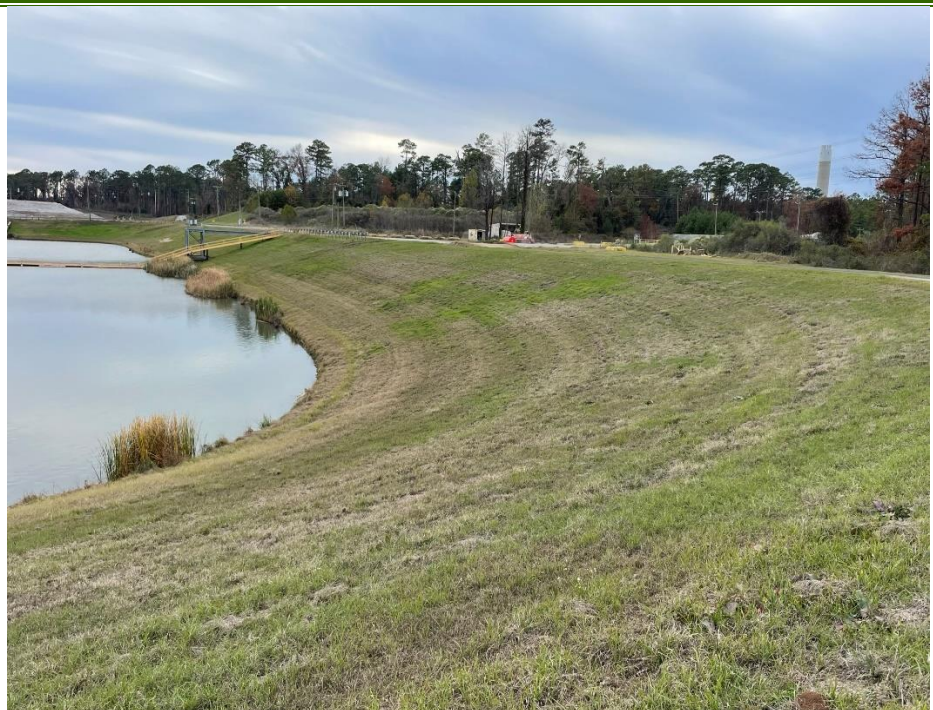
Interior slopes (northeast corner)

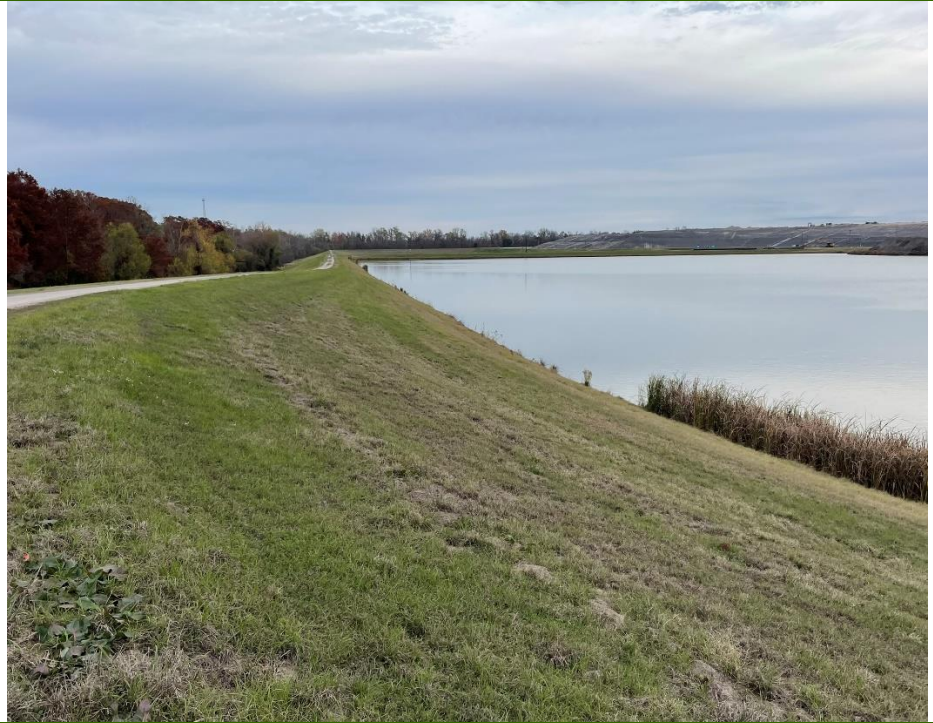
Interior pond slope and levee crown on east side

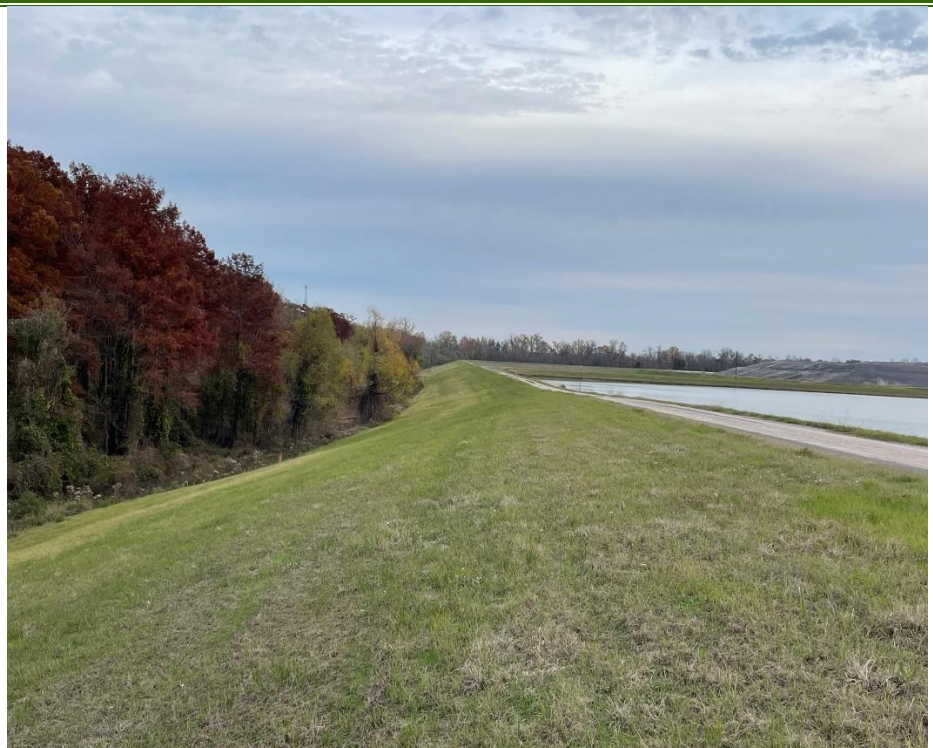
Exterior pond slope on east side
