BRAME ENERGY CENTER

CCR ANNUAL INSPECTION

LANDFILL—CELL 4

JANUARY 2024

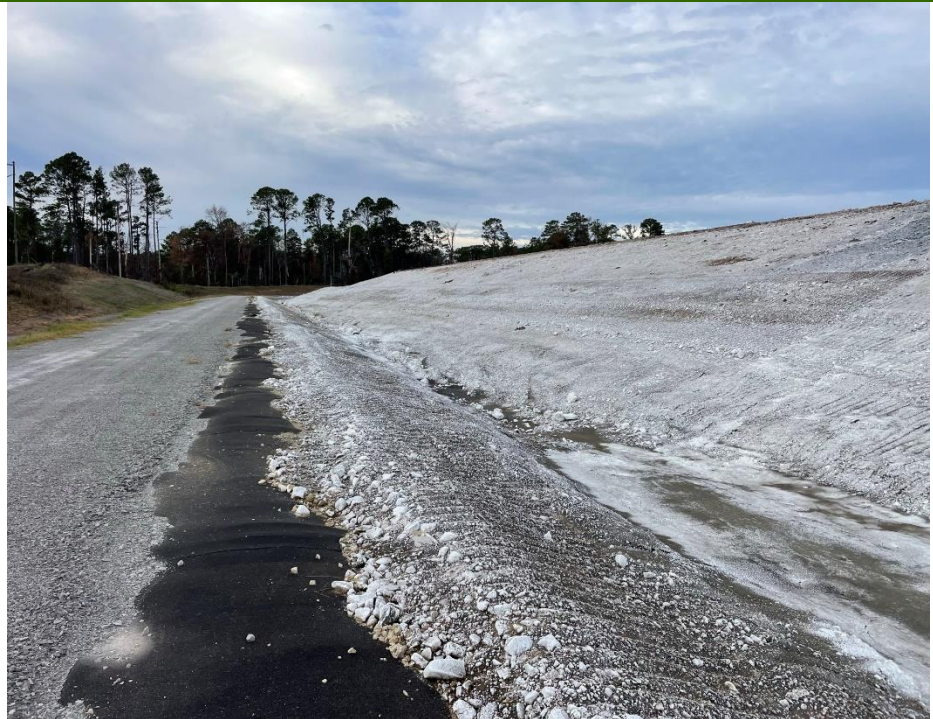
Landfill Cell 4

Western levee,
access road, and
interior ditch

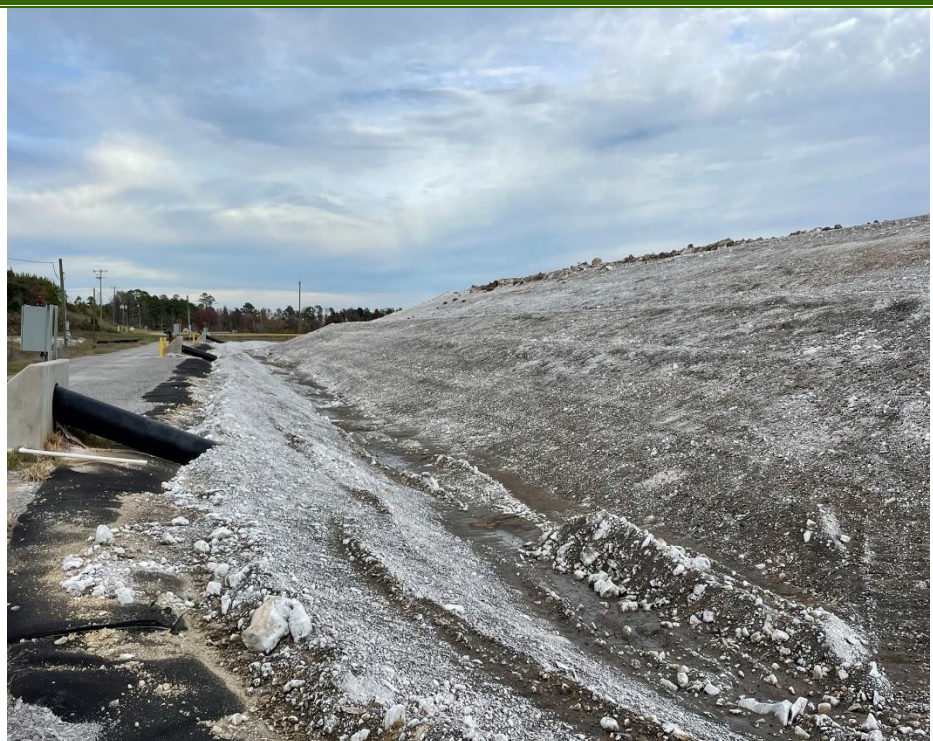
Landfill Cell 4

Northwest slope,
leachate extraction
risers, and interior
ditch

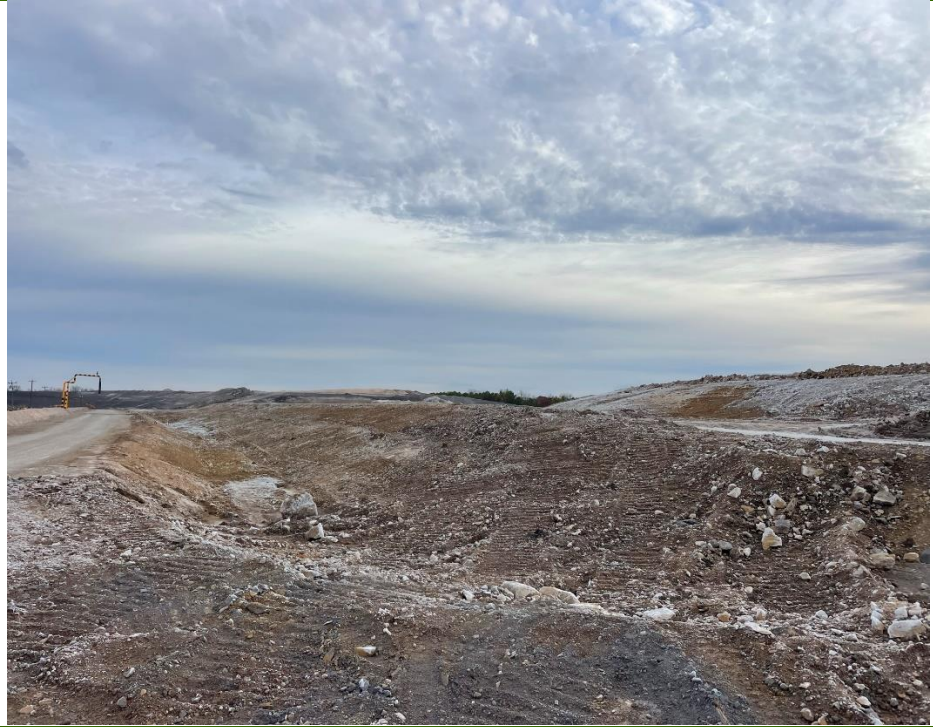
Landfill Cell 4

Active portion of Cell 4
