<b>ANNUAL CCR SURFACE IMPOUNDMENT INSPECTION</b>			
<b>Facility Name:</b>		Cleco Brame Energy Center	
<b>Address:</b>		275 Rodemacher Rd. Lena, LA	
<b>Surface Impoundment Name :</b>	Bottom Ash Pond	<b>Owner:</b>	Cleco Power LLC
<b>Surface Impoundment ID:</b>	P-0005	<b>Operator:</b>	Cleco Power LLC
<b>Nearest City:</b>	Boyce	<b>Parish:</b>	Rapides
<b>Inspector:</b>		James C. Van Hoof, P.E.	
<b>Company:</b>		Providence Engineering & Environmental Group LLC	
<b>Date of Inspection:</b>		12/15/2016	
<b>Weather at Time of Inspection:</b>		Sunny, Cool	
<b>DESCRIPTION OF THE OPERATION OF THE SURFACE IMPOUNDMENTS:</b>			
<p>The Brame Energy Center's Bottom Ash and Fly Ash surface impoundments are designed to accept the coal combustion residual (CCR) byproducts derived from burning of the Unit 2 coal for the generation of electricity. The ponds are classified by the Louisiana Department of Environmental Quality (LDEQ) as Type I Surface Impoundments. Water from the Fly Ash surface impoundment is pumped into the Bottom Ash impoundment which discharges by means of three pumps that discharge the wastewater through the outlet pipe on the northern end of the pond. This water discharges into Lake R

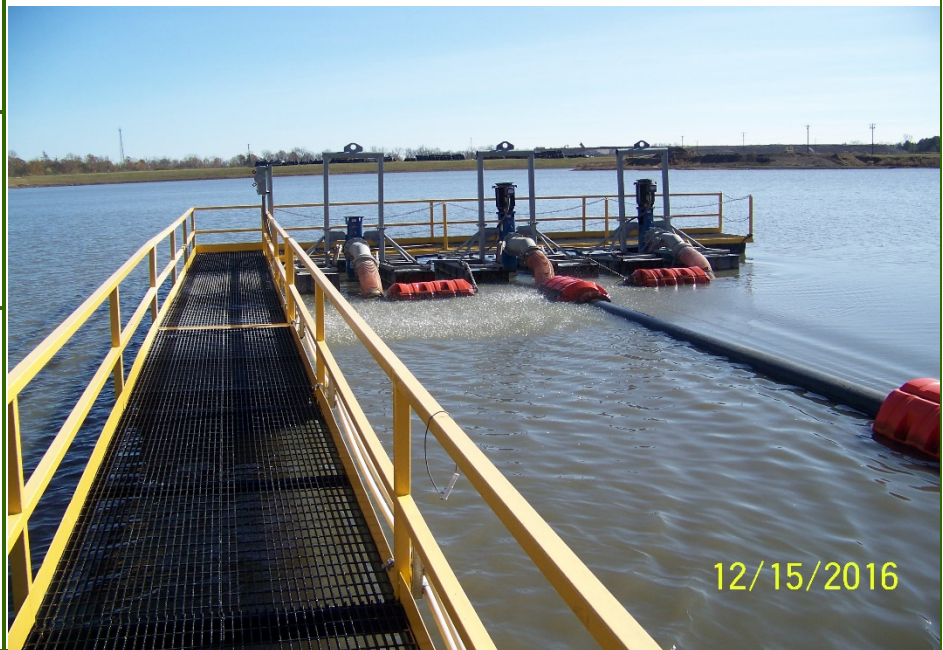
Floating pump structure in Bottom Ash Pond.

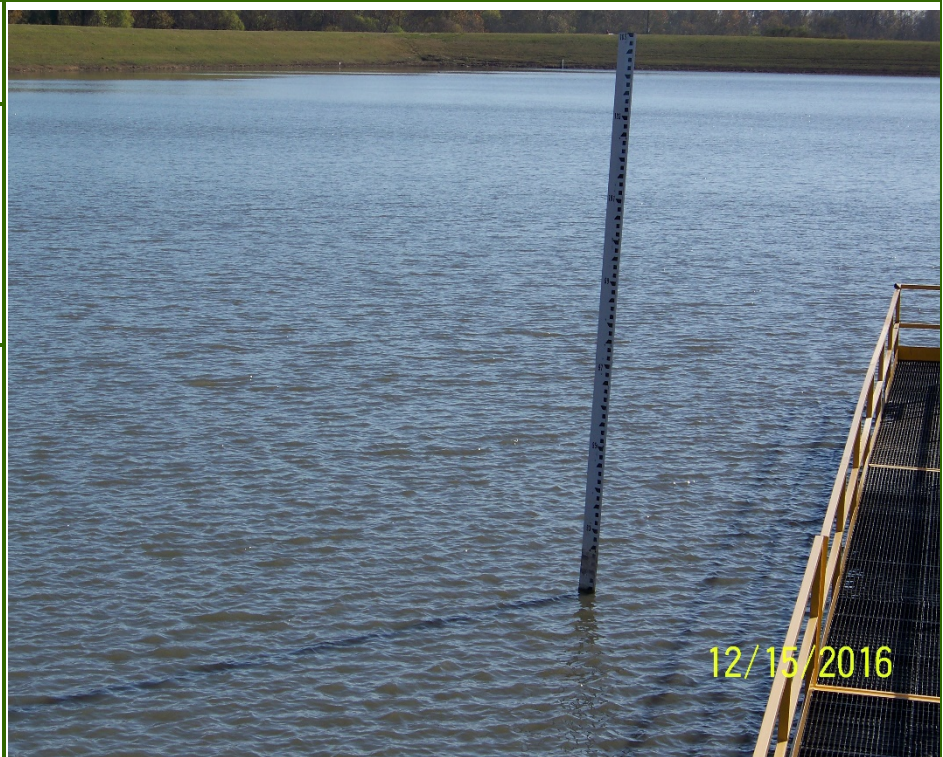
Level Gauge near floating pump structure in Bottom Ash Pond.

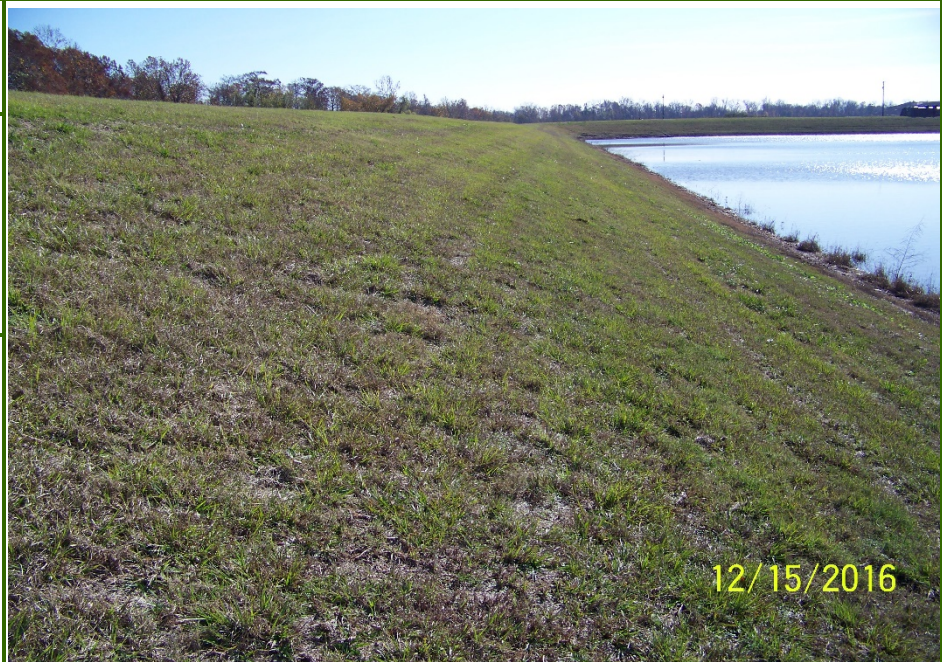
Northern slope of internal levee.

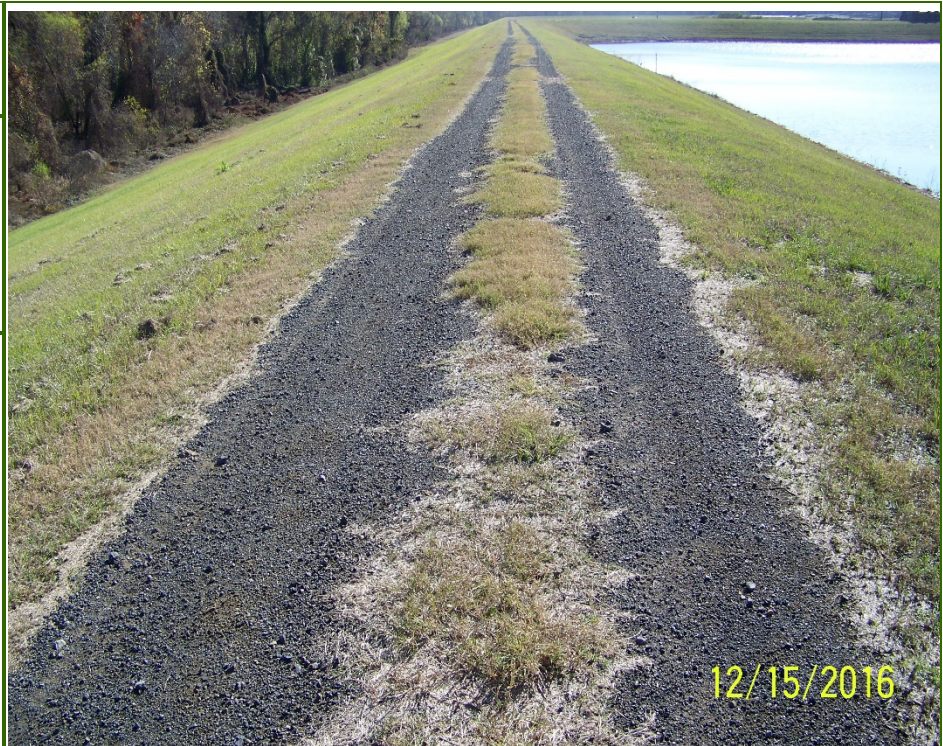
Crest of northern levee.

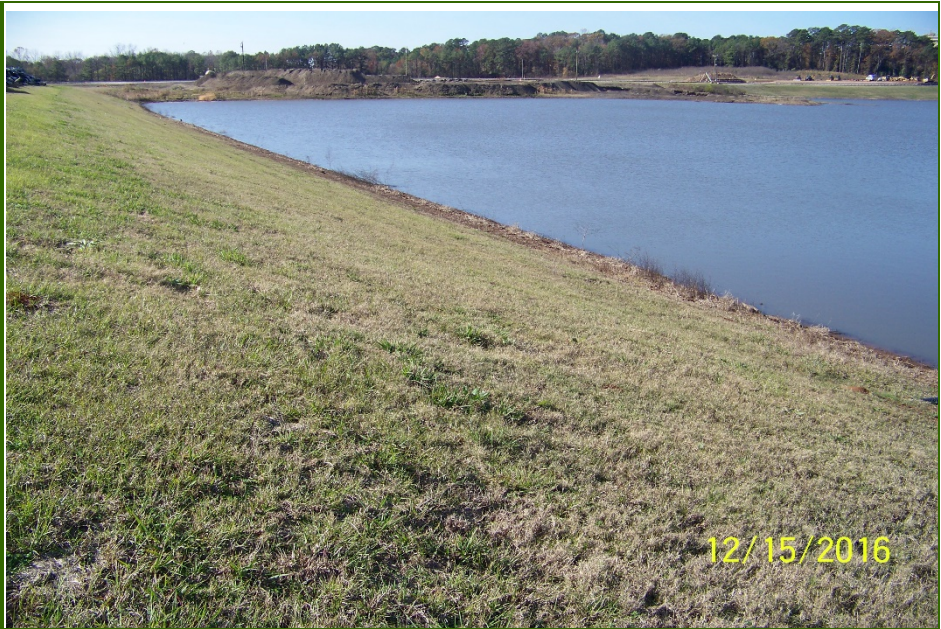
Inside slope of eastern levee.

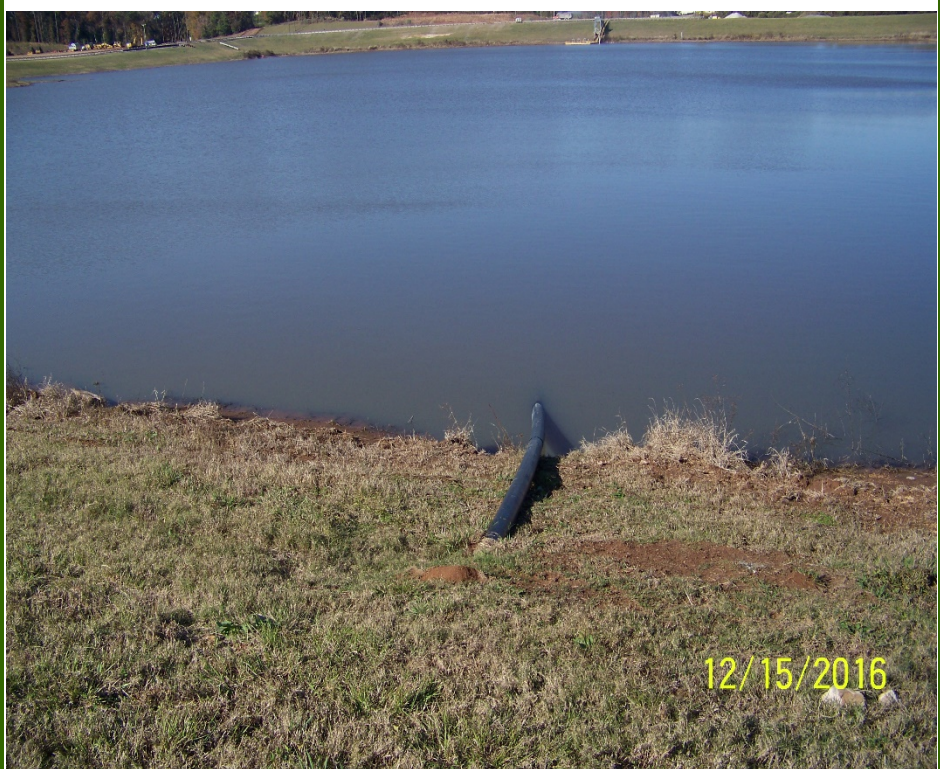
Discharge pipe from the Fly Ash Pond into the Bottom Ash Pond.

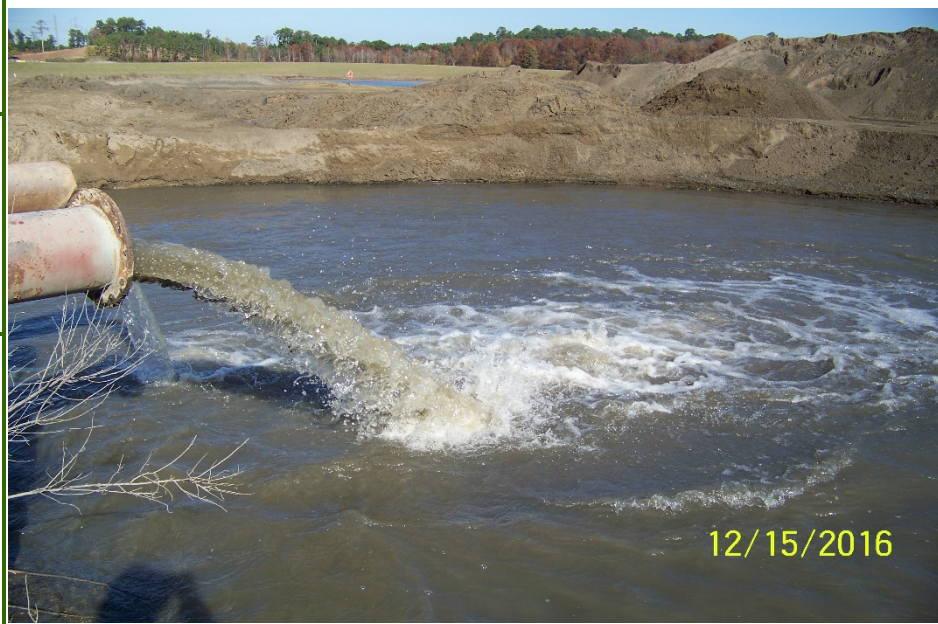
Sluice pipe discharging into the Bottom Ash Pond.

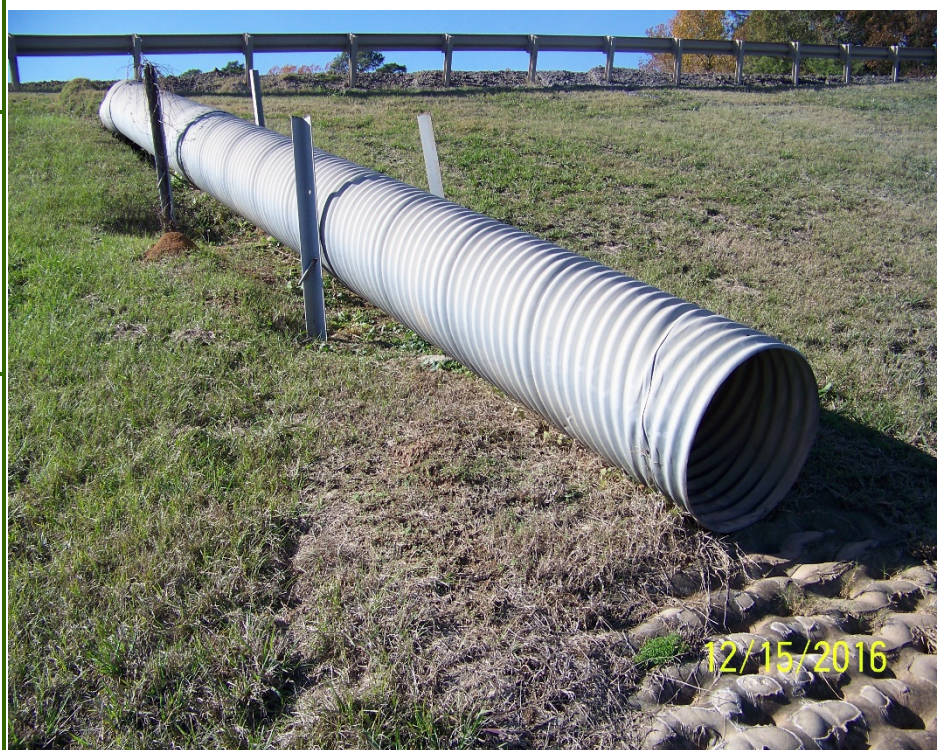
Storm water discharge pipe from sluice pipe trench.

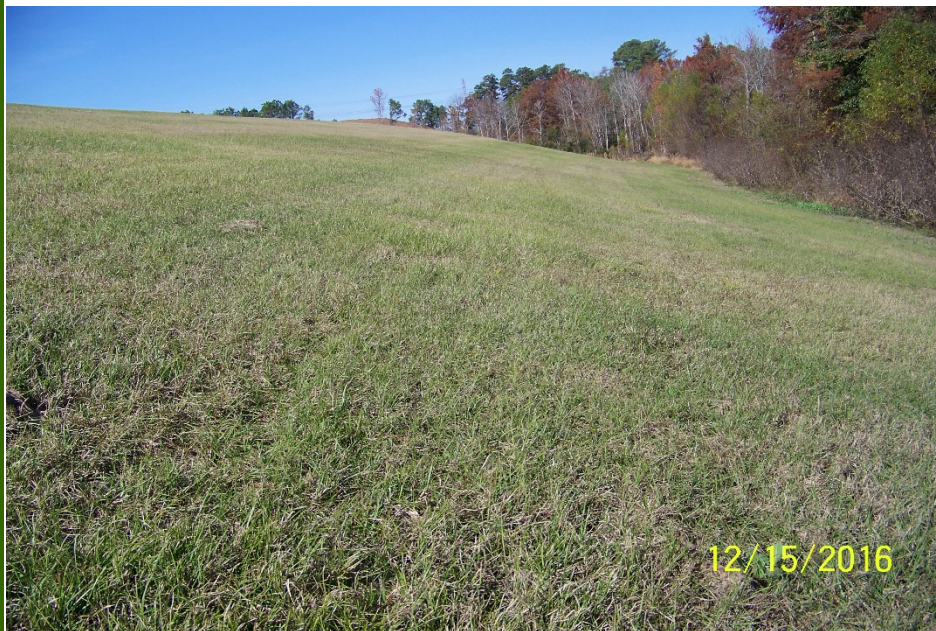
Exterior slope of northern levee.

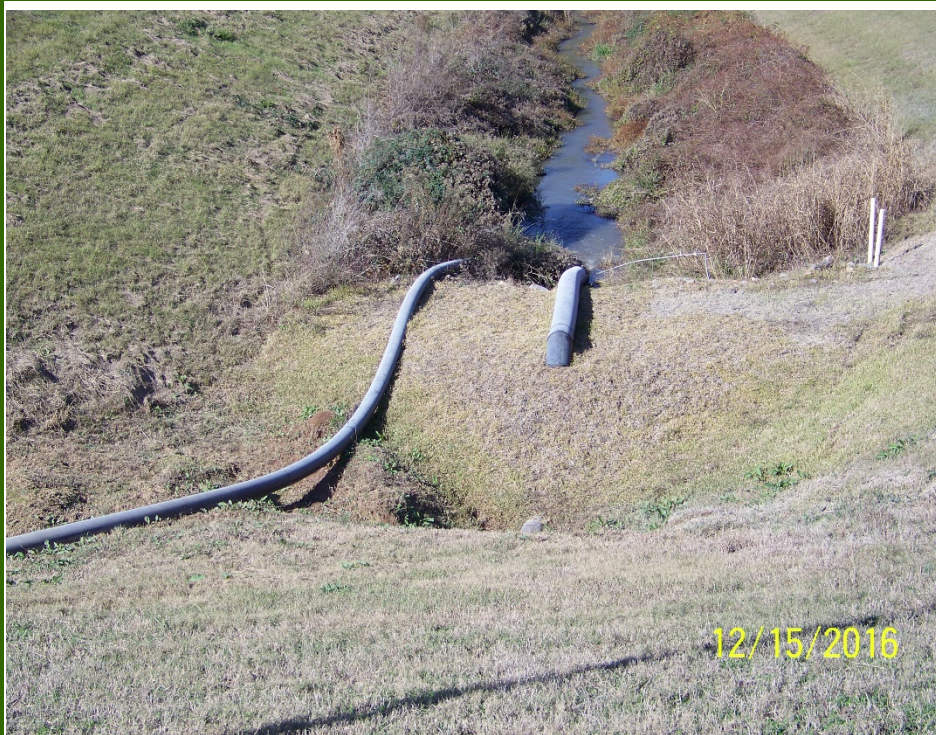
Bottom Ash discharge pipe shown outside the western levee towards Lake Rodemacher.
