SEPTEMBER 2018

# CLECO POWER LLC BRAME ENERGY CENTER

## FAULT AREAS ASSESSMENT

## BOTTOM ASH POND

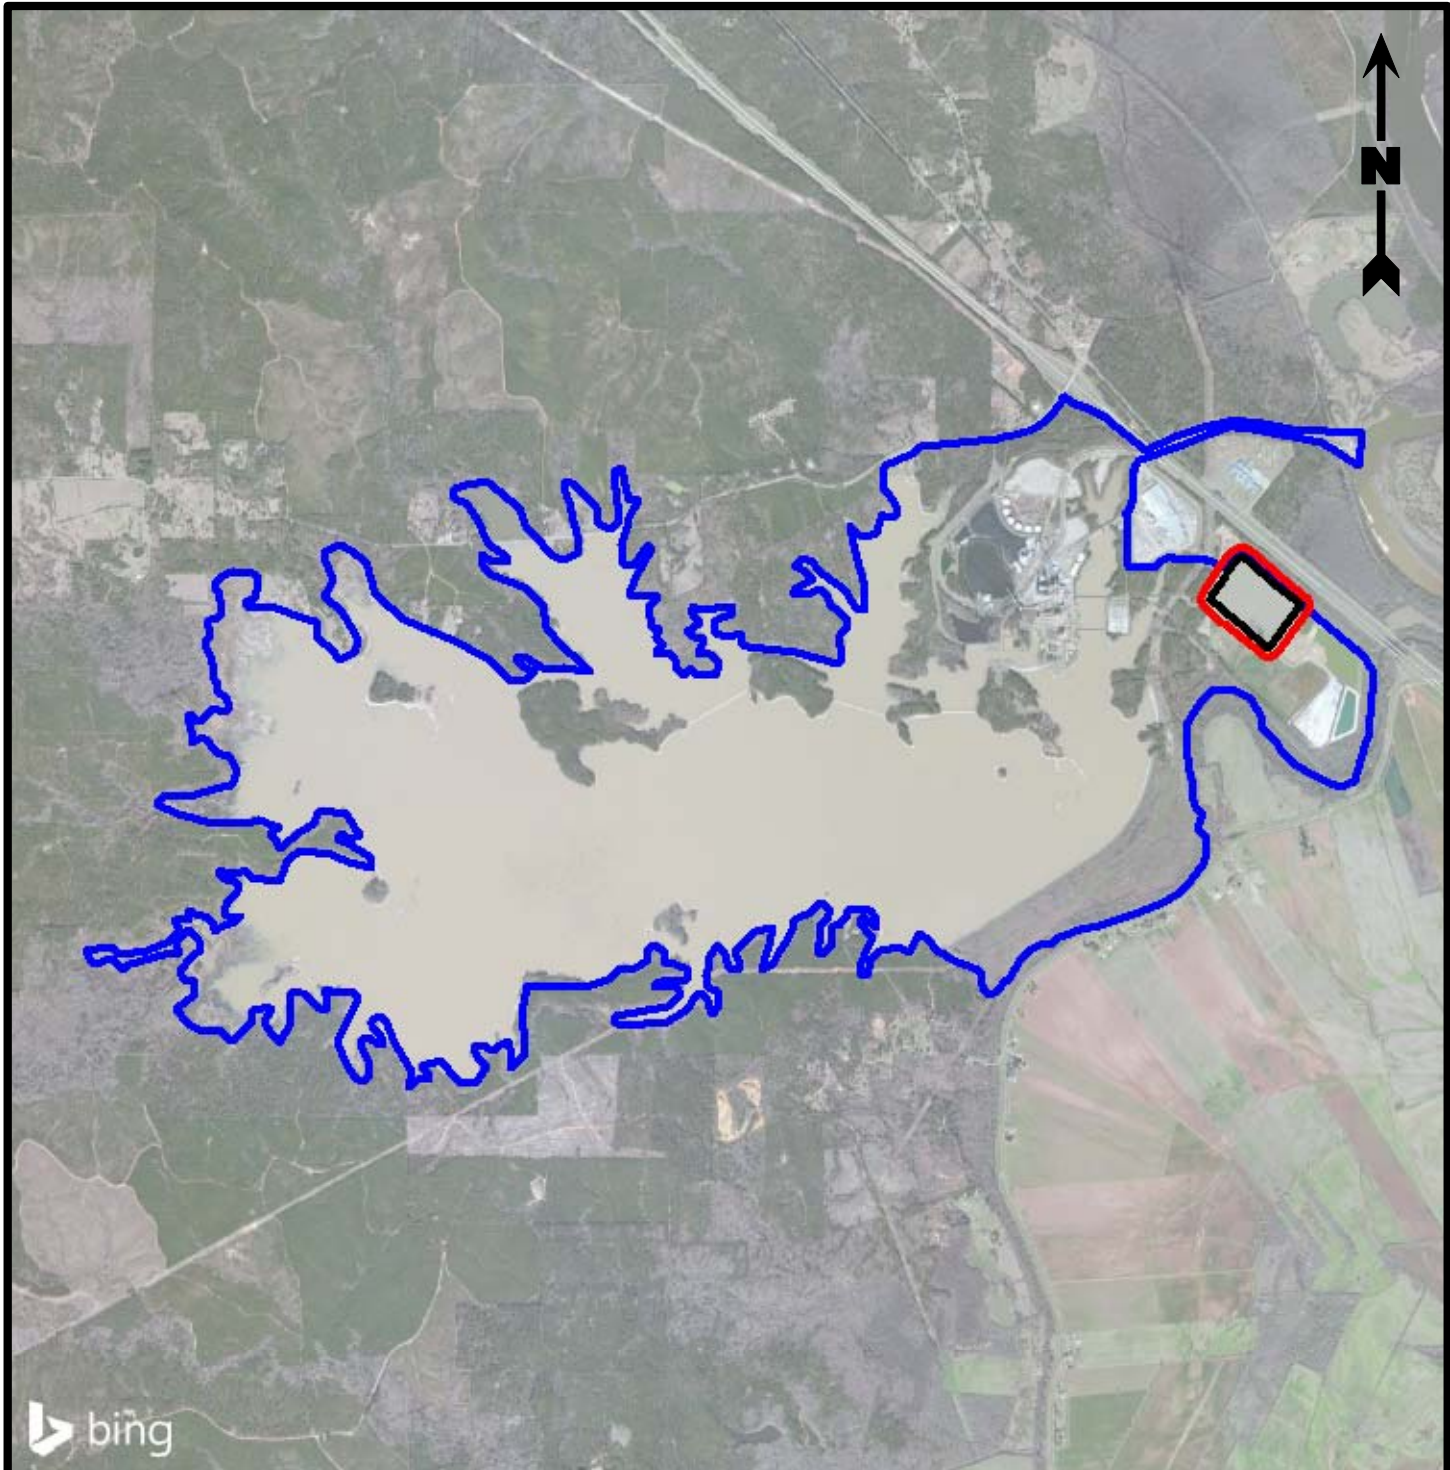
**FIGURE 3**  
**FAULT LOCATION MAP**

The fault locator map created on the USGS website, Mineral Resources, Online Spatial Data, By State (<https://mrdata.usgs.gov/geology/state/state.php?state=LA>) indicates no faults located within 60 meters (200 feet). This 200-foot buffer is shown in **Figure 3**.

There are no faults located within a 200' buffer of the Bottom Ash Pond.
