ANNUAL CCR SURFACE IMPOUNDMENT INSPECTION			
Facility Name:		Cleco Brame Energy Center	
Address:		275 Rodemacher Rd. Lena, LA	
Surface Impoundment Name :	Fly Ash Pond	Owner:	Cleco Power LLC
Surface Impoundment ID:	P-0005	Operator:	Cleco Power LLC
Nearest City:	Boyce	Parish:	Rapides
Inspector:		James C. Van Hoof, P.E.	
Company:		Providence Engineering & Environmental Group LLC	
Date of Inspection:		12/11/2017	
Weather at Time of Inspection:		Sunny, Cool	
DESCRIPTION OF THE OPERATION OF THE SURFACE IMPOUNDMENTS:			
<p>The Brame Energy Center's Bottom Ash and Fly Ash surface impoundments are designed to accept the coal combustion residual (CCR) byproducts derived from burning of the Unit 2 coal for the generation of electricity. The ponds are classified by the Louisiana Department of Environmental Quality (LDEQ) as Type I Surface Impoundments. Water from the Fly Ash surface impoundment is pumped into the Bottom Ash impoundment which discharges by means of three pumps that discharge the wastewater through the outlet pipe on the western end of the pond. This water discharges into Lake Rodemacher via LPDES outfall 401, thence to Bayou Jean de Jean via LPDES outfall 001, then to the Red R

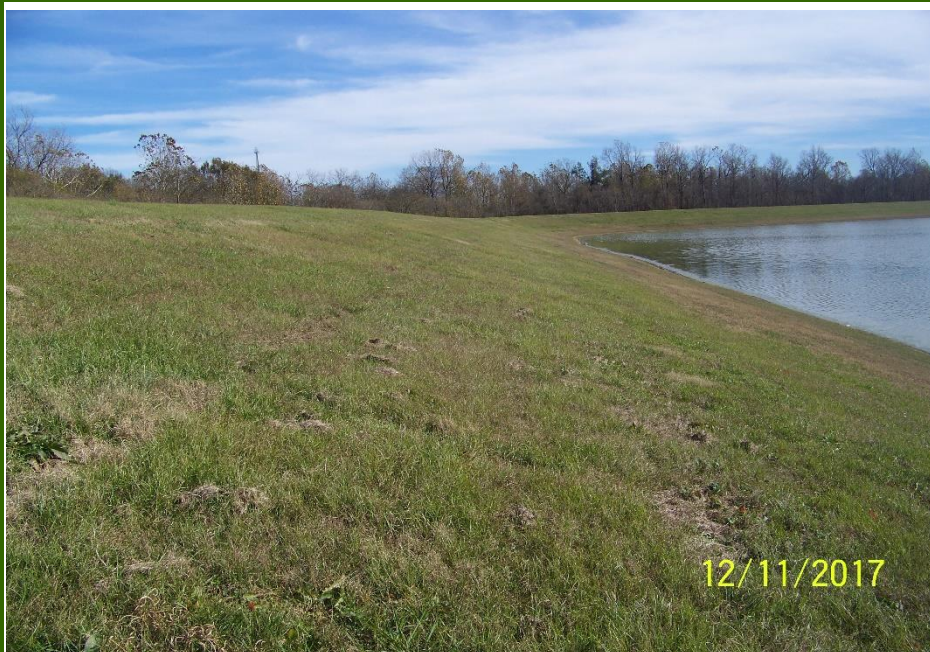
Interior slope of northern levee.

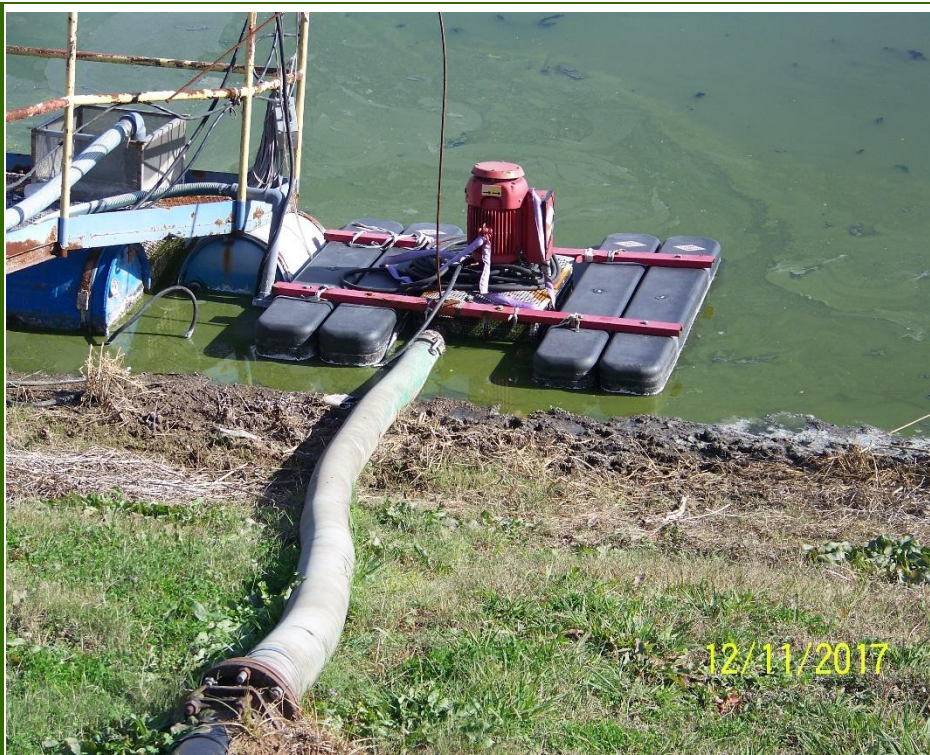
Pump system in Fly Ash Pond that pumps discharge water into the Bottom Ash Pond.

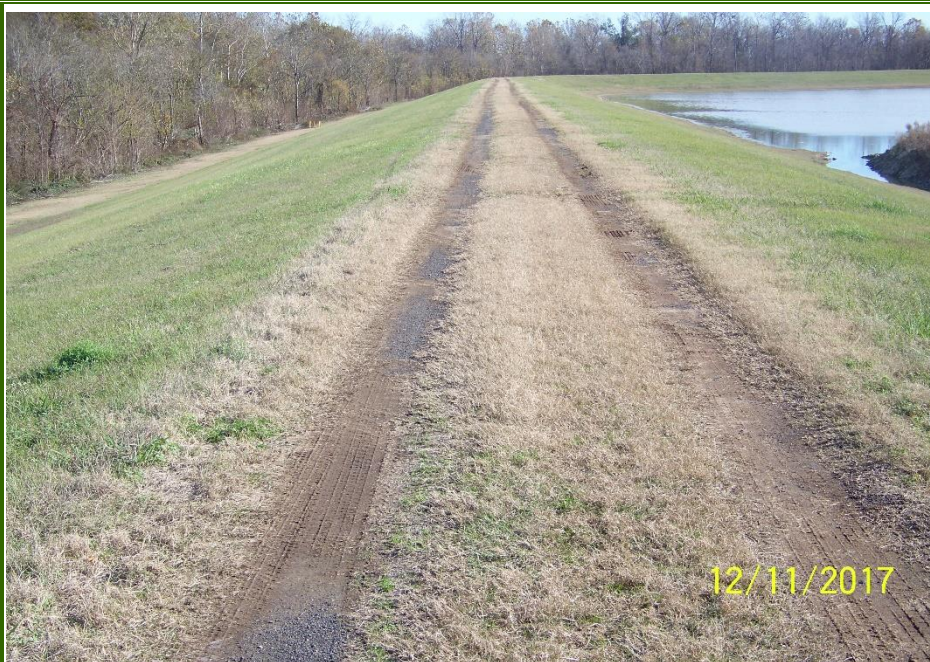
Crest along the northern levee.

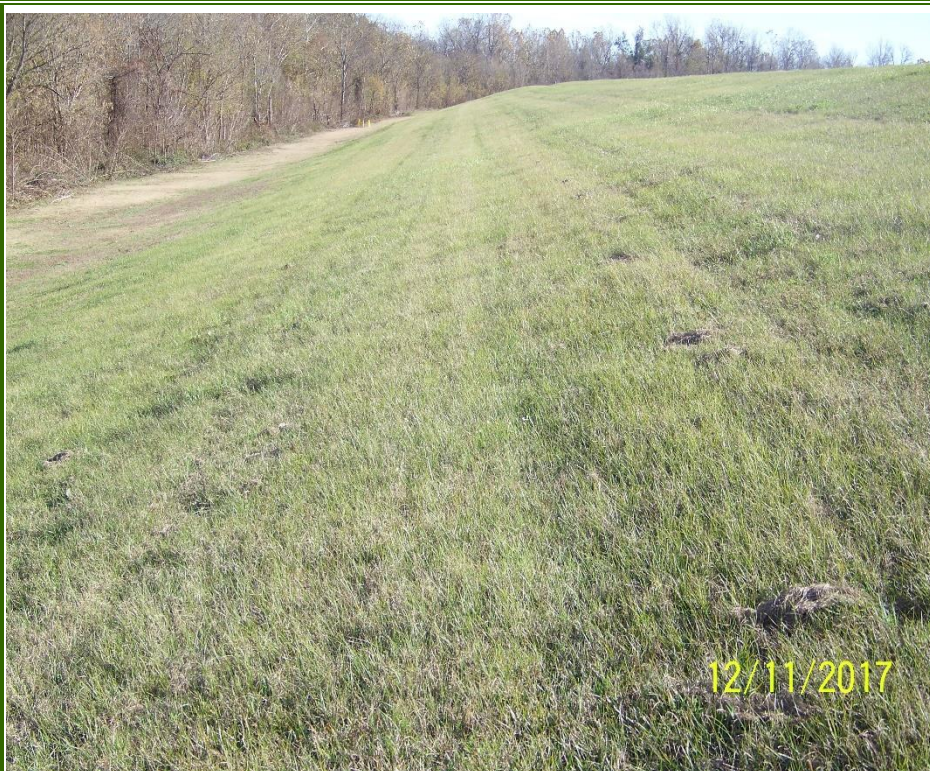
Northern exterior levee slope.

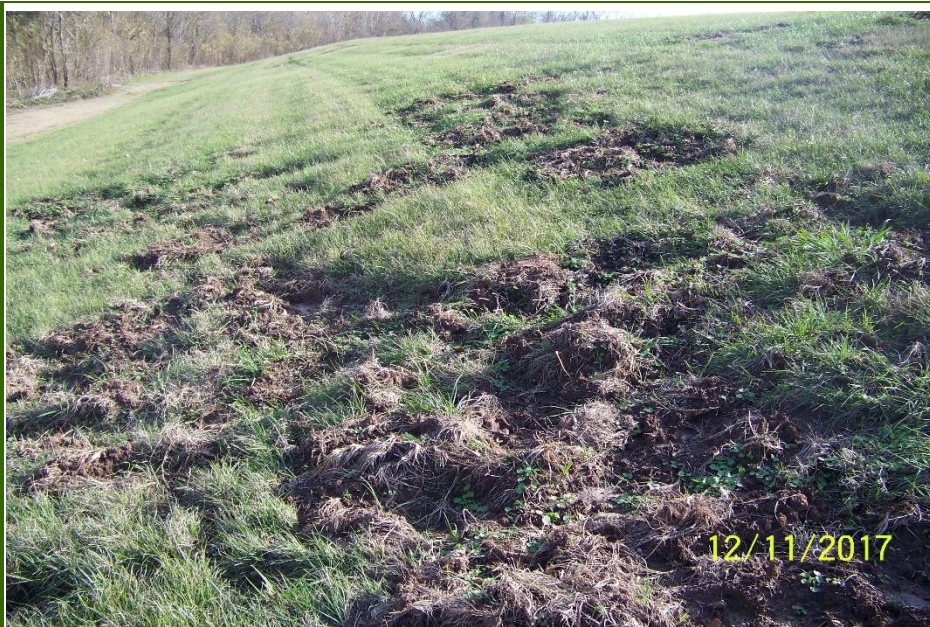
DOCUMENTATION REVIEW:	
Weekly Inspections Reviewed:	<input checked="" type="checkbox"/> Yes <input type="checkbox"/> No
Findings: Feral hogs rutted topsoil on exterior levee.	
Monthly Instrument Inspections Reviewed:	<input checked="" type="checkbox"/> Yes <input type="checkbox"/> No
Findings: No Issues.	
Groundwater Monitoring:	Monitoring wells are in-place.
Drawings Reviewed:	<input checked="" type="checkbox"/> Yes <input type="checkbox"/> No
Are there any changes in the geometry of the surface impoundment structure since the previous inspection?	<input type="checkbox"/> Yes <input checked="" type="checkbox"/> No <input type="checkbox"/> NA
If yes, describe (size, location, etc.)	
Other observations:	None

Area along the exterior levee showing where the feral hogs have recently rooted the topsoil.

Are there any trees on the slopes?	<input type="checkbox"/> Yes <input checked="" type="checkbox"/> No
If yes, describe (type of vegetation, size, location, etc.)	
Findings:	The exterior slope was inspected and appeared to be in satisfactory condition. Only minor corrective actions are required at this time based on other observations below.
Other observations on the exterior slopes: Feral hogs have rooted an approximate 2,000 square foot topsoil area on the exterior slope of the Fly Ash Pond along the north and northeast levee. Cleco will smooth the rutted area, then seed and fertilize to prevent erosion.

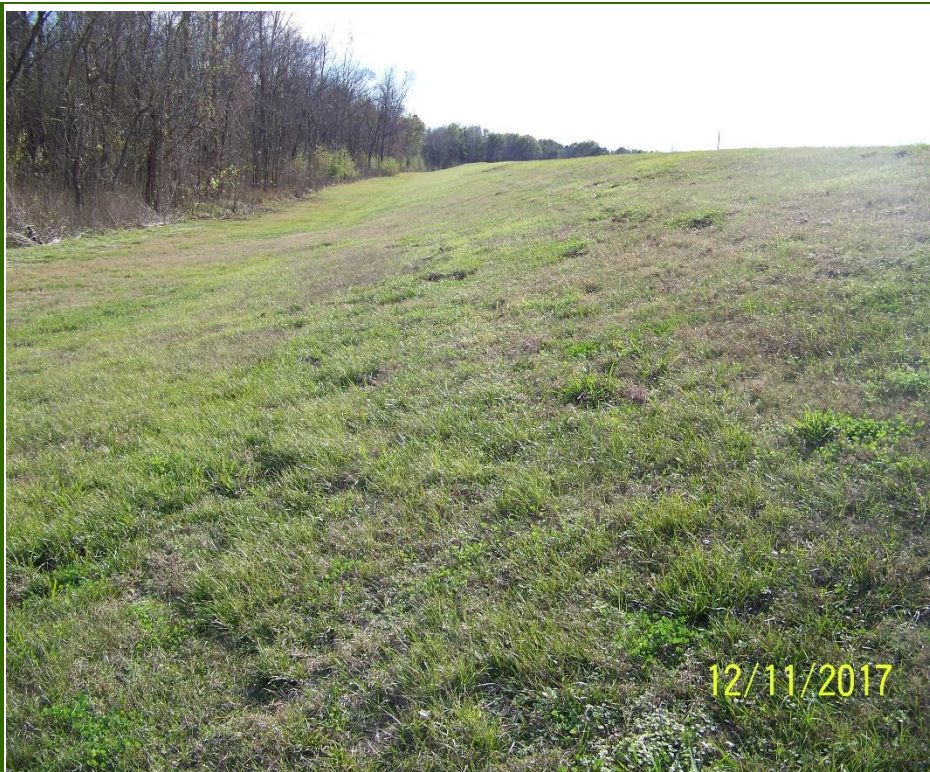
Eastern exterior slope of levee.

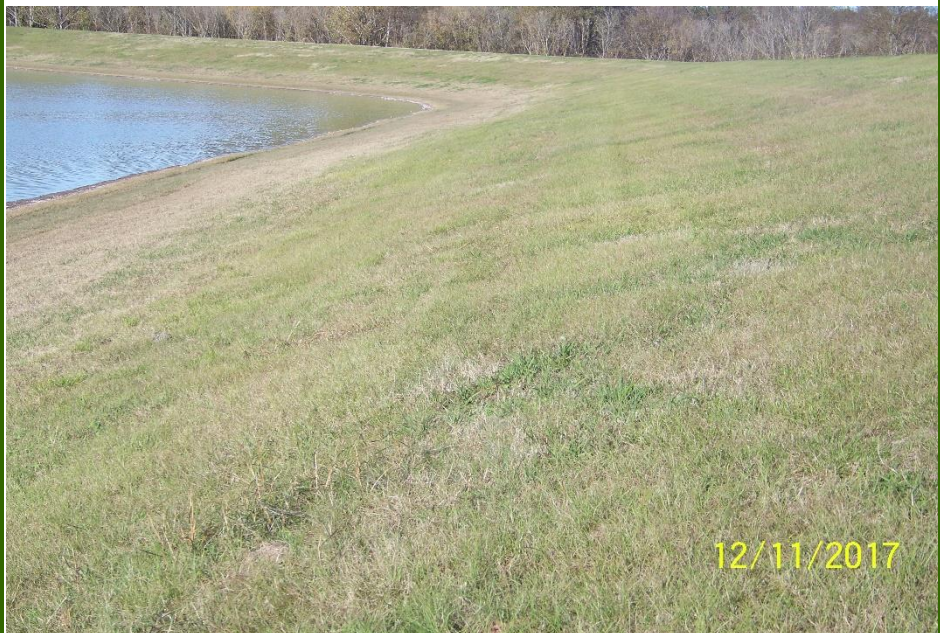
Eastern interior slope of levee.

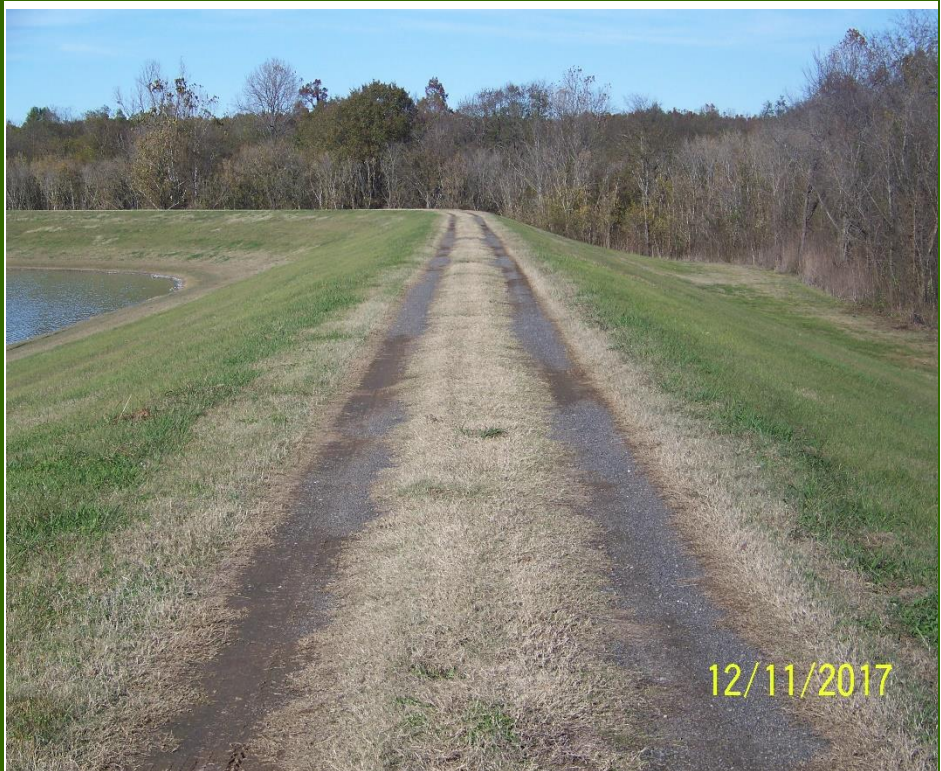
Crest along eastern levee.

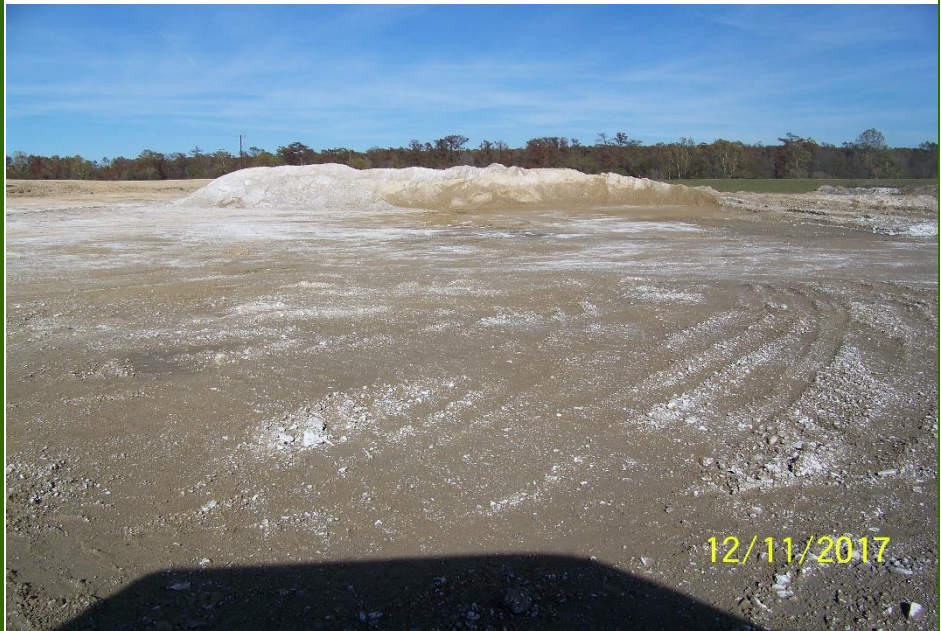
Fly ash in the Fly Ash Pond.

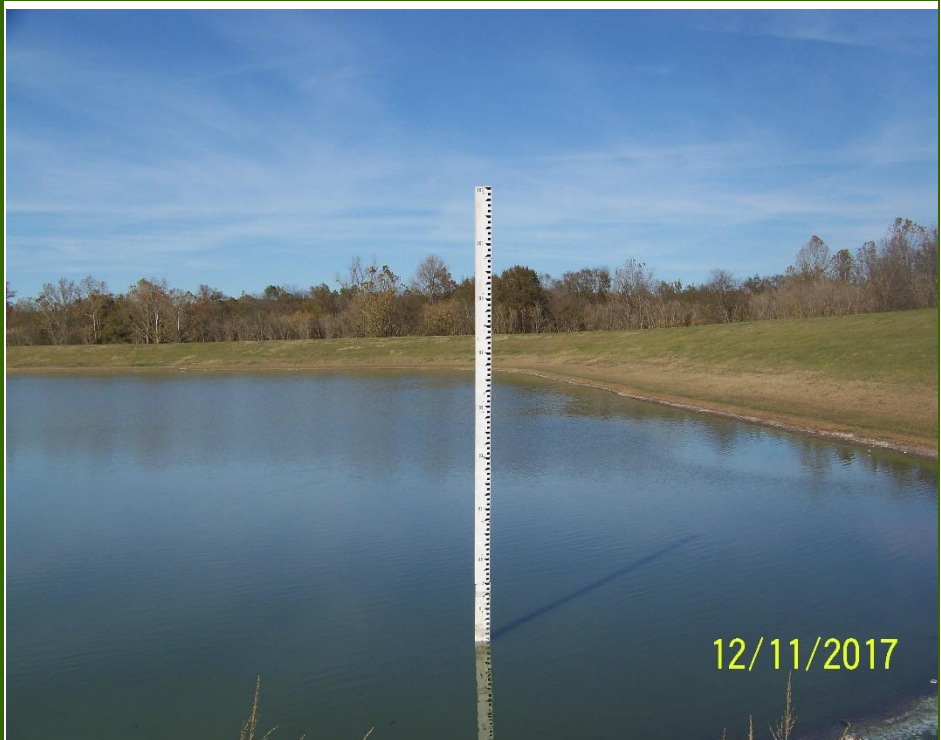
Level Gauge in Fly Ash Pond.
