<b>ANNUAL CCR SURFACE IMPOUNDMENT INSPECTION</b>			
<b>Facility Name:</b>		Cleco Brame Energy Center	
<b>Address:</b>		275 Rodemacher Rd. Lena, LA	
<b>Surface Impoundment Name :</b>	Fly Ash Pond	<b>Owner:</b>	Cleco Power LLC
<b>Surface Impoundment ID:</b>	P-0005	<b>Operator:</b>	Cleco Power LLC
<b>Nearest City:</b>	Boyce	<b>Parish:</b>	Rapides
<b>Inspector:</b>		James C. Van Hoof, P.E.	
<b>Company:</b>		Providence Engineering & Environmental Group LLC	
<b>Date of Inspection:</b>		12/15/2016	
<b>Weather at Time of Inspection:</b>		Sunny, Cool	
<b>DESCRIPTION OF THE OPERATION OF THE SURFACE IMPOUNDMENTS:</b>			
<p>The Brame Energy Center's Bottom Ash and Fly Ash surface impoundments are designed to accept the coal combustion residual (CCR) byproducts derived from burning of the Unit 2 coal for the generation of electricity. The ponds are classified by the Louisiana Department of Environmental Quality (LDEQ) as Type I Surface Impoundments. Water from the Fly Ash surface impoundment is pumped into the Bottom Ash impoundment which discharges by means of three pumps that discharge the wastewater through the outlet pipe on the northern end of the pond. This water discharges into Lake Rode

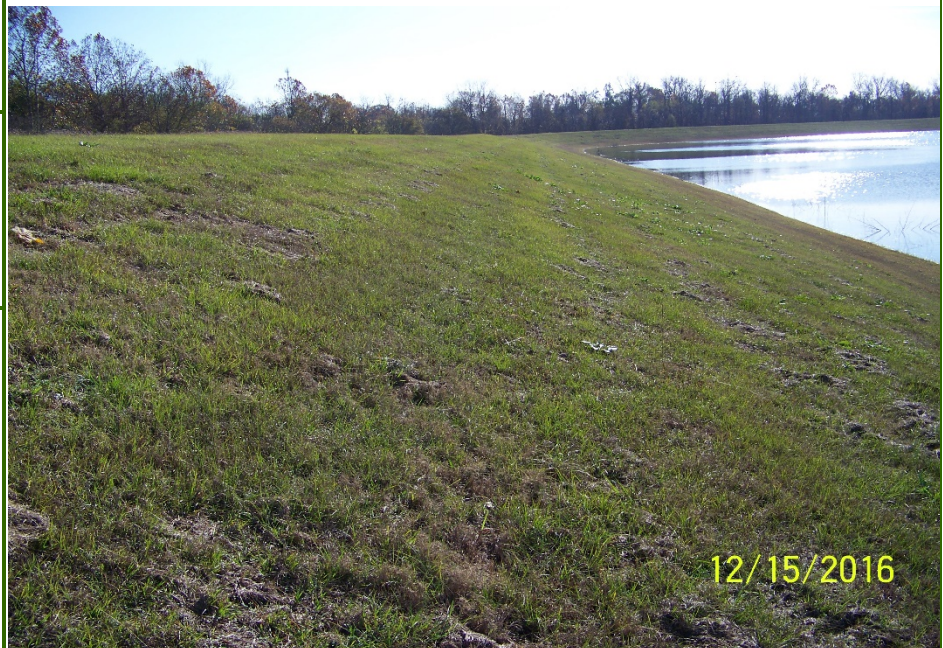
**Fly Ash Pond**

Interior slope of northern levee.

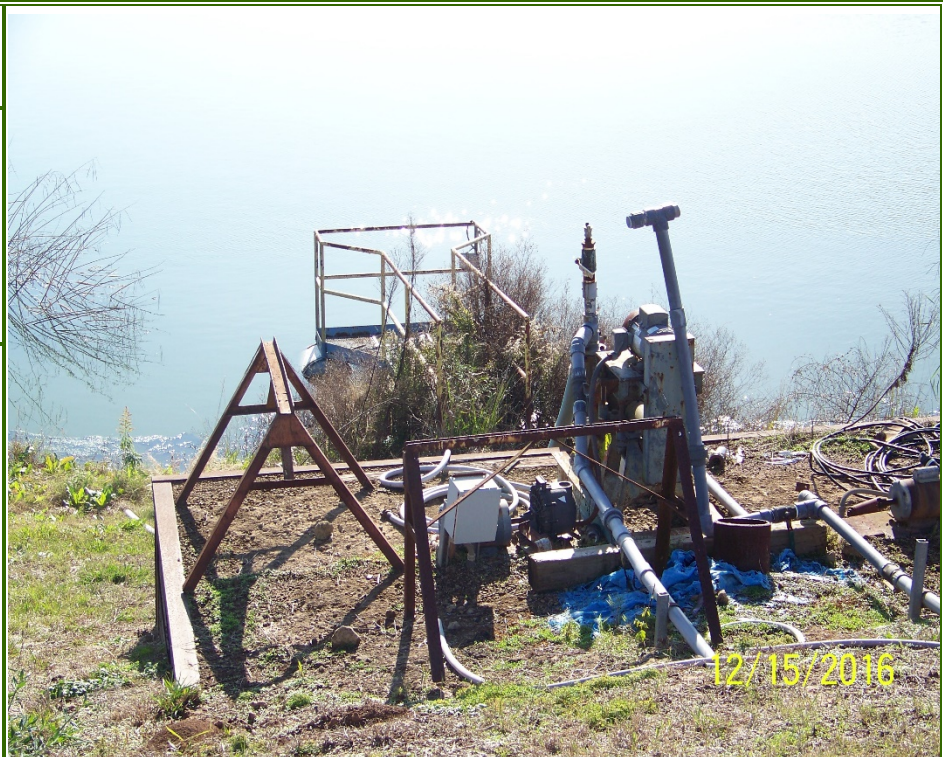
**Fly Ash Pond**

Pump system in Fly Ash Pond that pumps discharge water into the Bottom Ash Pond.

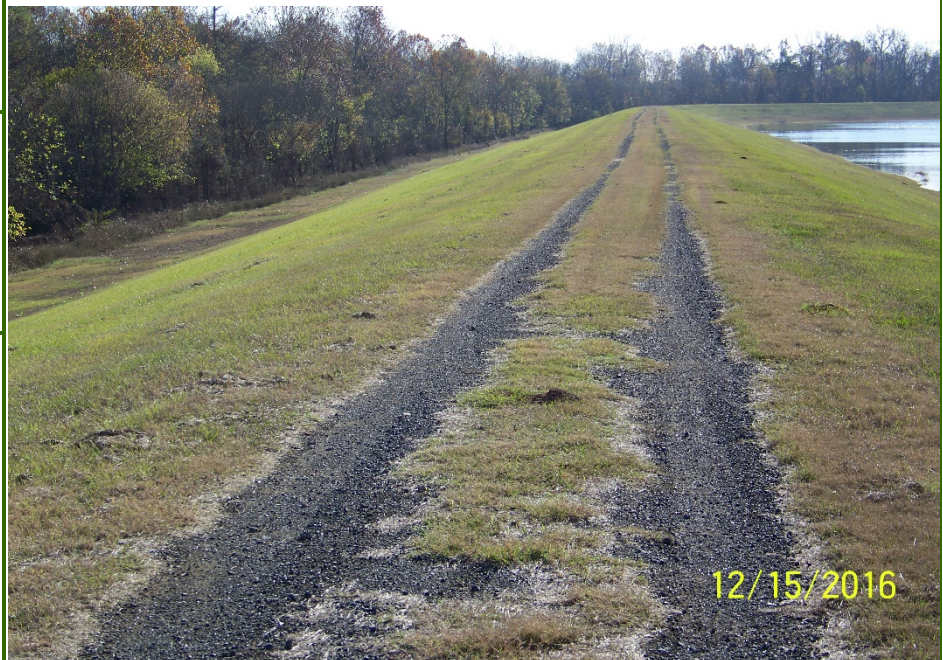
**Fly Ash Pond**

Crest along the northern levee.

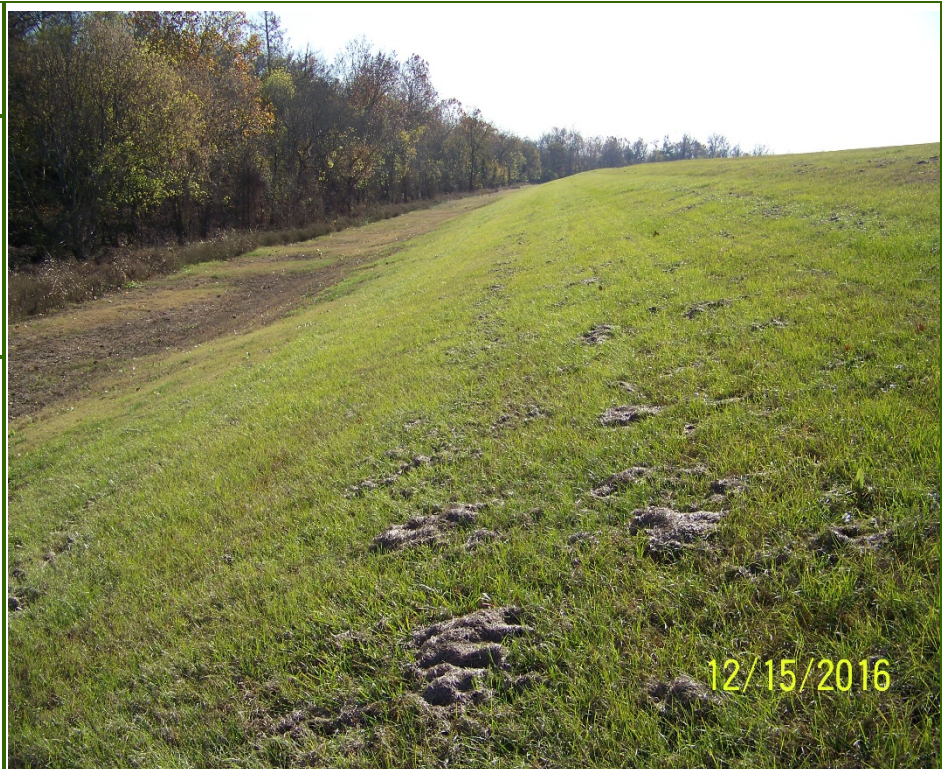
**Fly Ash Pond**

Northern exterior levee slope.

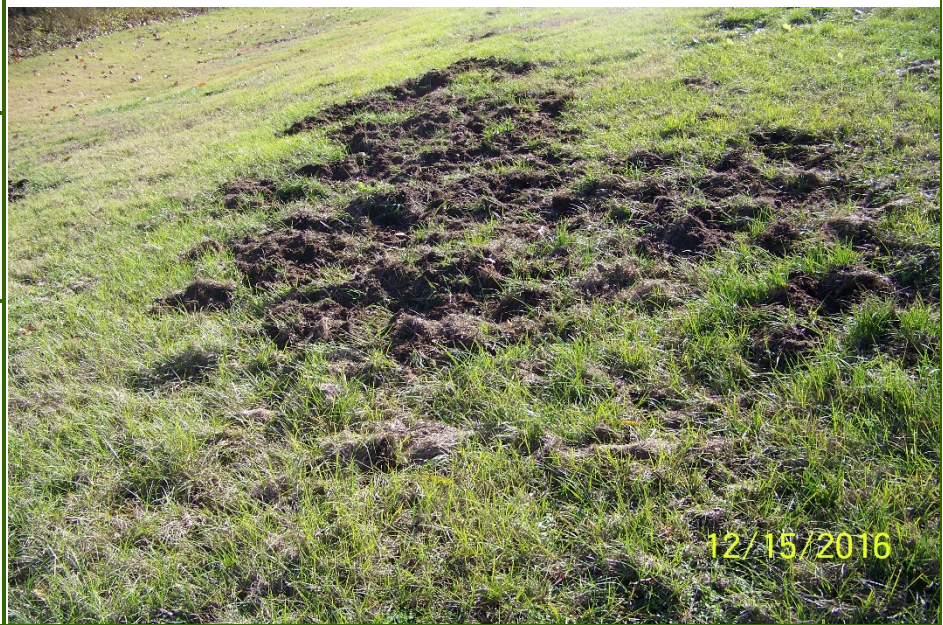
**Fly Ash Pond**

DOCUMENTATION REVIEW:	
<b>Weekly Inspections Reviewed:</b>	<input checked="" type="checkbox"/> Yes <input type="checkbox"/> No
<b>Findings:</b> Feral hogs rooting on Fly Ash Pond exterior levee was noted.	
<b>Monthly Instrument Inspections Reviewed:</b>	<input checked="" type="checkbox"/> Yes <input type="checkbox"/> No
<b>Findings:</b> Main discharge pump down for maintenance. Backup pump available.	
<b>Groundwater Monitoring:</b>	Monitoring wells are in-place.
<b>Drawings Reviewed:</b>	<input checked="" type="checkbox"/> Yes <input type="checkbox"/> No
<b>Are there any changes in the geometry of the surface impoundment structure since the previous inspection?</b>	<input checked="" type="checkbox"/> Yes <input type="checkbox"/> No <input type="checkbox"/> NA
If yes, describe (size, location, etc.)	Section of southern levee has been raised to elevation 105 ft. NAVD 88 in 2016.
<b>Other observations:</b>	None

Area along the exterior levee showing where the feral hogs have recently rooted the area.

If yes, describe (size of area, location, severity, etc.)	
<b>Are there any trees on the slopes?</b>	<input type="checkbox"/> Yes <input checked="" type="checkbox"/> No
If yes, describe (type of vegetation, size, location, etc.)	
<b>Findings:</b>	The exterior slope was inspected and appeared to be in satisfactory condition. Only minor corrective actions are required at this time based on other observations below.
<b>Other observations on the exterior slopes:</b> Feral hogs have rooted an approximate 4,000 square foot area on the exterior slope of the Fly Ash Pond along the north and northeast levee. Cleco will smooth the rutted area, then seed and fertilize to prevent erosion.

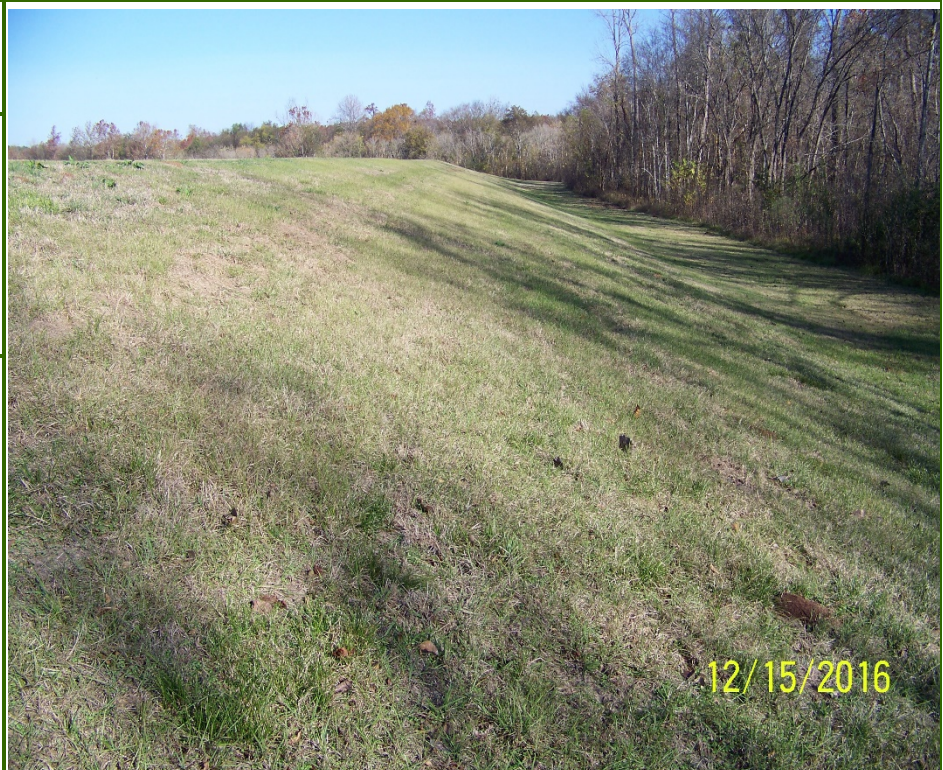
**Fly Ash Pond**

Eastern exterior slope of levee.

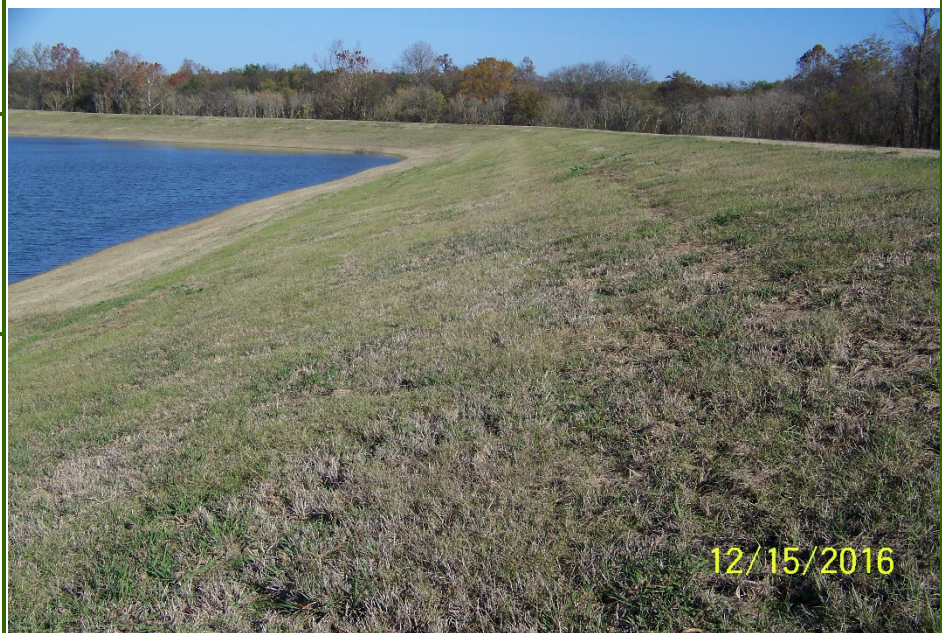
**Fly Ash Pond**

Eastern interior slope of levee.

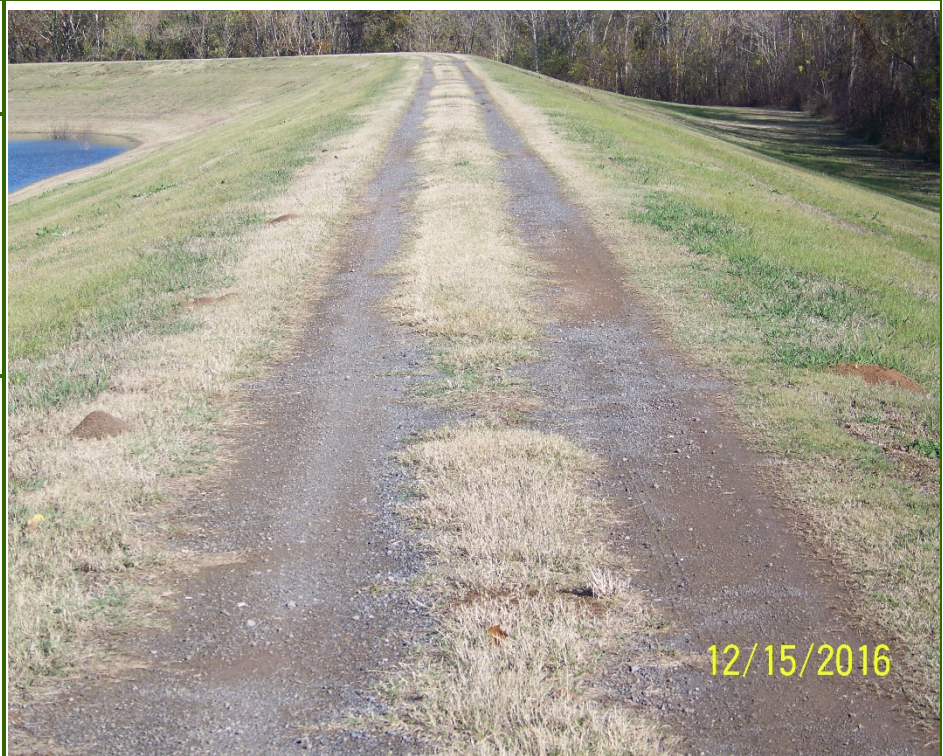
**Fly Ash Pond**

Crest along eastern levee.

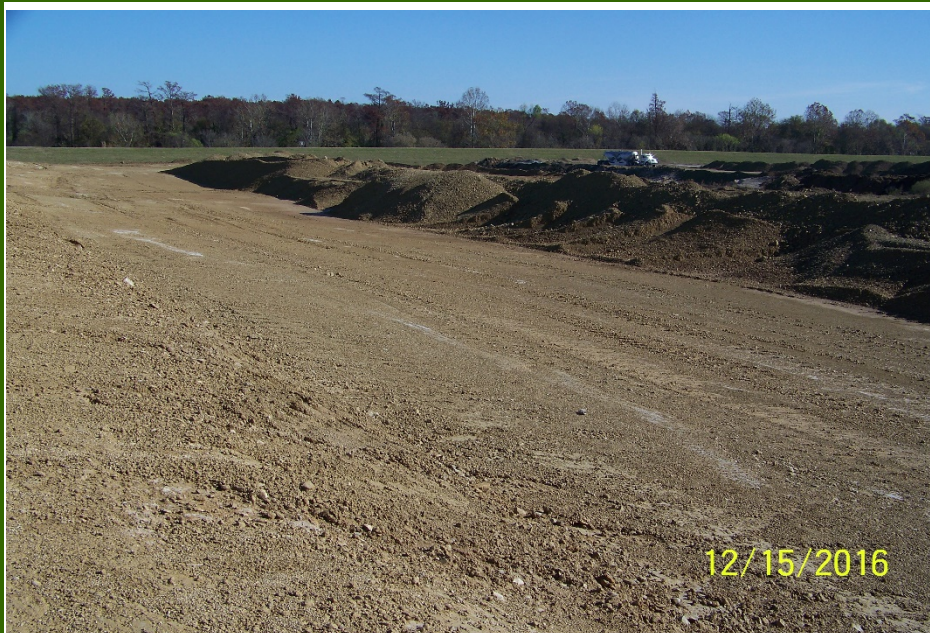
**Fly Ash Pond**

**Comments:**  
Fly ash in the Fly Ash Pond.

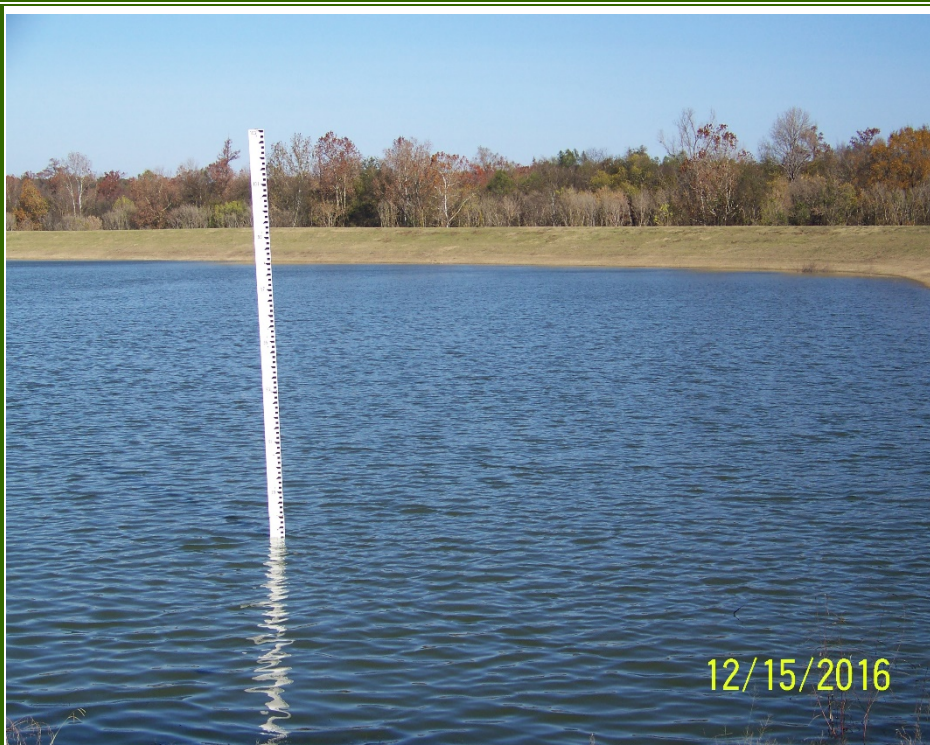
**Fly Ash Pond**

**Comments:**  
Level Gauge in Fly Ash Pond.
