DOLET HILLS POWER STATION

CCR ANNUAL INSPECTION

ASH BASIN NO. 1

JANUARY 2026

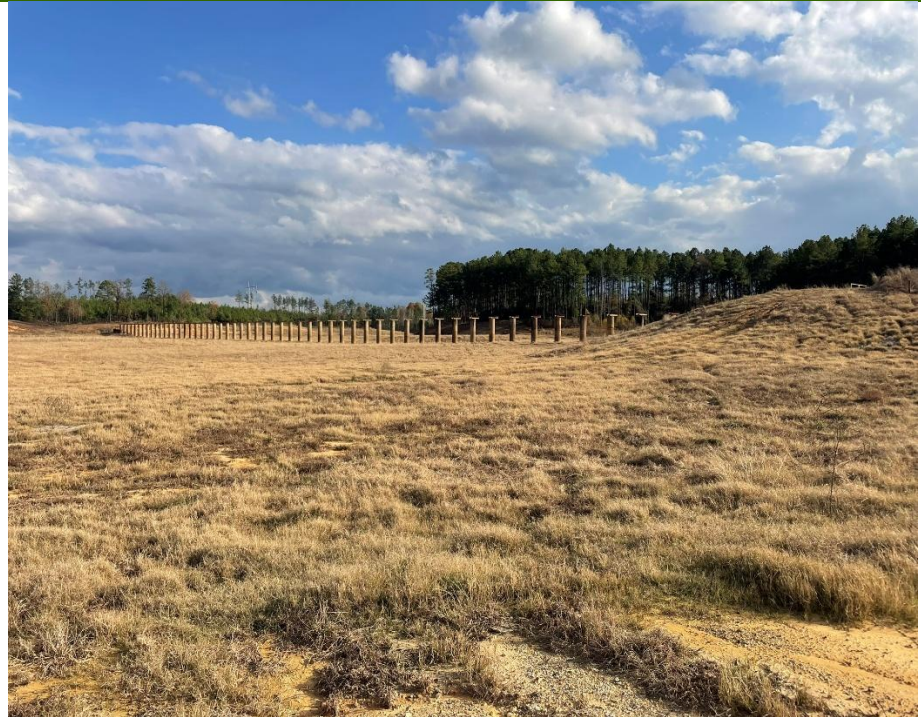
Ash Basin No. 1

Southeasterly

Supports of former sluice structure in background. Area mostly vegetated.

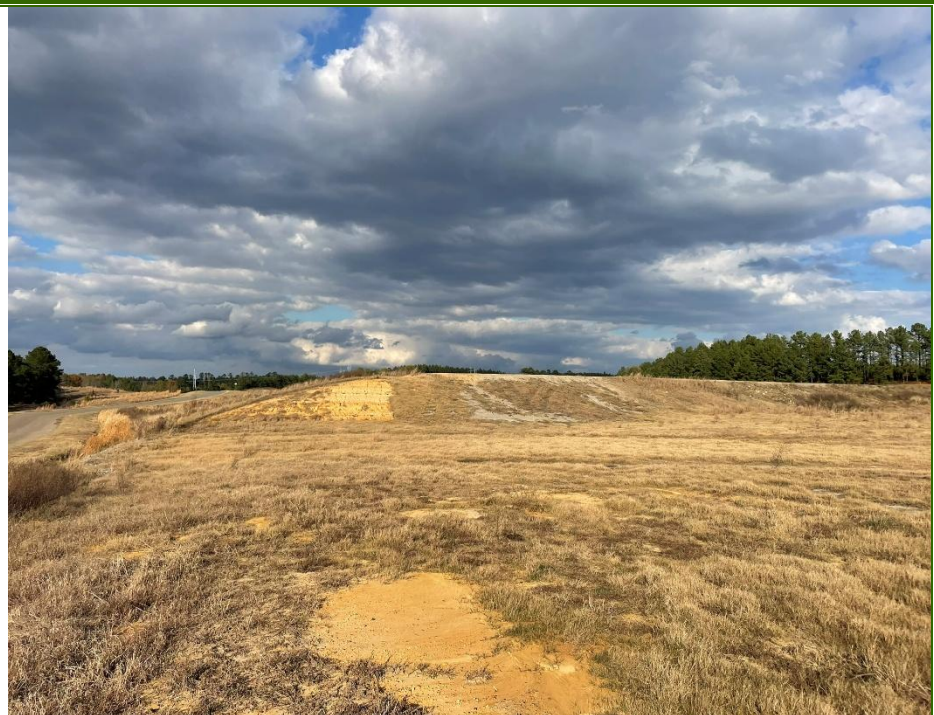
Ash Basin No. 1

Northerly

Western edge of Ash Basin No. 1.
