CLECO POWER LLC DOLET HILLS POWER STATION

CCR ANNUAL INSPECTION

ASH BASIN NO. 2

JANUARY 2026

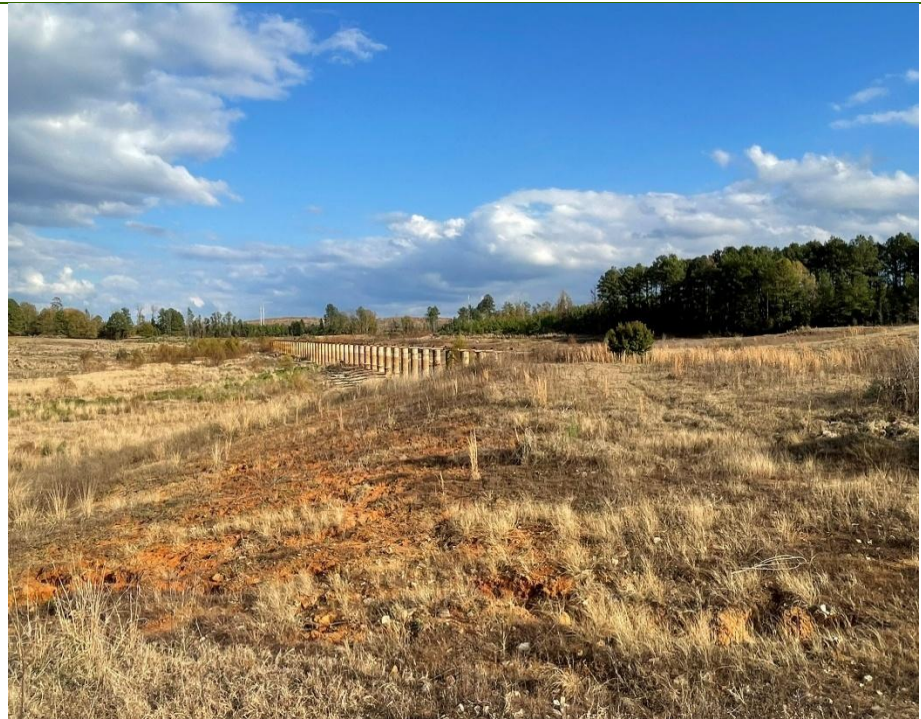
Ash Basin No. 2

Southern portion of Ash Basin No. 2. Supports of former sluice structure remaining.

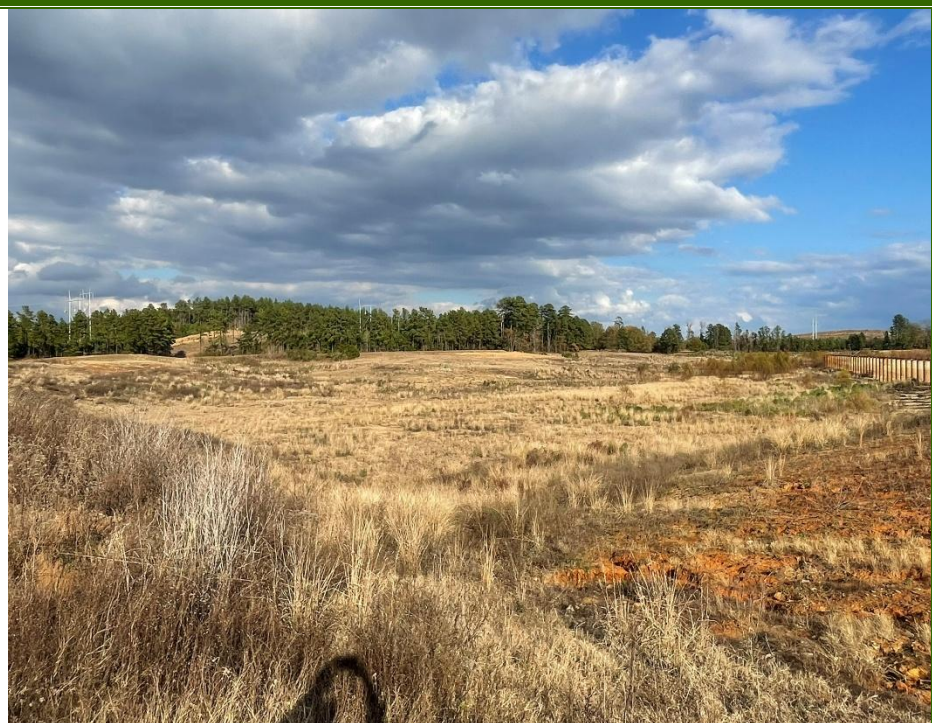
Ash Basin No. 2

Vegetation established within footprint of former Ash Basin No. 2.
