CLECO POWER LLC DOLET HILLS POWER STATION

CCR ANNUAL INSPECTION

FLY ASH/SCRUBBER SLUDGE LANDFILL

JANUARY 2026

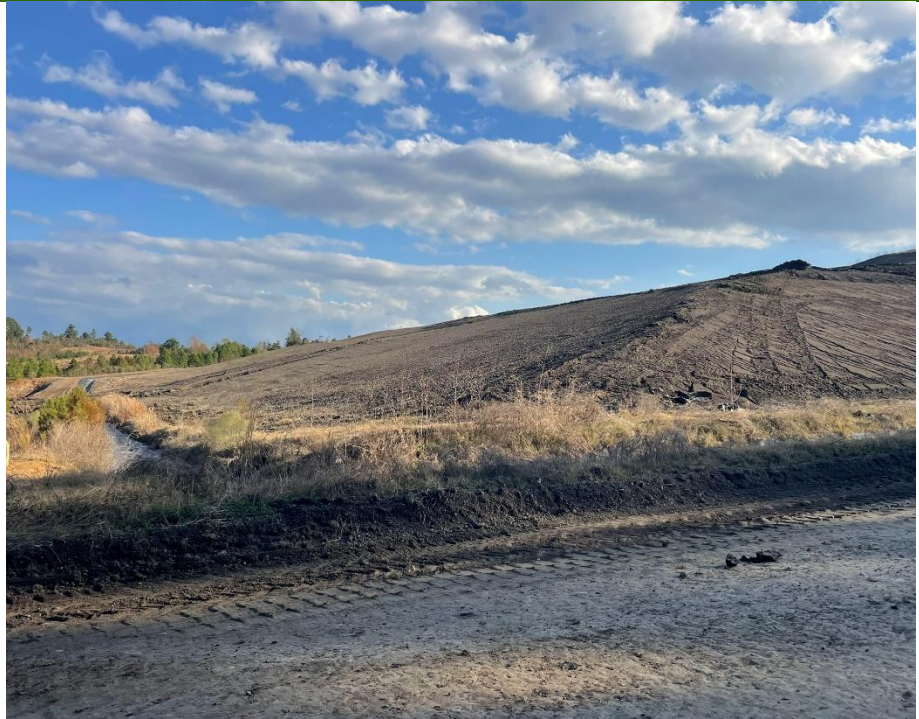
Northwest corner of landfill.

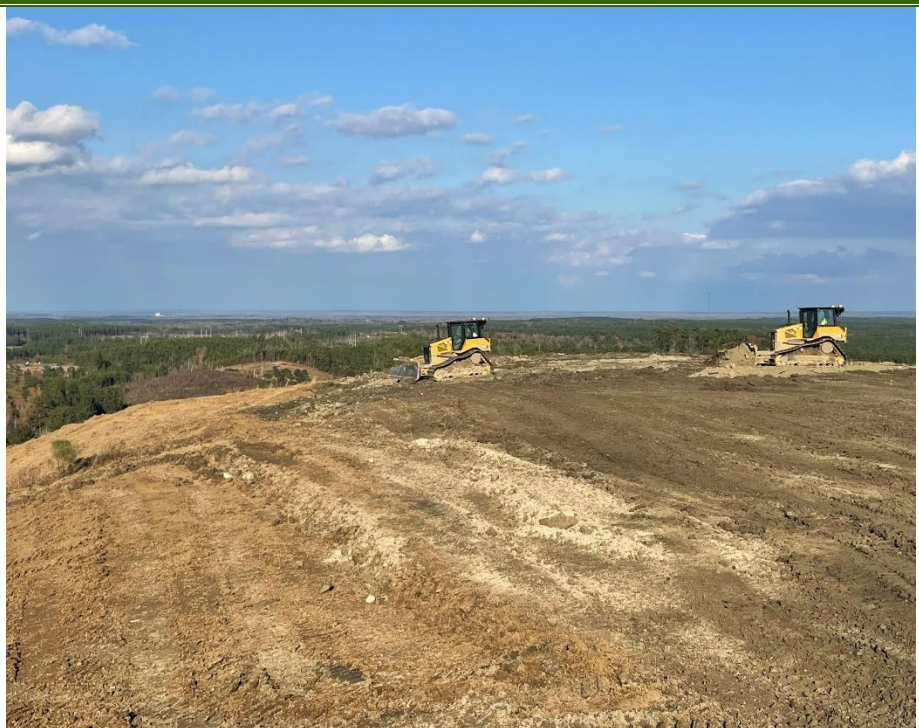
Findings:	The upper elevation flat cap area was inspected and appeared to be in satisfactory condition. Some minor rutting where vehicles have been traveling. Vehicles have been accessing the crown to support final capping of the landfill.
Other observations on the upper elevation flat cap area:	None

Final waste grading near crown of the landfill.

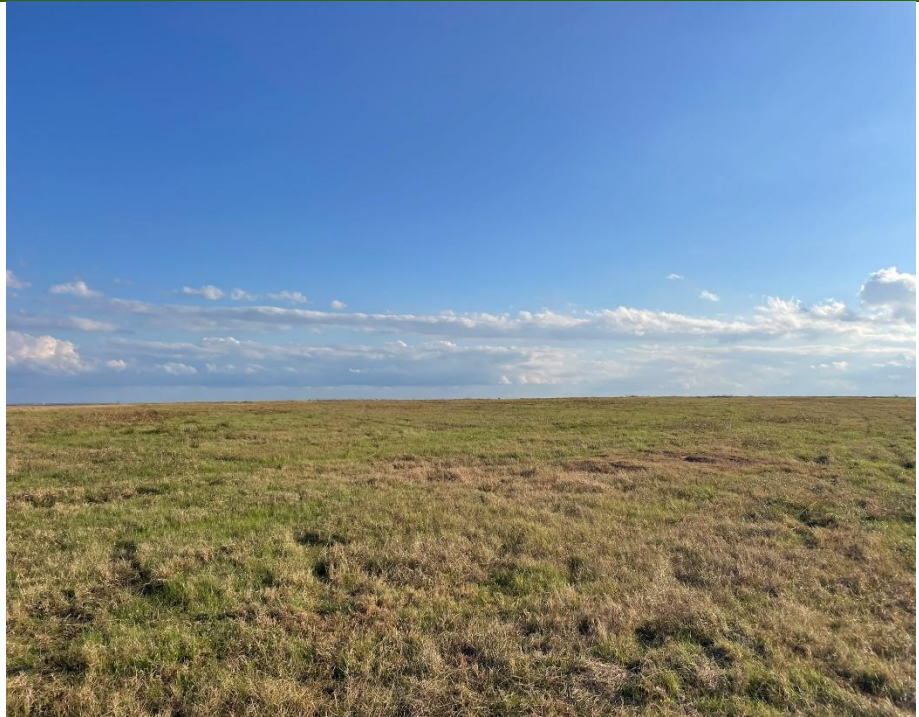
Vegetation on crown of landfill.

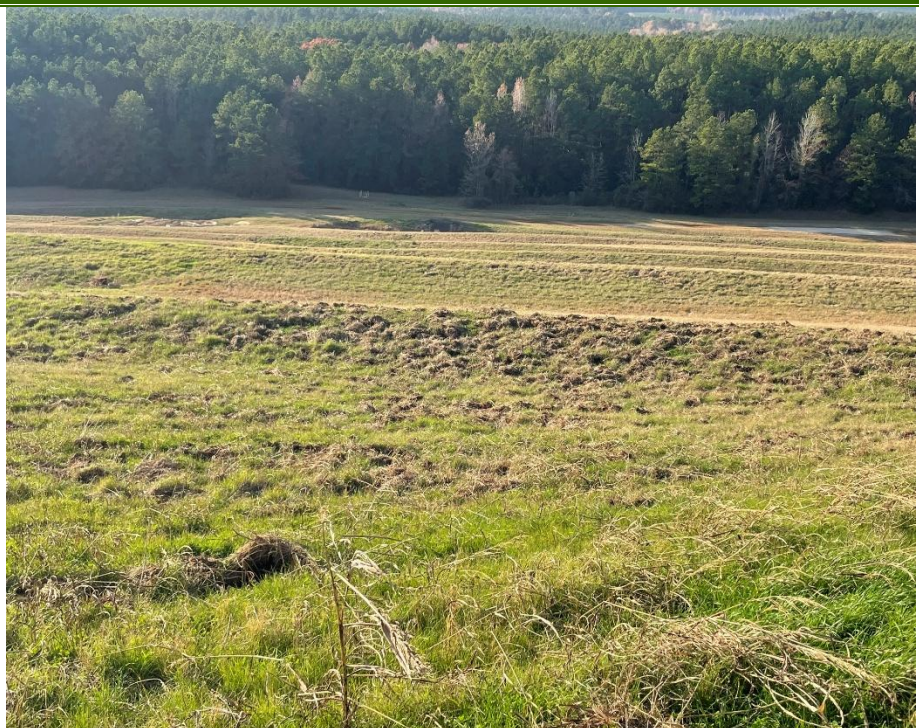
Vegetation and terraces on west slope of landfill.

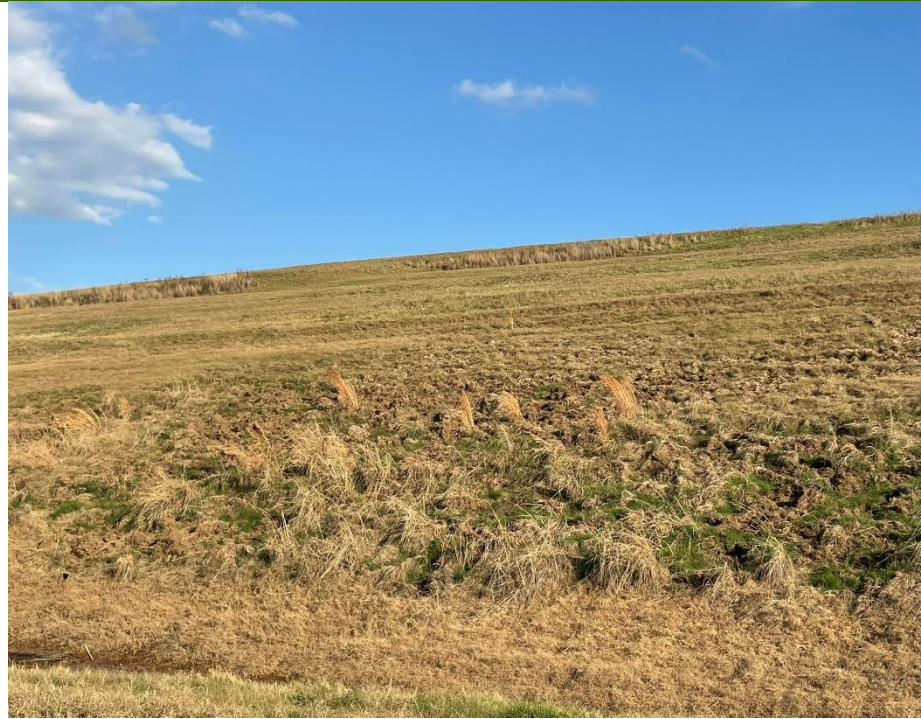
Minor feral hog rootings on western slope of landfill.

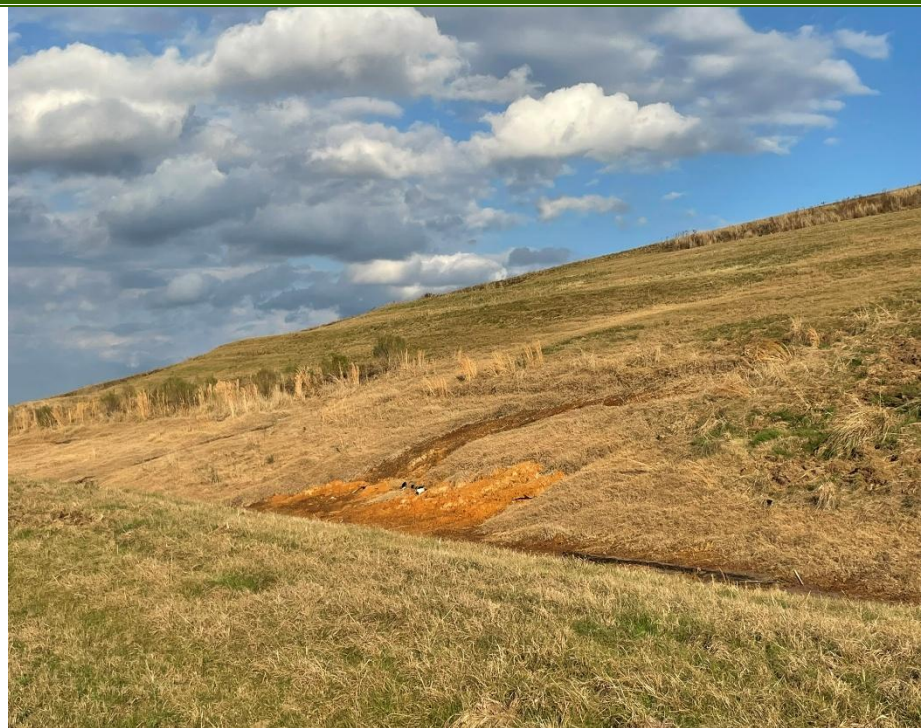
Use of reinforced downchutes and buried pipe downchutes	
Is the stormwater infrastructure in good condition?	<input checked="" type="checkbox"/> Yes <input type="checkbox"/> No
Findings:	The exterior slopes were inspected and appeared to be in fair to good condition. Wet areas and some seepage and erosion on west slope above perimeter ditch.
Other observations on the exterior slopes:	None

Leachate seeps above perimeter ditch along toe of west slope

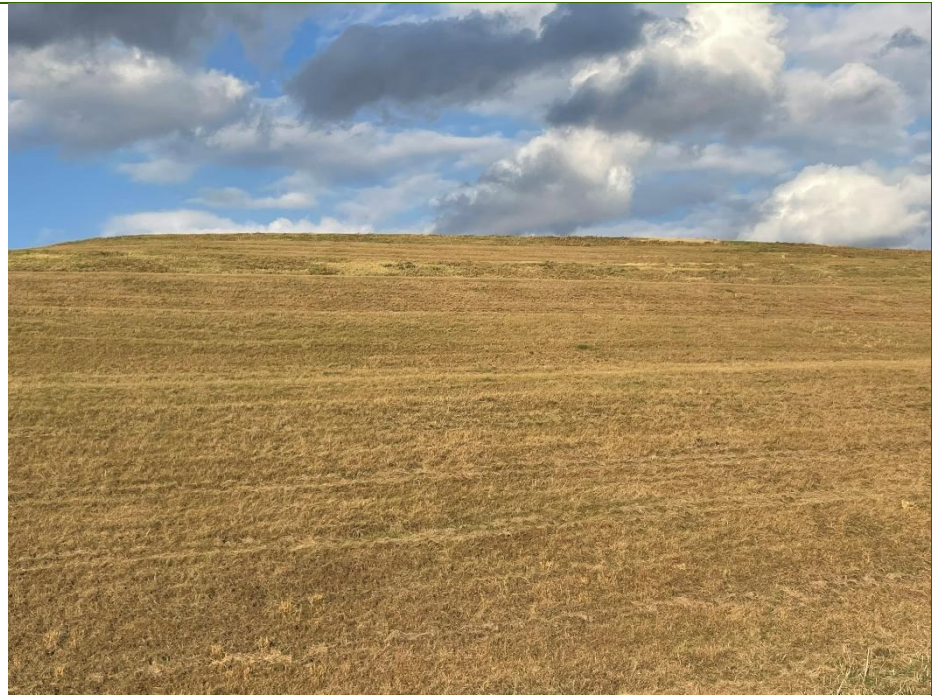
South perimeter slope of landfill.

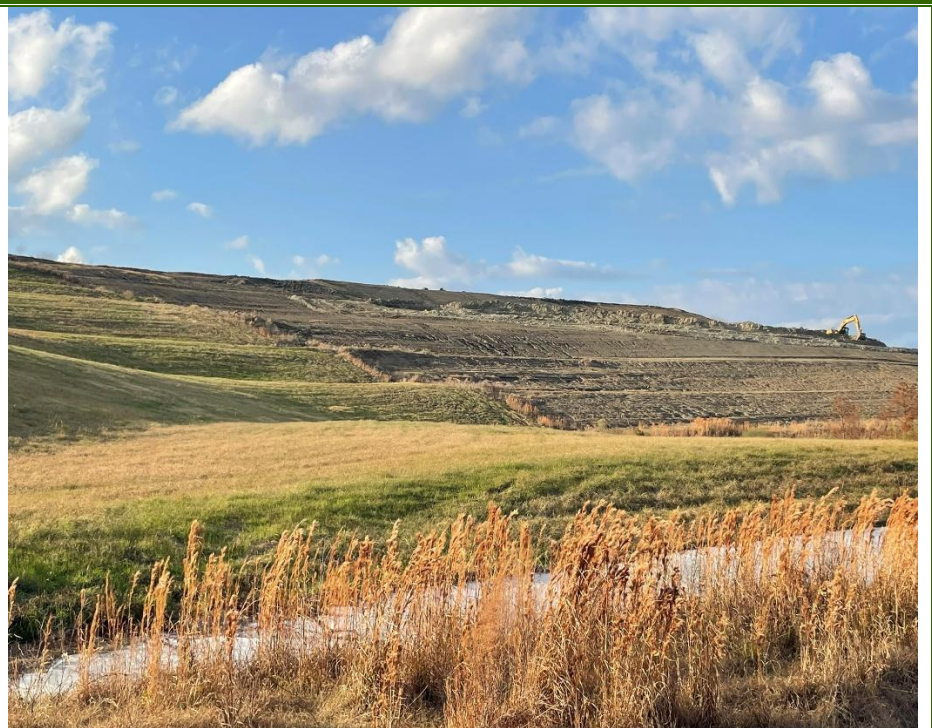
Northeast slope of landfill.

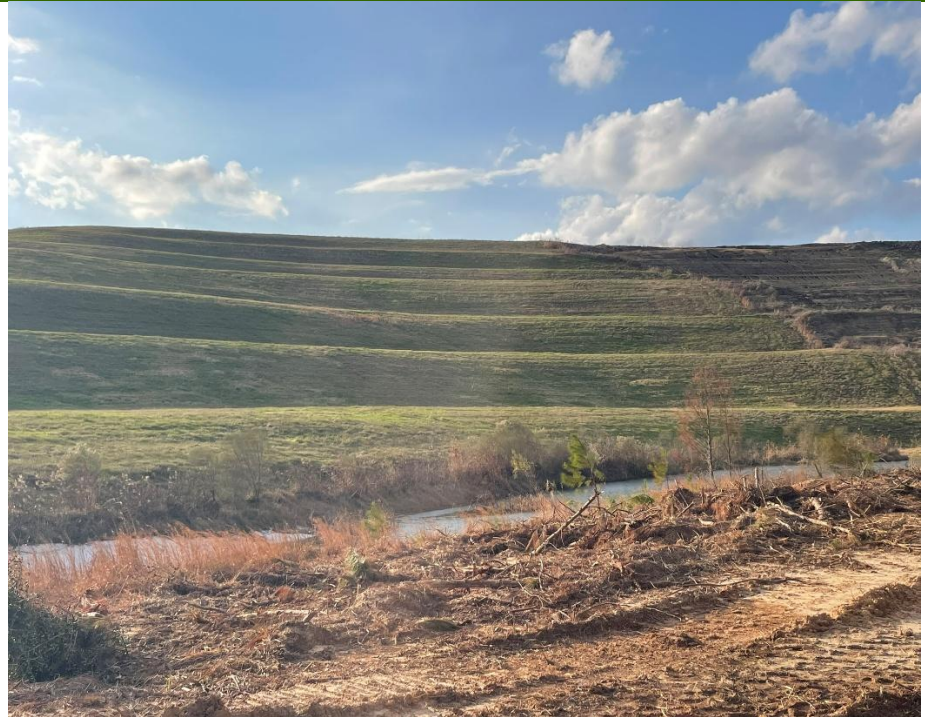
East slope of landfill.

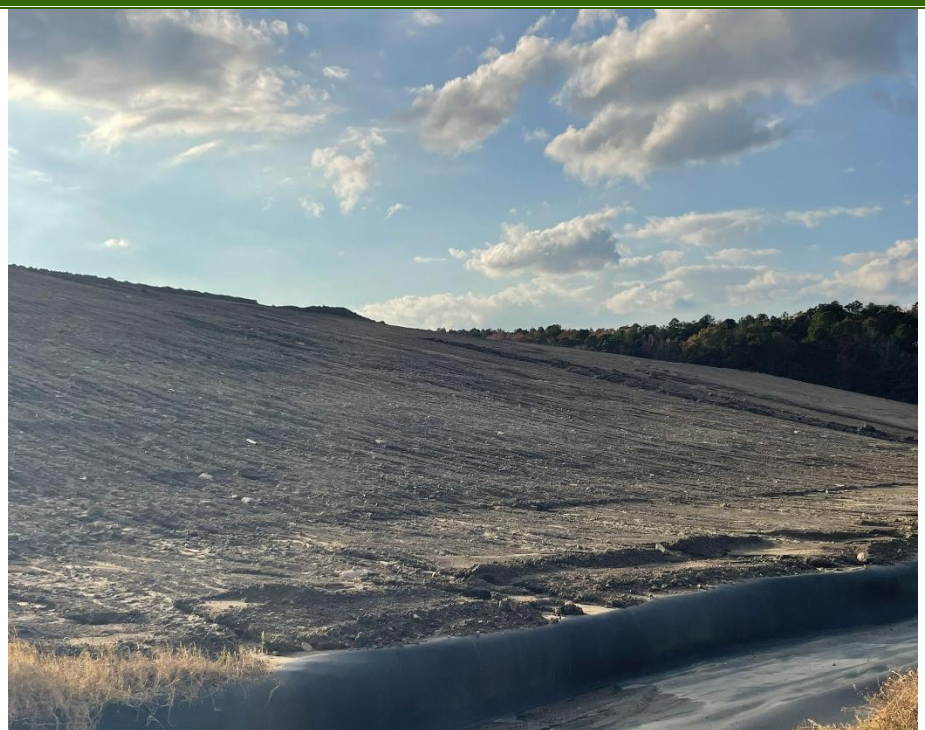
Northeast corner of landfill.
