# **CLECO POWER LLC** BRAME ENERGY CENTER

# 5-YEAR PERIODIC REVIEW SAFETY FACTOR ASSESSMENT

# **BOTTOM ASH POND**

**OCTOBER 2021**

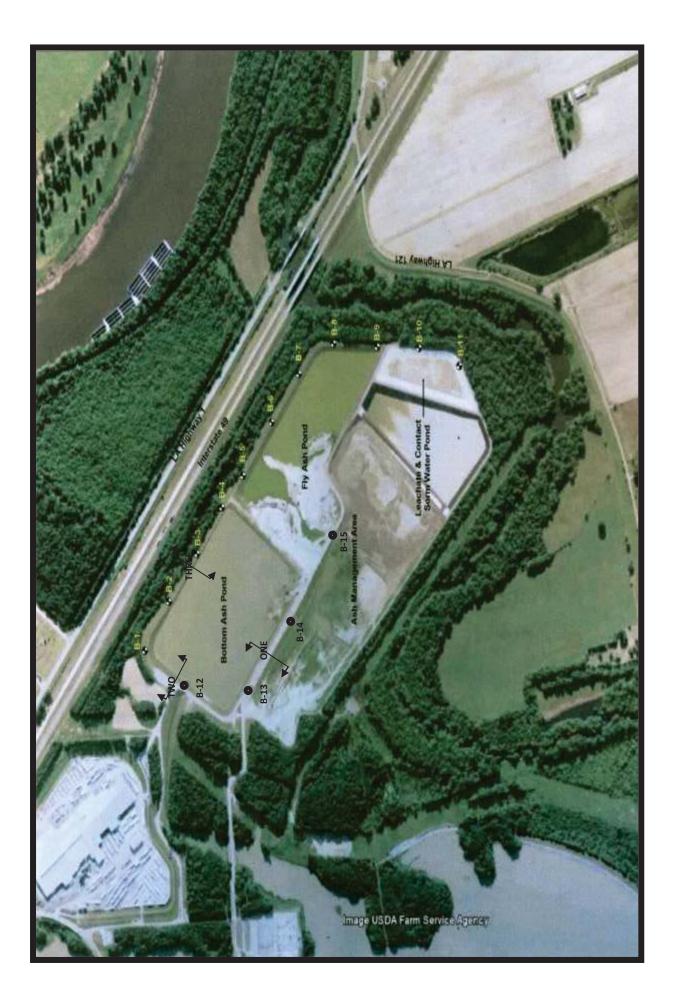
CLECO BRAME ENERGY CENTER BOTTOM ASH POND - SECTION 1 SHORT TERM SLOPE STABILITY ANALYSIS SOIL BORING B-13 (FROM GTL REPORT NO.: 04-16-061)

Pond	Section #	Condition	Flood Side Water Elevation (feet, NAVD88)	Factor of Safety Obtained	Notes
	1	Short Term	103.5	1.53	
Dettern	1	Long Term	103.5	1.68	
Bottom Ash	2	Short Term	103.5	2.27	
Pond	2	Long Term	103.5	2.32	
FUIU	3	Short Term	103.5	1.58	
	3	Long Term	103.5	1.60
