CLECO POWER LLC BRAME ENERGY CENTER

5-YEAR PERIODIC REVIEW HAZARD POTENTIAL CLASSIFICATION ASSESSMENT

FLY ASH POND

OCTOBER 2021

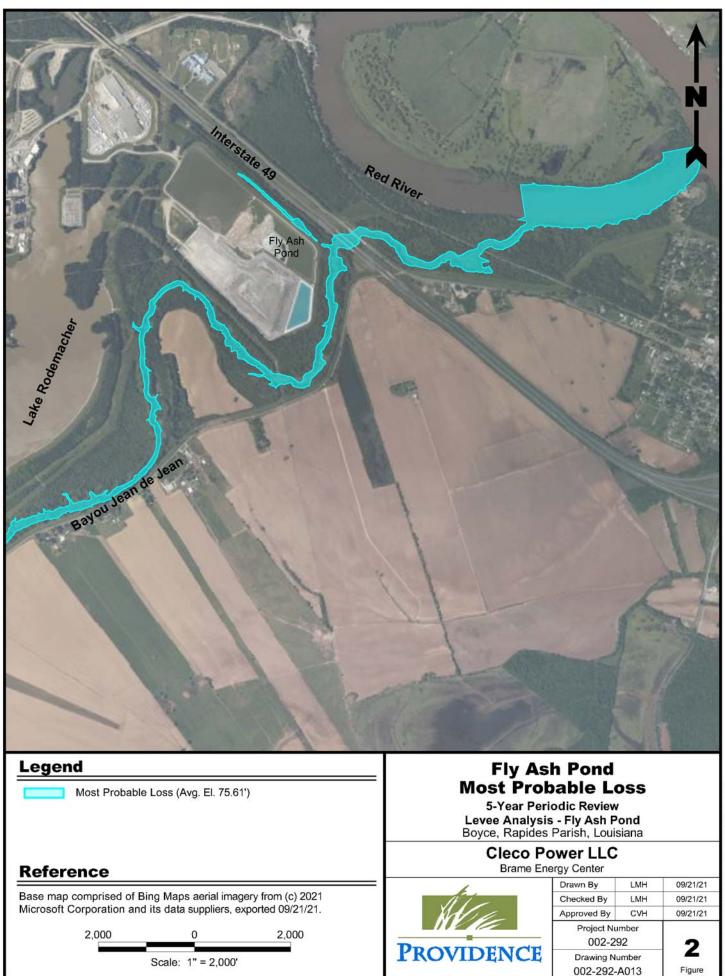
FLY ASH POND MOST PROBABLE LOSS

For the Fly Ash Pond, the Most Probable Loss condition results in no more than 1' increase which is localized to the channel adjacent to the pond and has no effects to surrounding properties or Interstate 49. The Maximum condition results in no more than a 7' increase which is localized to the channel adjacent to the pond and has no effects to surrounding properties or Interstate 49. The Fly Ash Pond results are presented in **Figures 2** and **3**.

It should be noted that the average elevation shown in **Figure 2** and **Figure 3** represents the average elevation of the entire outflow path.
