BRAME ENERGY CENTER

CCR ANNUAL INSPECTION

LANDFILL—CELL 4

JANUARY 2026

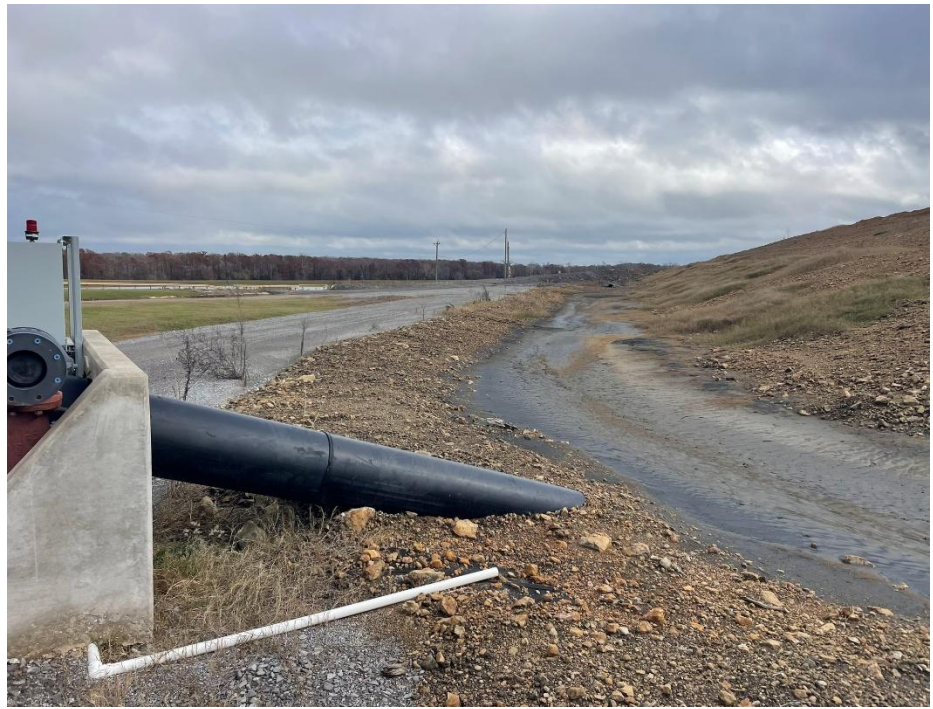
Landfill Cell 4

Leachate sideslope riser and perimeter ditch along inside of Cell 4.

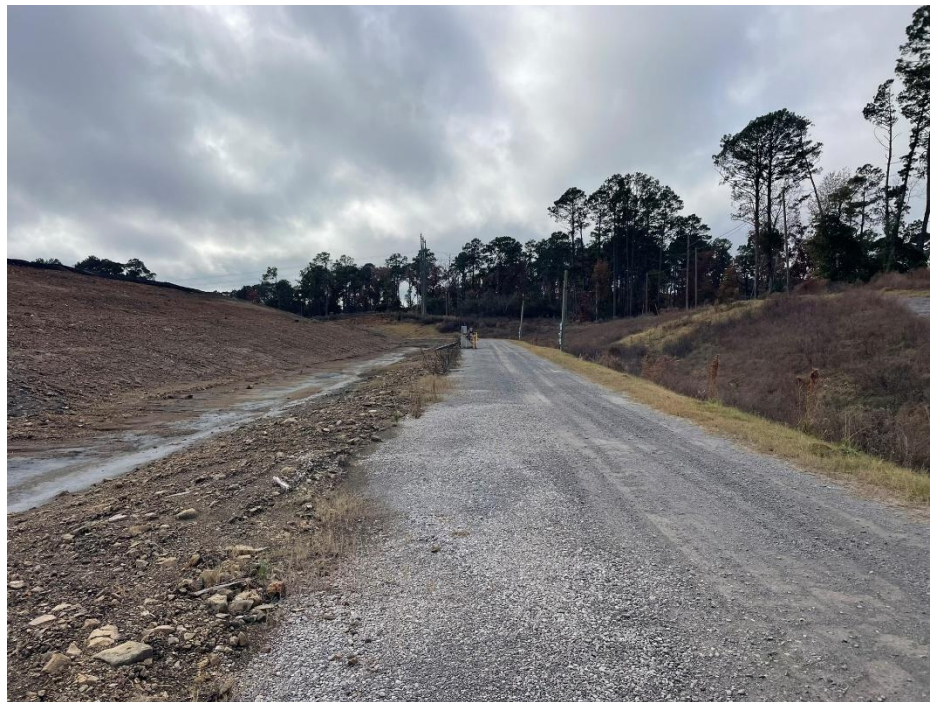
Landfill Cell 4

Perimeter roadway and interior ditch of Cell 4.

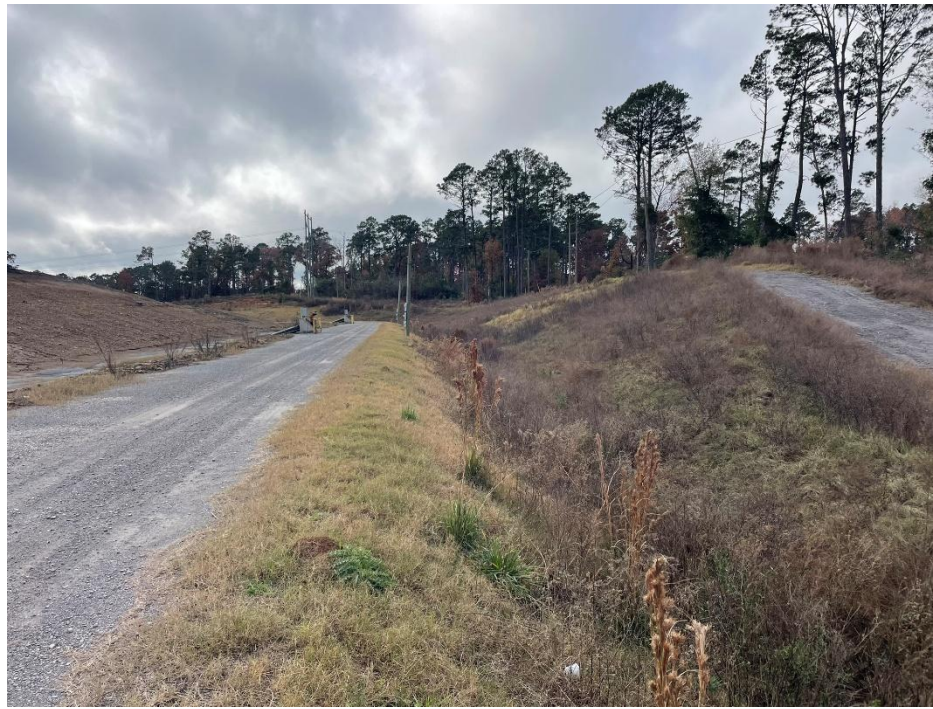
Landfill Cell 4

Perimeter roadway
and exterior ditch

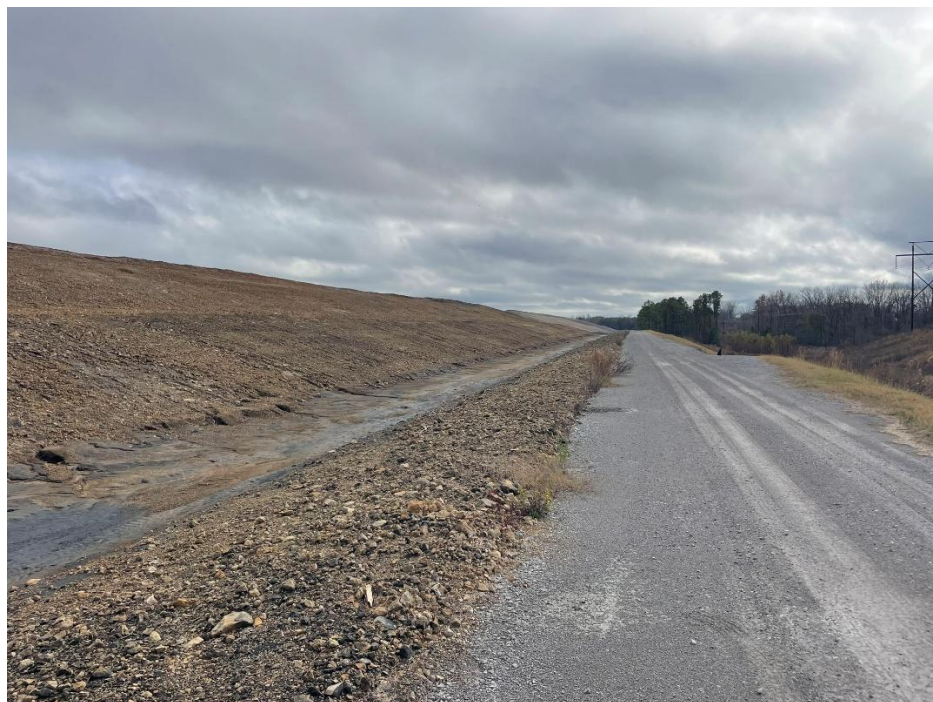
Landfill Cell 4

Perimeter roadway
and interior ditch of
Cell 4.

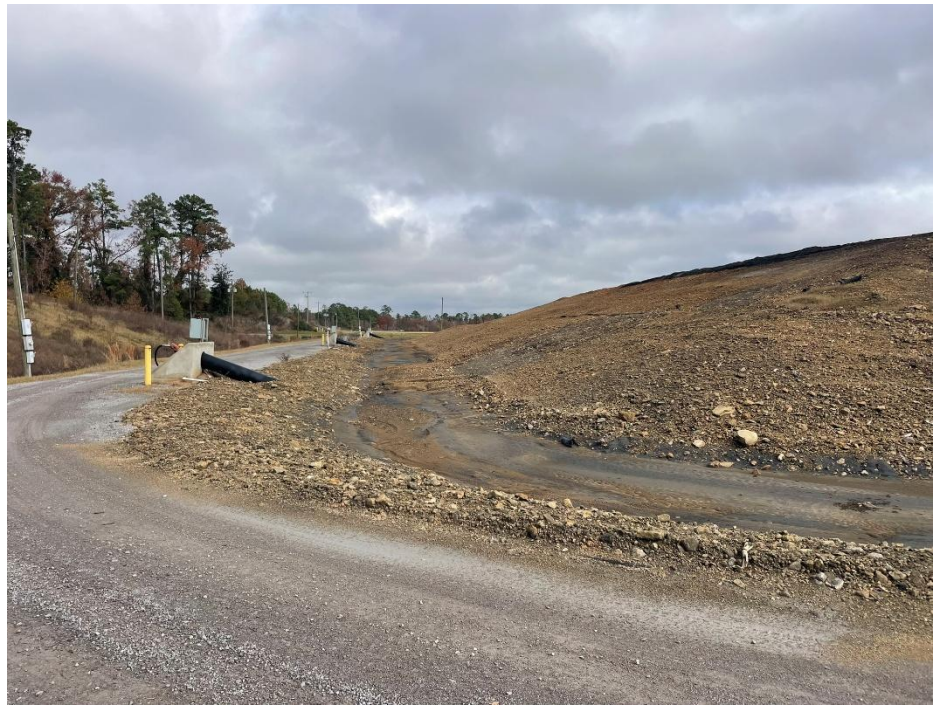
Landfill Cell 4

Perimeter roadway and interior ditch of Cell 4.

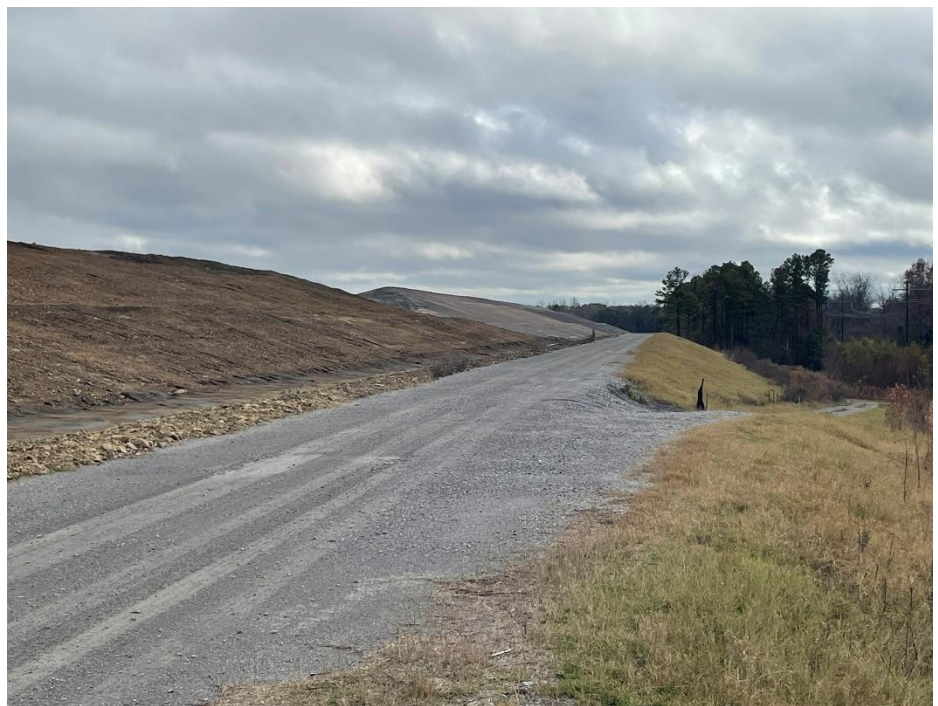
Landfill Cell 4

Perimeter roadway and exterior slope of Cell 4

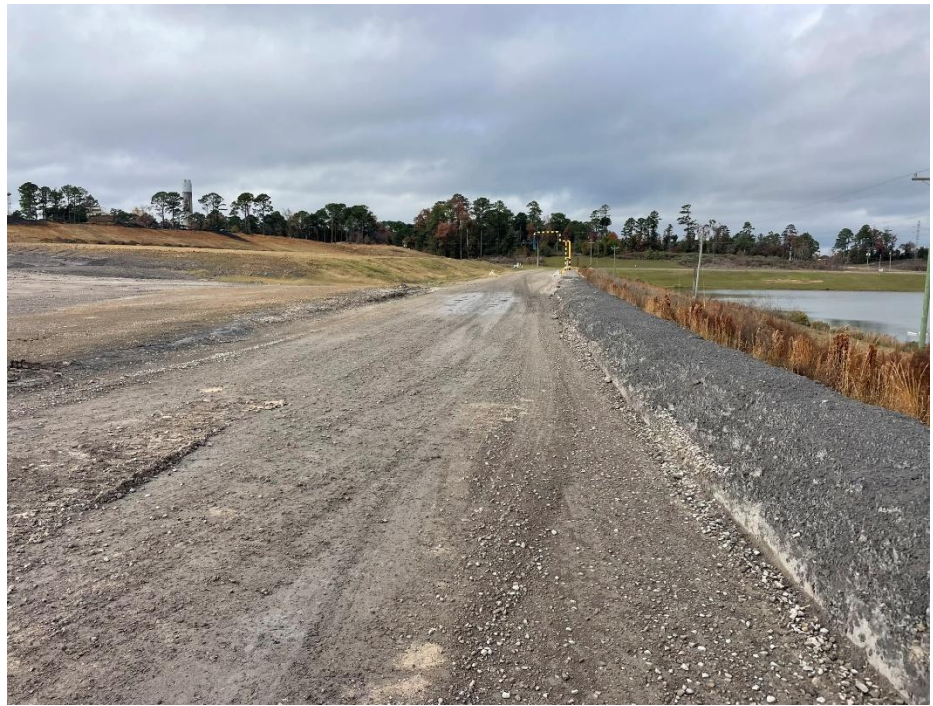
Landfill Cell 4

Perimeter roadway along northeast side Cell 4.

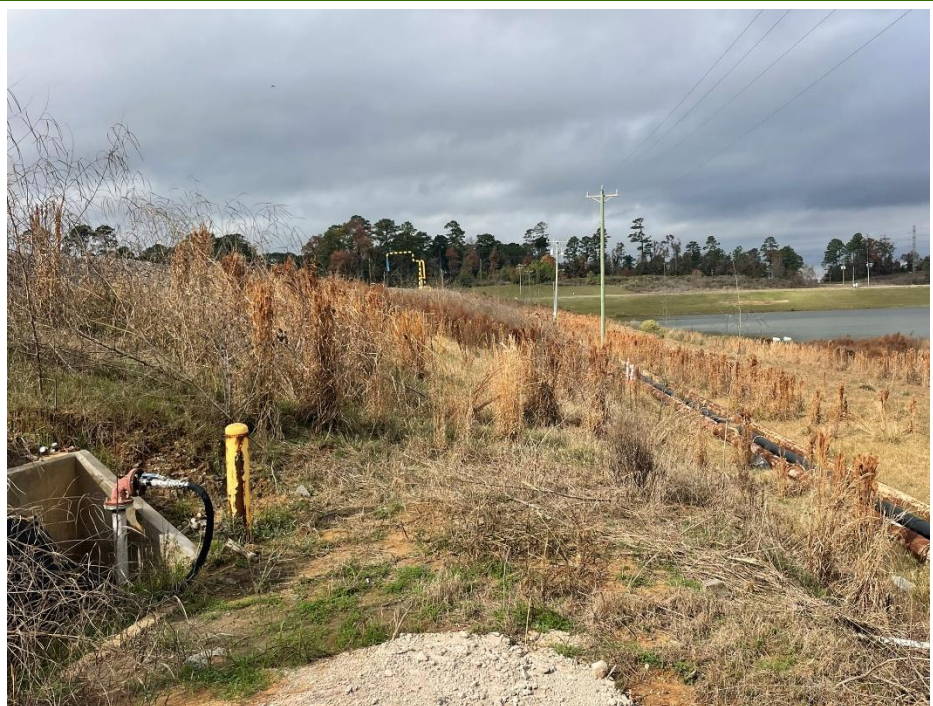
Landfill Cell 4

Overgrown vegetation on exterior slope of Cell 4. Vegetation needs to be managed.

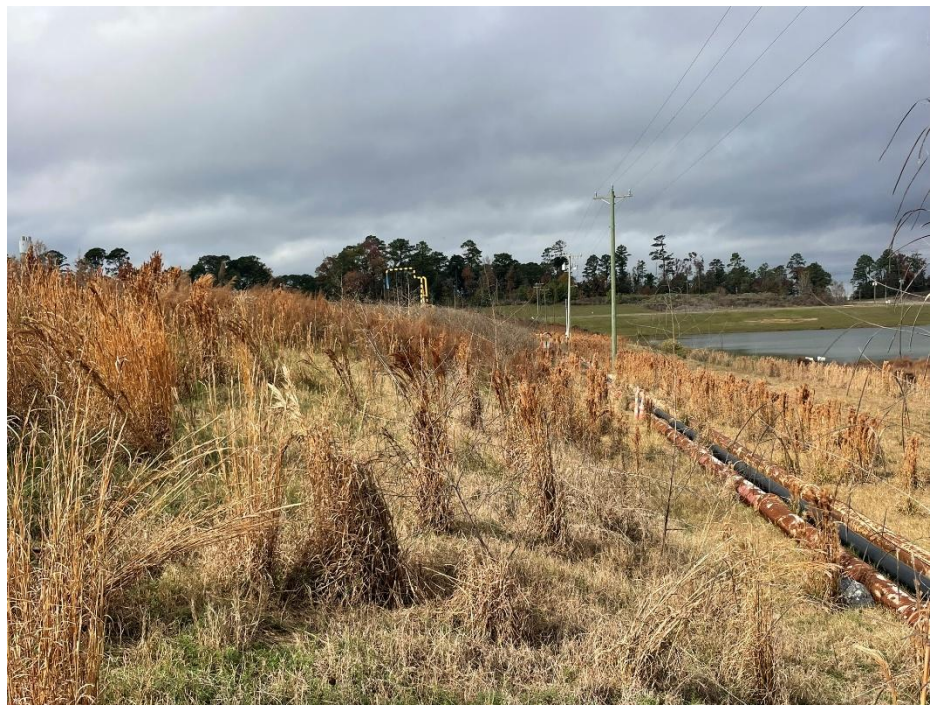
Landfill Cell 4

Sluice lines between eastern edge of cell 4 and Bottom Ash Pond. Overgrown vegetation needs to be managed.

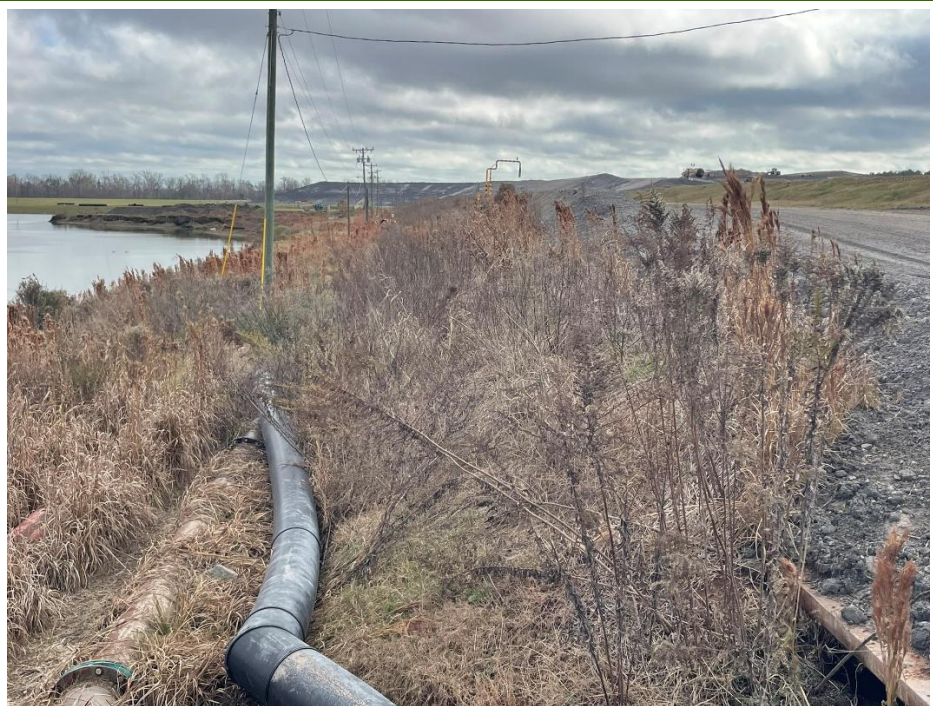
Landfill Cell 4

Sluice lines between eastern edge of cell 4 and Bottom Ash Pond. Overgrown vegetation needs to be managed.

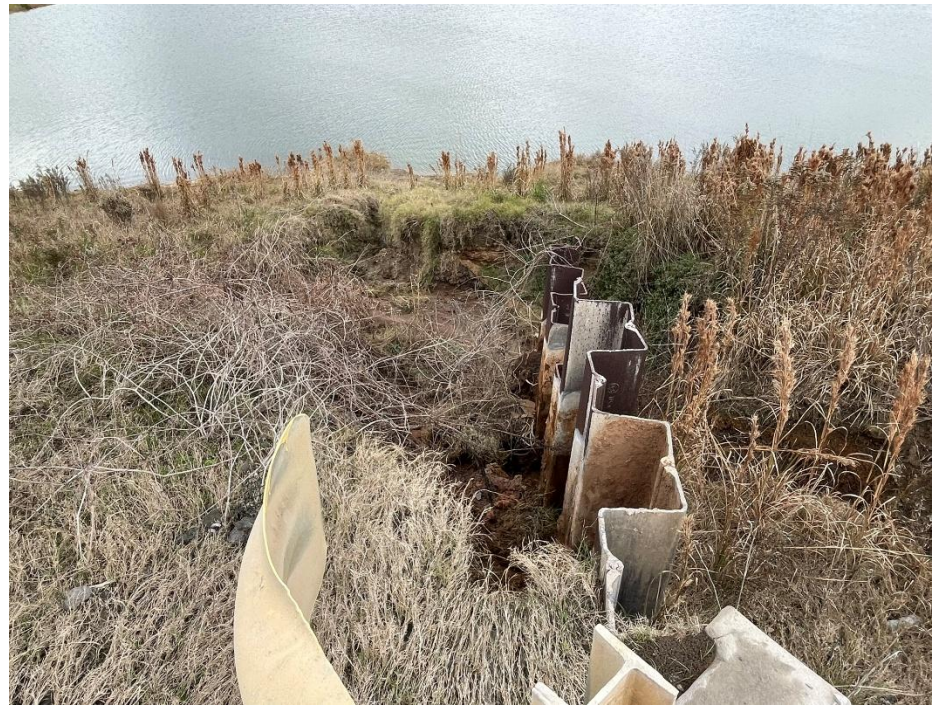
Landfill Cell 4

If yes, describe (size, location, etc.)	
Is the stormwater being properly diverted by the existing infrastructure?	<input checked="" type="checkbox"/> Yes <input type="checkbox"/> No
If yes, describe (size, location, etc.)	
Is the stormwater infrastructure in good condition?	<input checked="" type="checkbox"/> Yes <input type="checkbox"/> No
Findings:	The exterior slopes of Cell 4 were inspected and appeared to be in fair to good condition. Excess vegetation on the north slope needs to be managed. Erosion in northwest corner needs to be addressed.
Other observations on the exterior slopes:	None

Eroded area
between Cell 4 and
Bottom Ash pond.
This was noted in
previous inspection.
Needs repair.
