CLECO POWER LLC

BRAME ENERGY CENTER

CCR ANNUAL INSPECTION

BOTTOM ASH POND

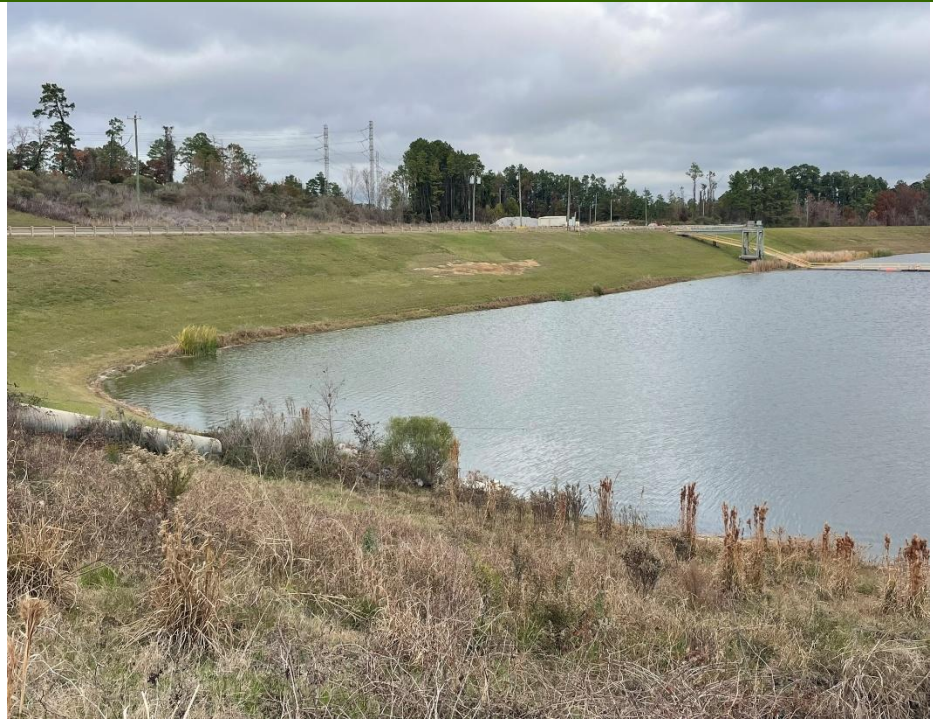
North levee pond slope

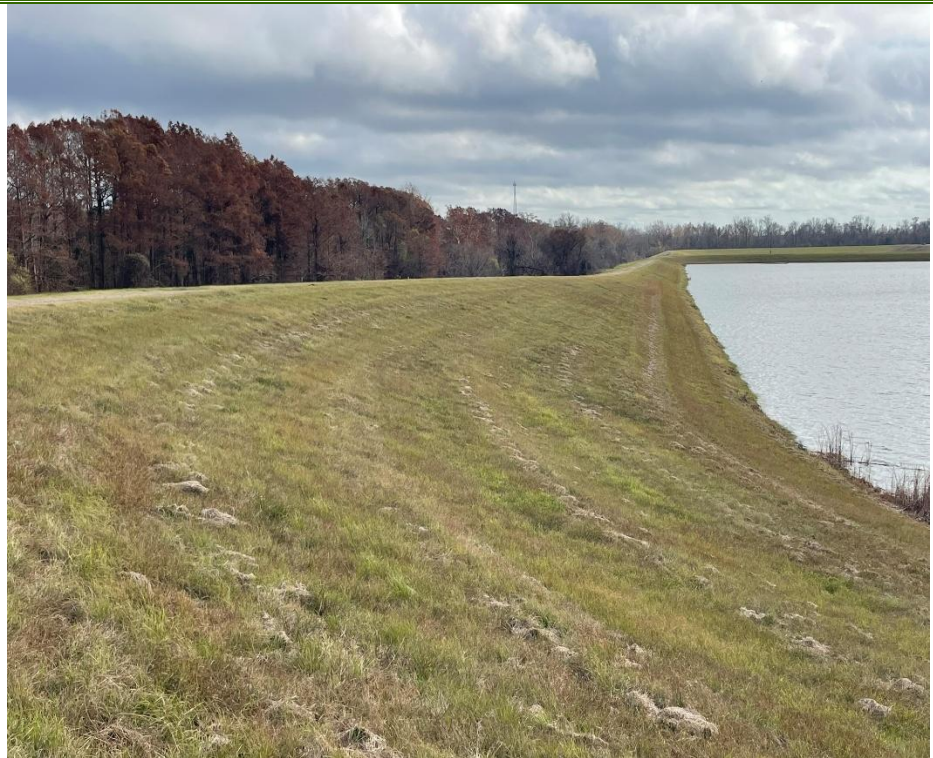
Interior slope on north side of pond

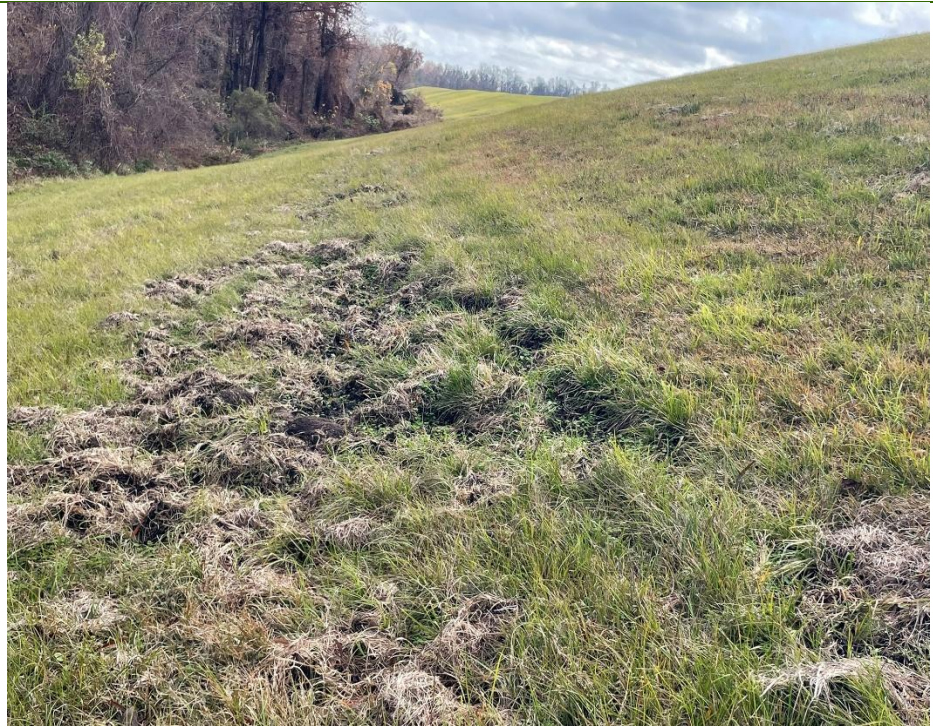
If yes, describe (size of area, location, severity, etc.)	
Are there any trees on the slopes?	<input type="checkbox"/> Yes <input checked="" type="checkbox"/> No
If yes, describe (type of vegetation, size, location, etc.)	
Findings:	The exterior slope was inspected and appeared to be in satisfactory condition. Minor feral hog rootings observed on north exterior slope.
Other observations on the exterior slopes:	None

Exterior slope of pond—minor feral hog rootings

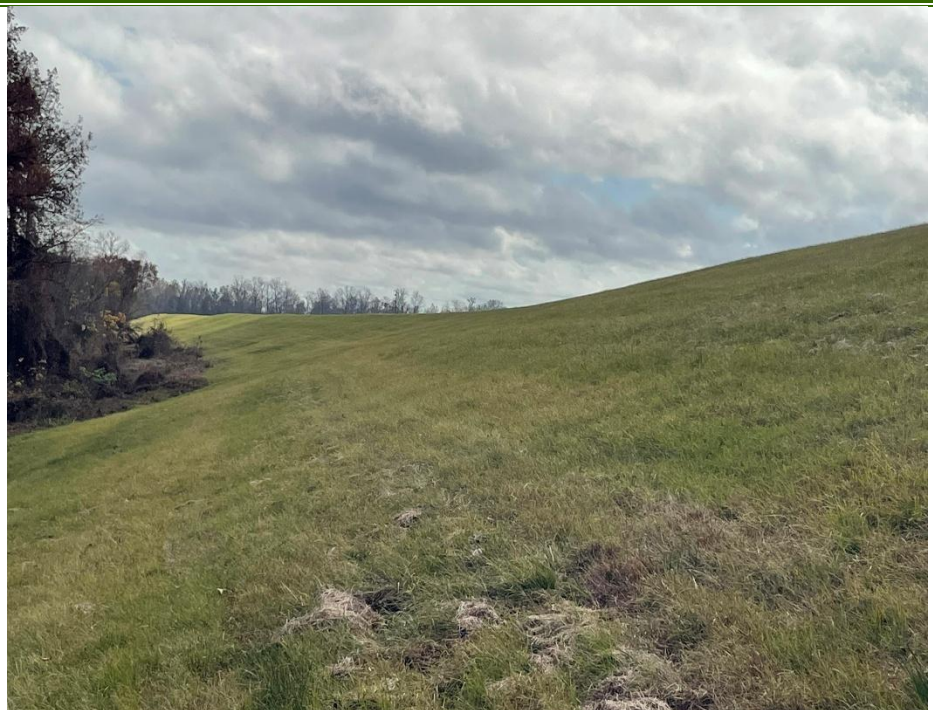
Exterior slope of Bottom Ash Pond

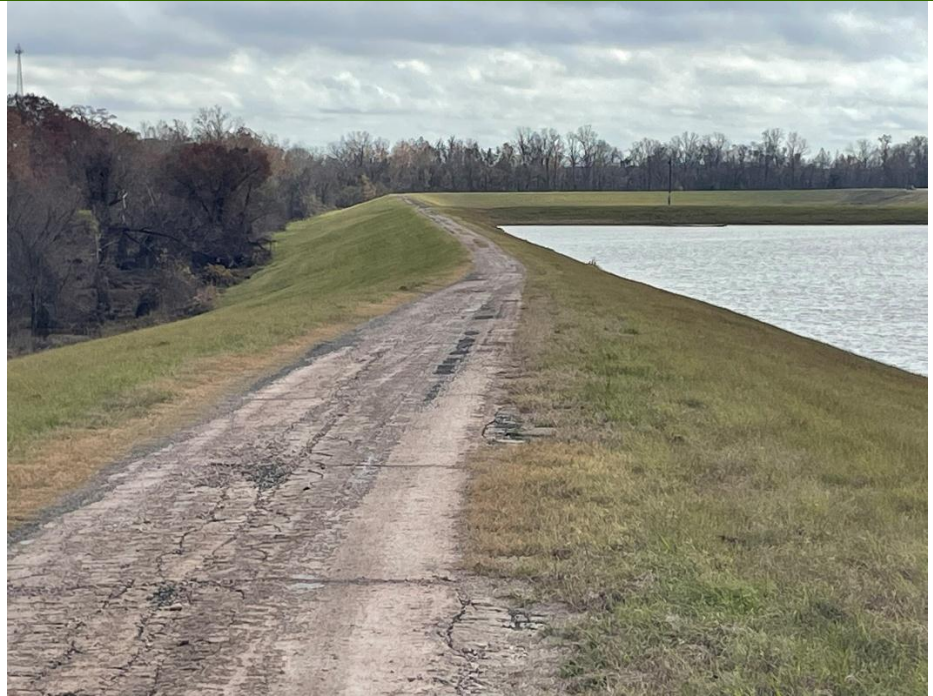
Crown of perimeter levee on Bottom Ash Pond

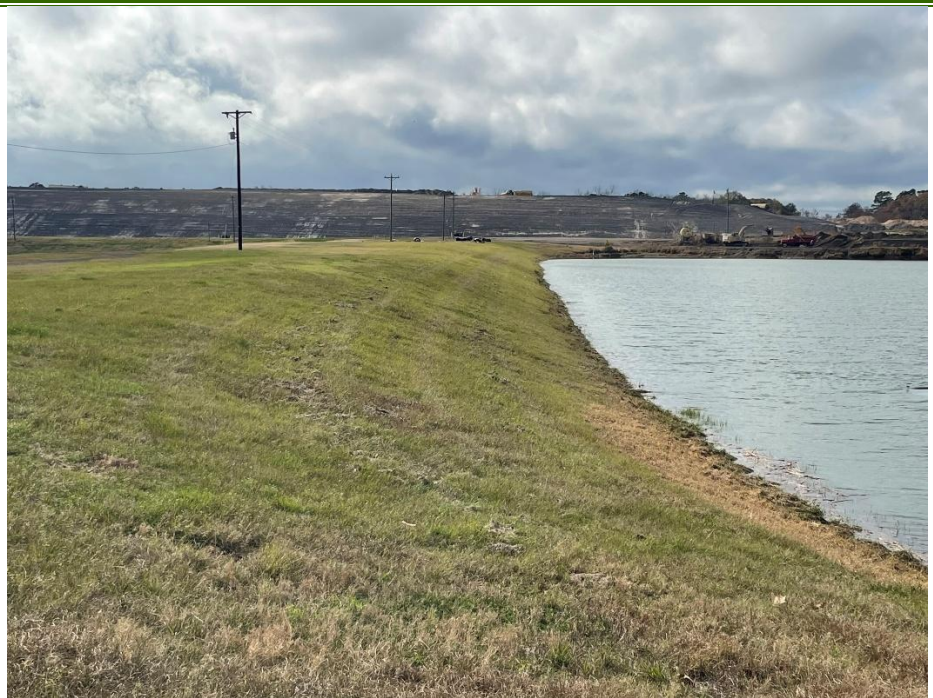
South levee, inside slope
