**CLECO POWER LLC  
BRAME ENERGY CENTER**

**BOTTOM ASH POND  
AND  
FLY ASH POND  
LENA, LA**

**Application to Submit  
Alternate Liner Demonstrations  
Pursuant to 40 C.F.R. § 257.71(d)(1)**

**December 14, 2020**

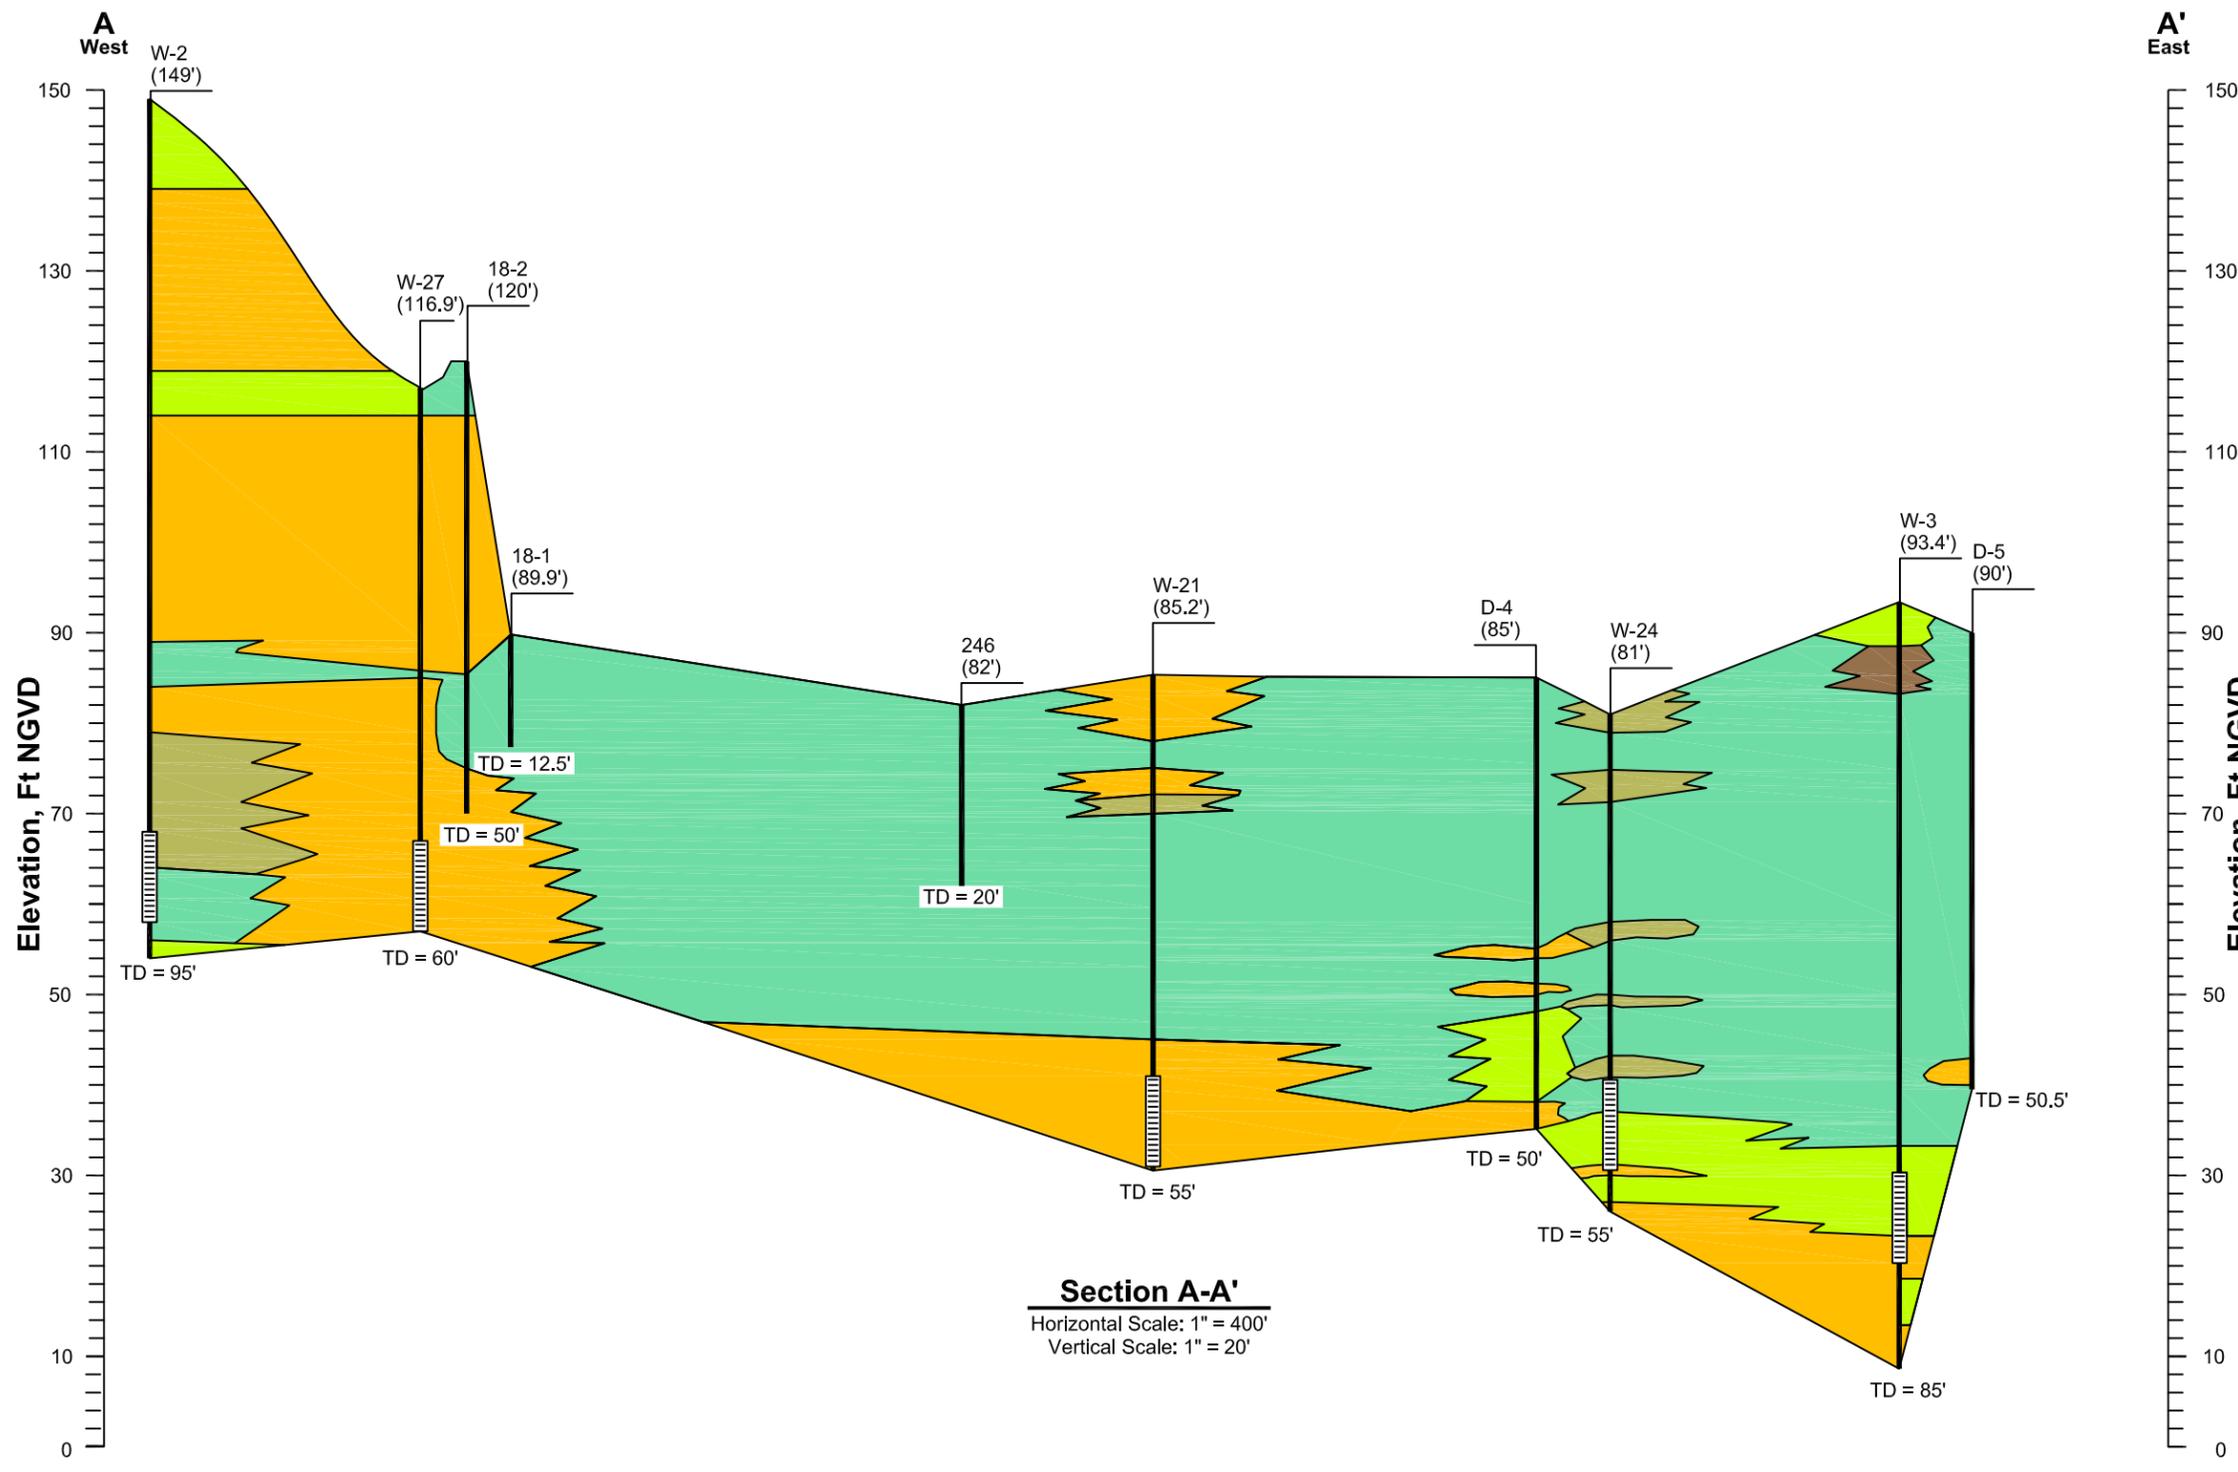
**Figure F-1**

**Reference**  
 Stratigraphy between borings are inferred. Actual conditions may vary.

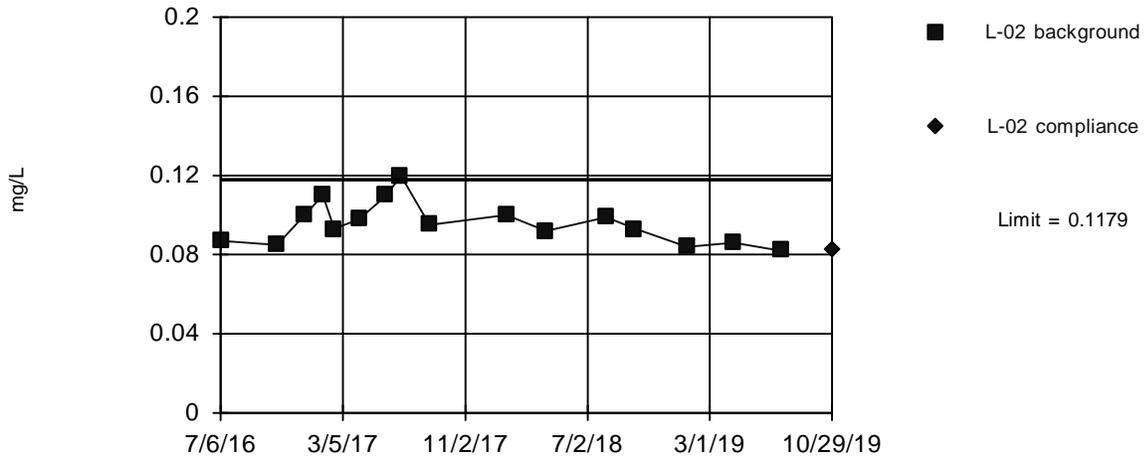
Prediction Limit  
Intrawell Parametric

Background Data Summary: Mean=0.09588, Std. Dev.=0.01061, n=16. Seasonality was not detected with 95% confidence. Normality test: Shapiro Wilk @alpha = 0.01, calculated = 0.9329, critical = 0.844. Kappa = 2.076 (c=7, w=4, 1 of 2, event alpha = 0.05132). Report alpha = 0.00188. EPA 1989 outlier screening was performed on the background data (to establish suspected outliers for Dixon's/Rosner's). No background outliers were found.

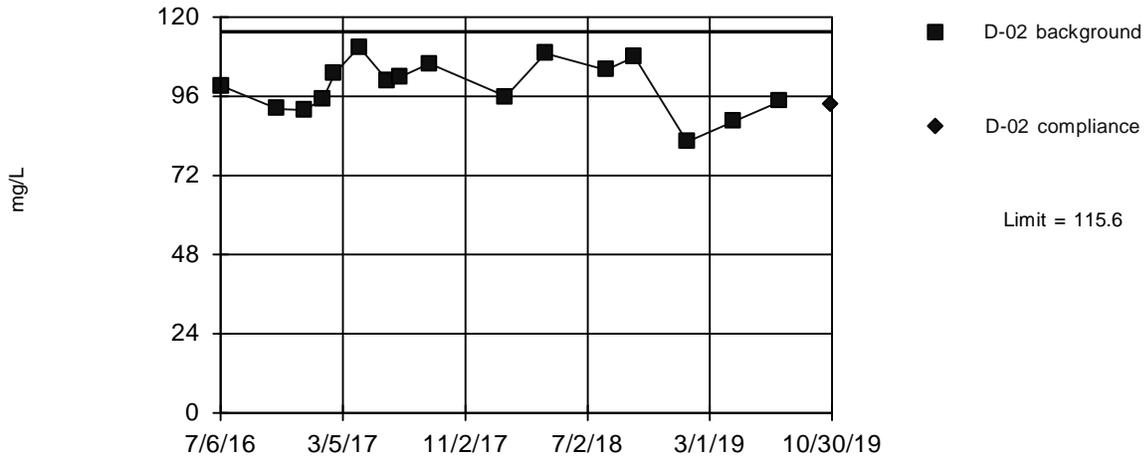
Intrawell Parametric

Background Data Summary: Mean=98.97, Std. Dev.=8.028, n=16. Seasonality was not detected with 95% confidence. Normality test: Shapiro Wilk @alpha = 0.01, calculated = 0.9739, critical = 0.844. Kappa = 2.076 (c=7, w=4, 1 of 2, event alpha = 0.05132). Report alpha = 0.00188. EPA 1989 outlier screening was performed on the background data (to establish suspected outliers for Dixon's/Rosner's). No background outliers were found.

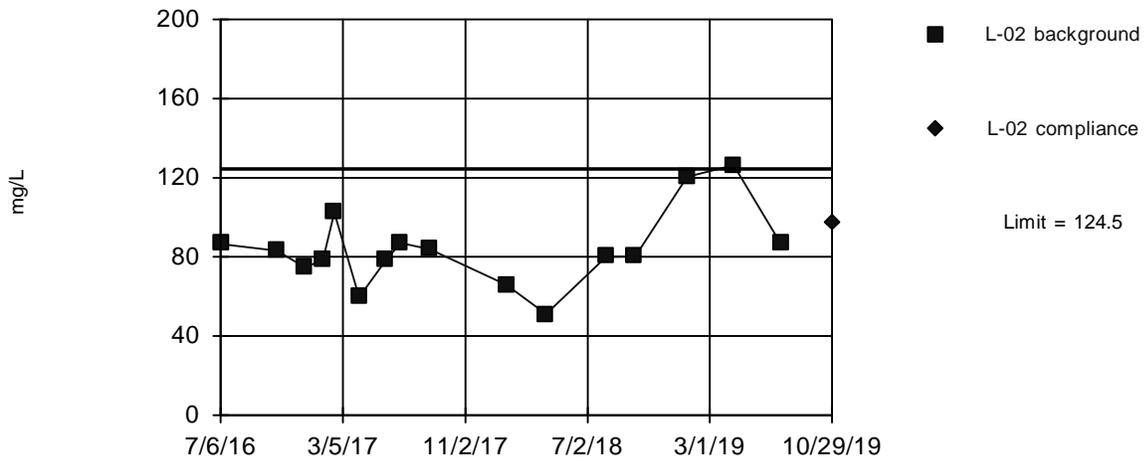
Prediction Limit  
Intrawell Parametric

Background Data Summary: Mean=84.12, Std. Dev.=19.44, n=16. Seasonality was detected with 95% confidence and data were deseasonalized. Normality test: Shapiro Wilk @alpha = 0.01, calculated = 0.9141, critical = 0.844. Kappa = 2.076 (c=7, w=4, 1 of 2, event alpha = 0.05132). Report alpha = 0.00188. Distribution was found to be non-normal after removal of suspect values, so outliers could not be identified.

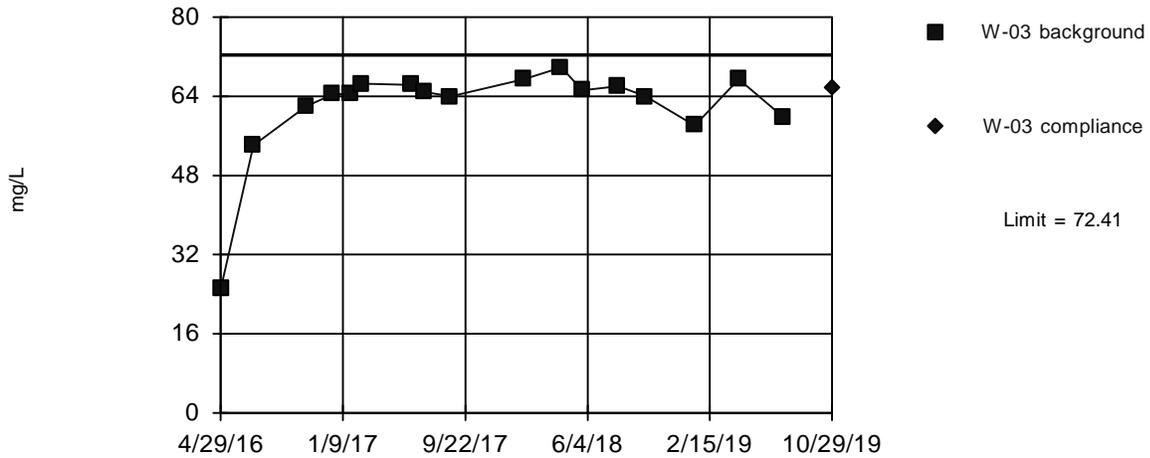
Prediction Limit  
Intrawell Parametric

Background Data Summary (based on  $x^4$  transformation): Mean=1.6e7, Std. Dev.=5502058, n=17. Seasonality was not detected with 95% confidence. Normality test: Shapiro Wilk @alpha = 0.01, calculated = 0.8648, critical = 0.851. Kappa = 2.054 (c=7, w=4, 1 of 2, event alpha = 0.05132). Report alpha = 0.00188. Distribution was found to be non-normal after removal of suspect values, so outliers could not be identified.

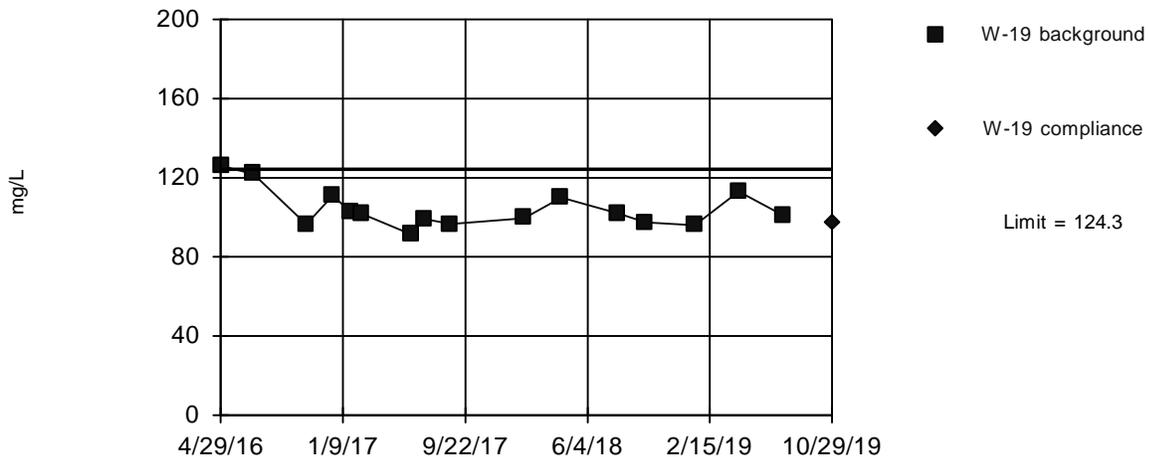
Prediction Limit  
Intrawell Parametric

Background Data Summary: Mean=104.2, Std. Dev.=9.697, n=16. Seasonality was not detected with 95% confidence. Normality test: Shapiro Wilk @alpha = 0.01, calculated = 0.8862, critical = 0.844. Kappa = 2.076 (c=7, w=4, 1 of 2, event alpha = 0.05132). Report alpha = 0.00188. EPA 1989 outlier screening was performed on the background data (to establish suspected outliers for Dixon's/Rosner's). No background outliers were found.

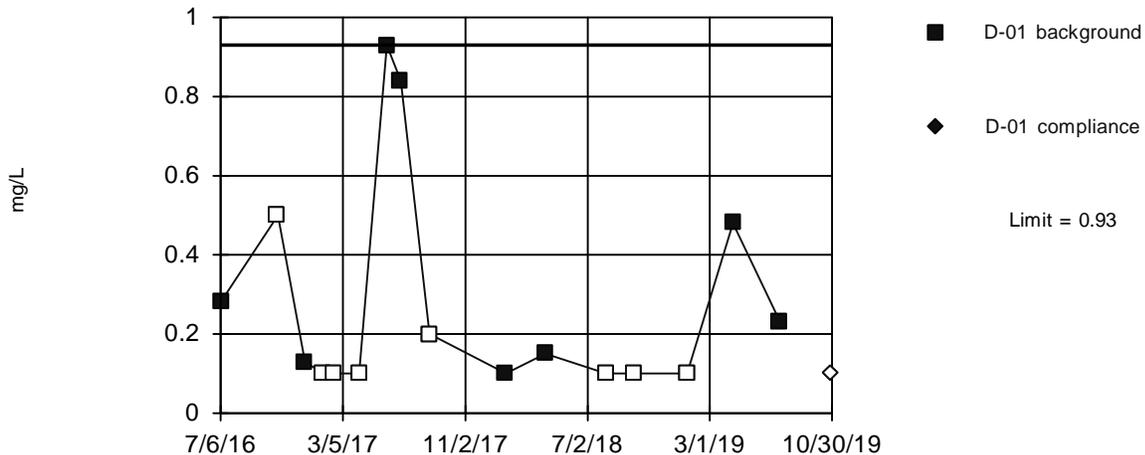
Prediction Limit  
Intrawell Non-parametric

Non-parametric test used in lieu of parametric prediction limit because the Shapiro Wilk normality test showed the data to be non-normal at the 0.01 alpha level. Limit is highest of 16 background values. 50% NDs. Well-constituent pair annual alpha = 0.01287. Individual comparison alpha = 0.006456 (1 of 2). Distribution was found to be non-normal after removal of suspect values, so outliers could not be identified. Seasonality was not detected with 95% confidence.
