CLECO POWER LLC

BRAME ENERGY CENTER
RAPIDES PARISH, LENA, LOUISIANA

5-YEAR PERIODIC REVIEW SAFETY FACTOR ASSESSMENT

BOTTOM ASH POND

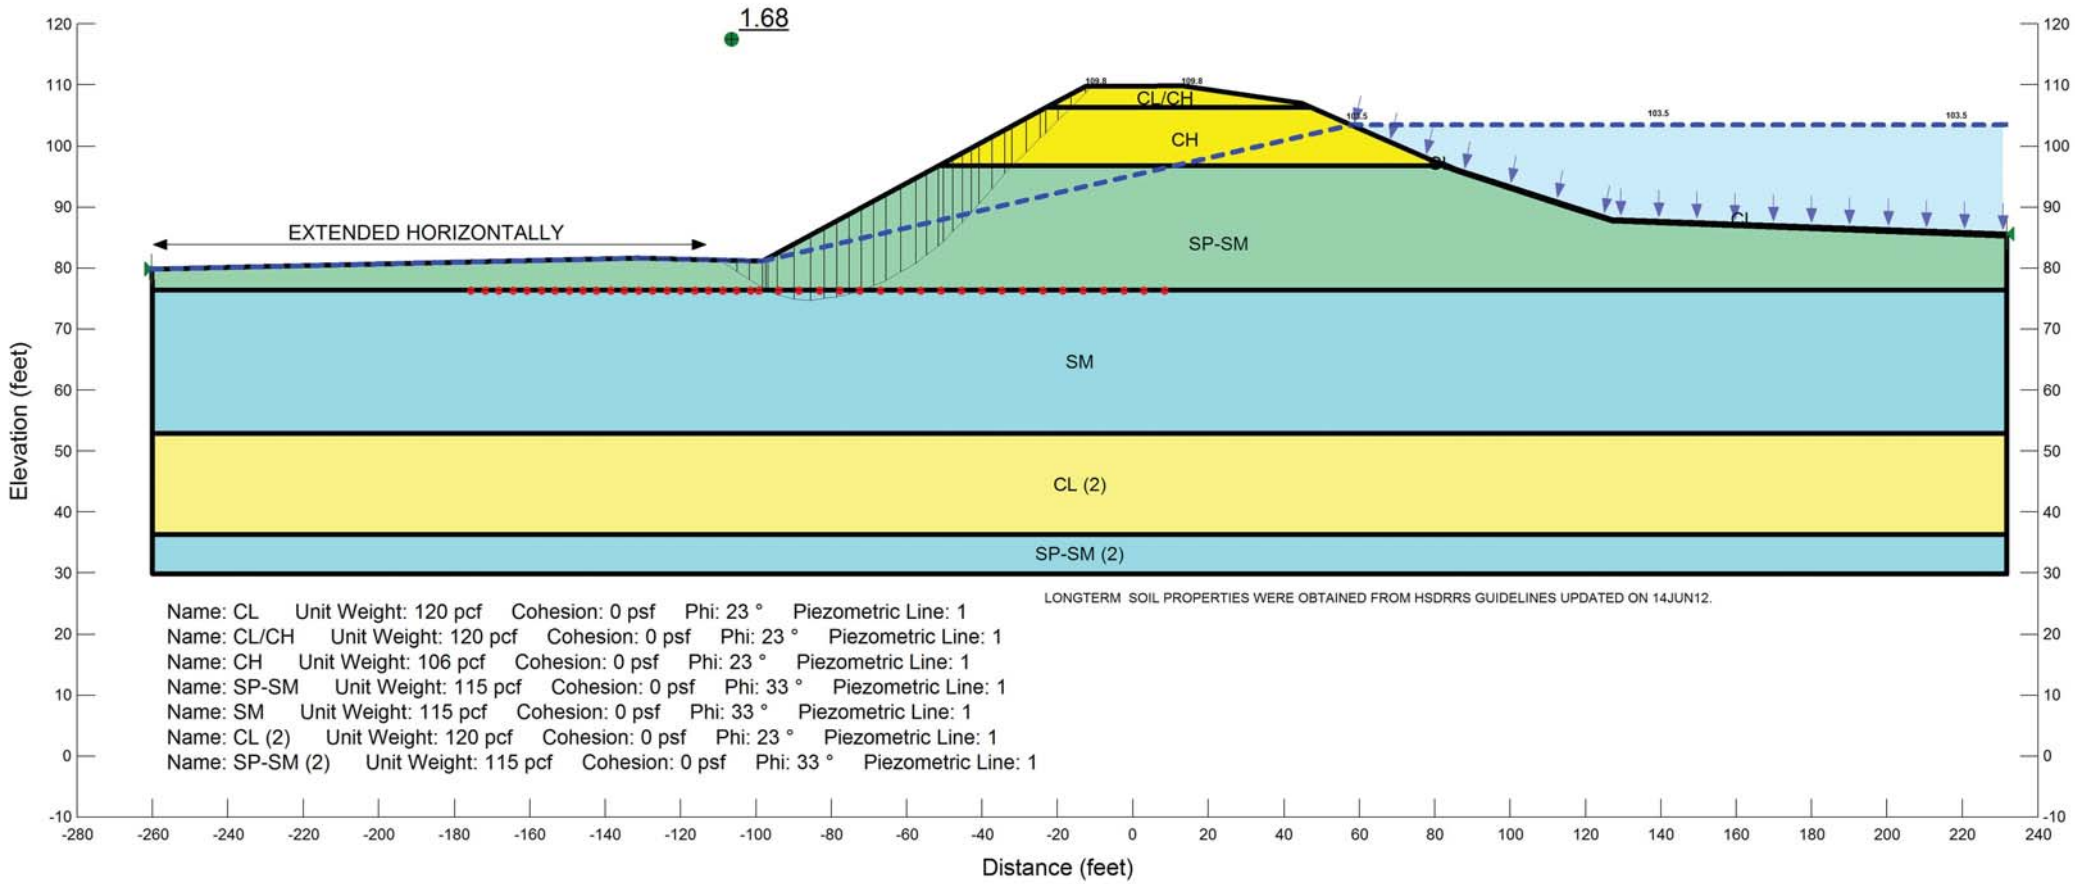
CLECO BRAME ENERGY CENTER
BOTTOM ASH POND - SECTION 1
SHORT TERM SLOPE STABILITY ANALYSIS
SOIL BORING B-13 (FROM GTL REPORT NO.: 04-16-061)

Pond	Section #	Condition	Flood Side Water Elevation (feet, NAVD88)	Factor of Safety Obtained	Notes
Bottom Ash Pond	1	Short Term	103.5	1.53	--
	1	Long Term	103.5	1.68	--
	2	Short Term	103.5	2.27	--
	2	Long Term	103.5	2.32	--
	3	Short Term	103.5	1.58	--
	3	Long Term	103.5	1.60	--

Name: CL Unit Weight: 120 pcf Cohesion: 1100 psf Piezometric Line: 1
Name: CL/CH Unit Weight: 120 pcf Cohesion: 550 psf Piezometric Line: 1
Name: CH Unit Weight: 106 pcf Cohesion: 250 psf Piezometric Line: 1
Name: SP-SM Unit Weight: 115 pcf Cohesion: 0 psf Phi: 30 ° Piezometric Line: 1
Name: SM Unit Weight: 115 pcf Cohesion: 0 psf Phi: 30 ° Piezometric Line: 1
Name: CL (2) Unit Weight: 120 pcf Cohesion: 1760 psf Piezometric Line: 1
Name: SP-SM (2) Unit Weight: 115 pcf Cohesion: 0 psf Phi: 30 ° Piezometric Line: 1
