# **CLECO POWER LLC BRAME ENERGY CENTER**

## **5-YEAR PERIODIC REVIEW SAFETY FACTOR ASSESSMENT**

### **FLY ASH POND**

**OCTOBER 2021**

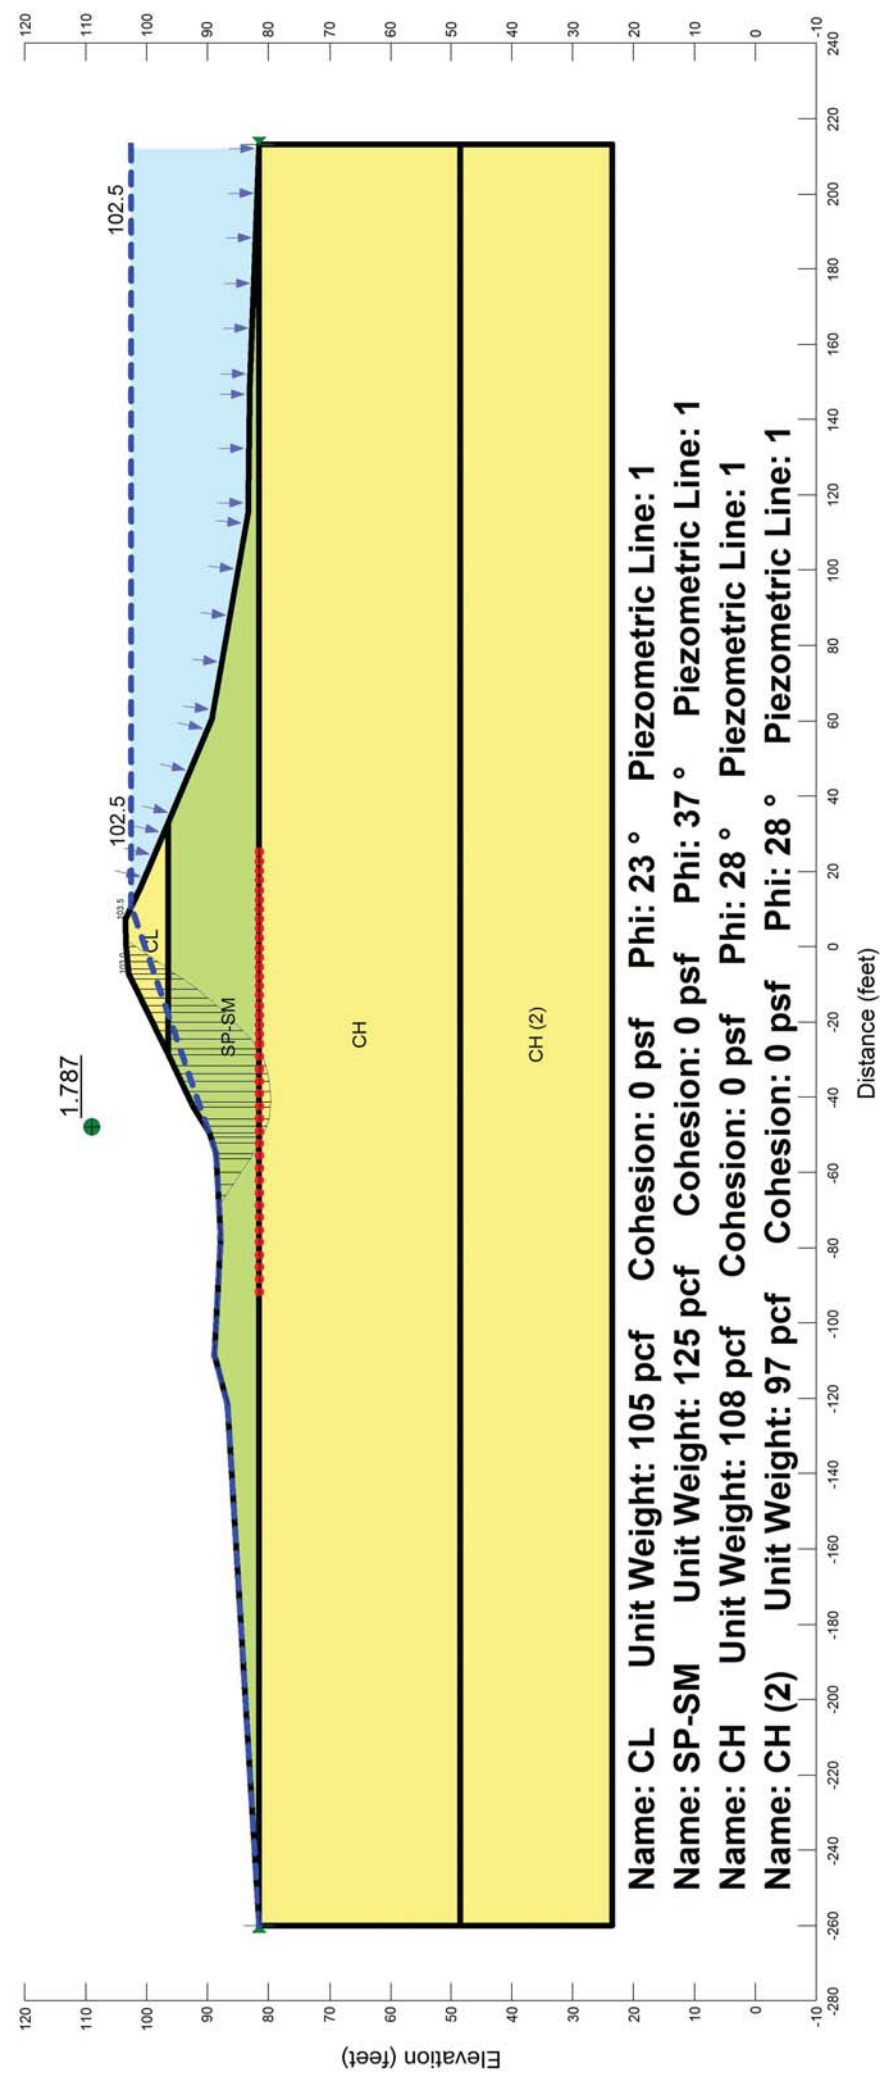
**CLECO BRAME ENERGY CENTER  
 FLY ASH POND - SECTION 3  
 LONG TERM SLOPE STABILITY ANALYSIS (S-CASE)  
 SOIL BORING B-8 (FROM GTL REPORT NO.: 06-11-090)**

Surface Impoundment	Section Number	Soil Boring No.	Maximum Water Elevation (feet NAVD 88)	Analysis	Factor of Safety
Fly Ash	Section 1	B-15	102.5	Spencer Method Deep Failure	1.56
Fly Ash	Section 2	B-6	102.5	Spencer Method Deep Failure	1.82
Fly Ash	Section 3	B-8	102.5	Spencer Method Deep Failure	2.75

**Name: CL    Unit Weight: 105 pcf    Cohesion: 0 psf    Phi: 23 °    Piezometric Line: 1**  
**Name: SP-SM    Unit Weight: 125 pcf    Cohesion: 0 psf    Phi: 37 °    Piezometric Line: 1**  
**Name: CH    Unit Weight: 108 pcf    Cohesion: 0 psf    Phi: 28 °    Piezometric Line: 1**  
**Name: CH (2)    Unit Weight: 97 pcf    Cohesion: 0 psf    Phi: 28 °    Piezometric Line: 1**
