OCTOBER 2016

# CLECO POWER LLC BRAME ENERGY CENTER

## SAFETY FACTOR ASSESSMENT:

## BOTTOM ASH POND

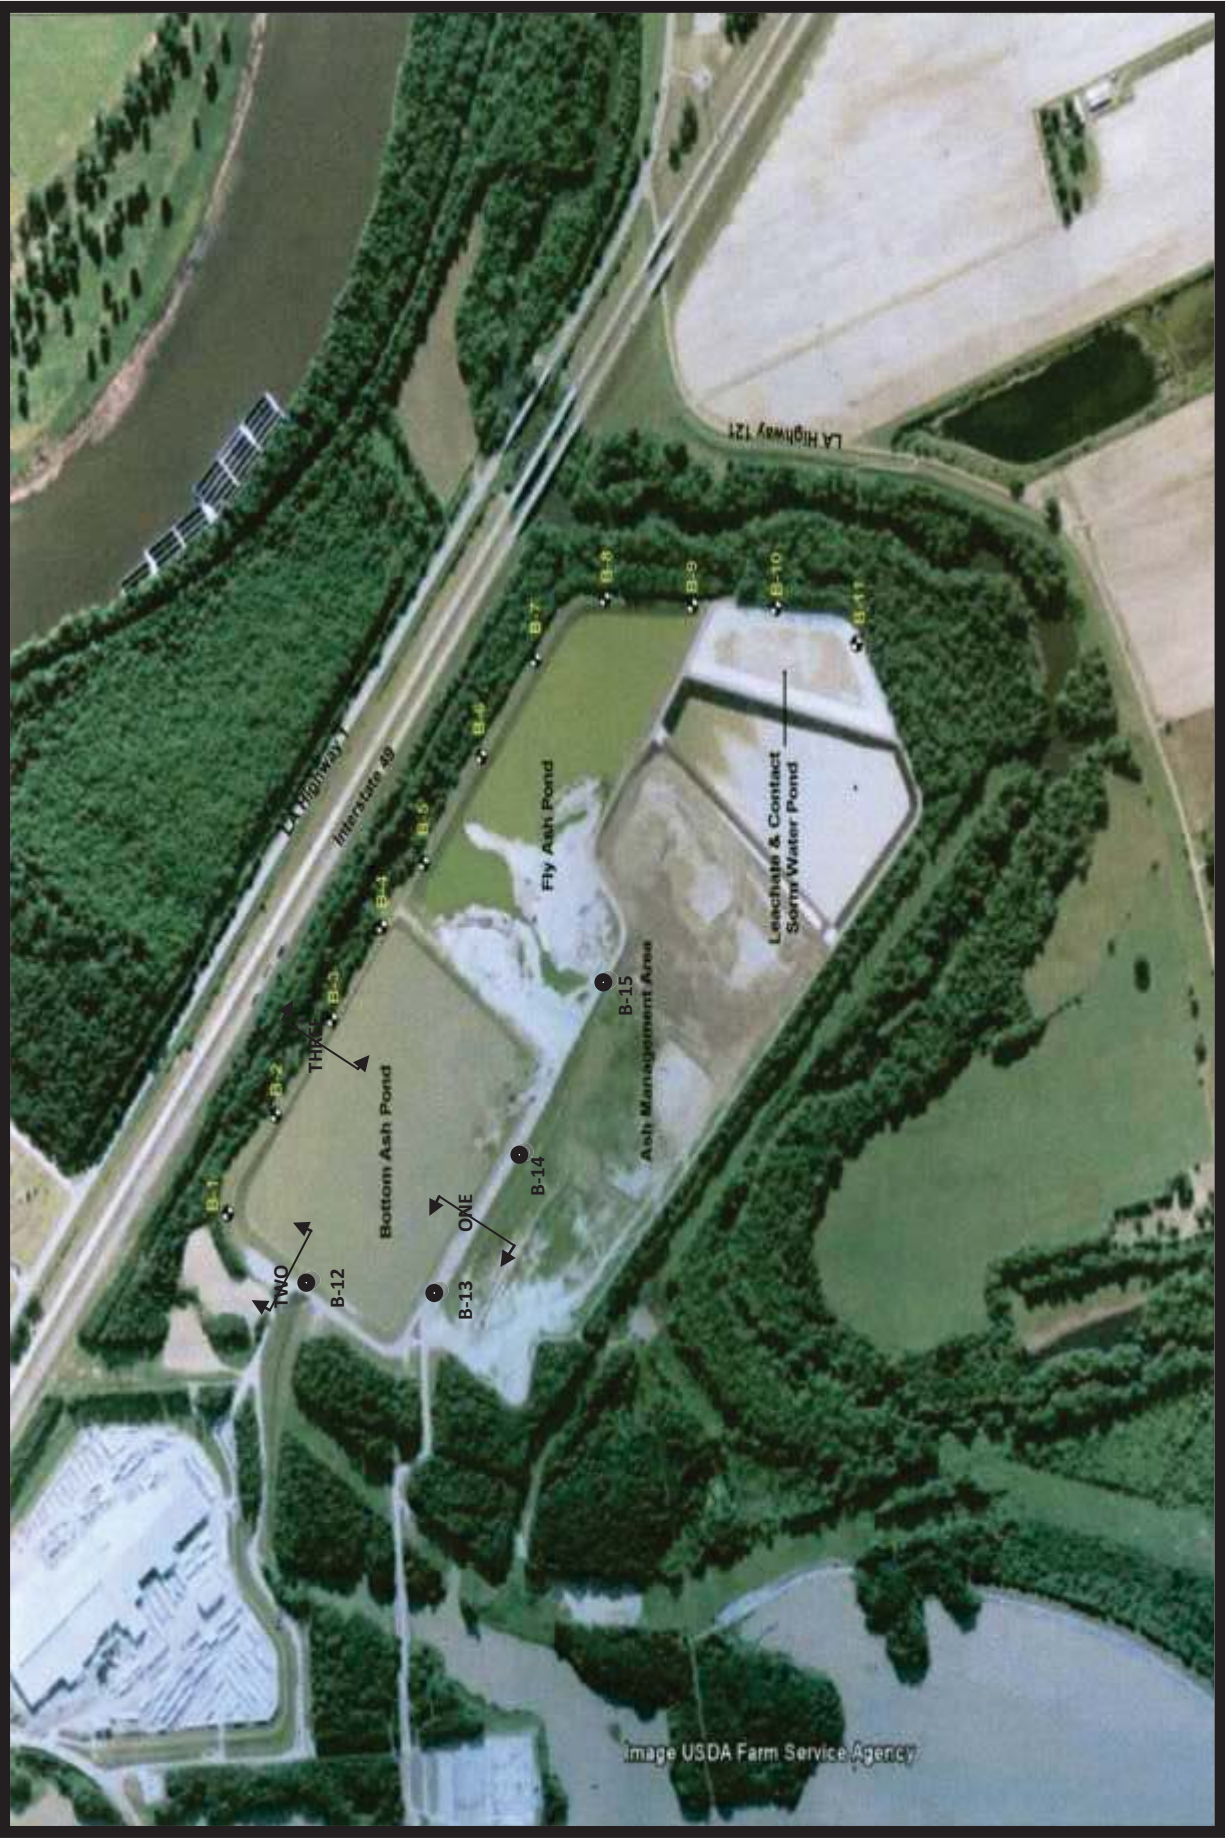
**CLECO BRAME ENERGY CENTER  
 BOTTOM ASH POND - SECTION 1  
 SHORT TERM SLOPE STABILITY ANALYSIS  
 SOIL BORING B-13 (FROM GTL REPORT NO.: 04-16-061)**

Surface Impoundment	Section Number	Soil Boring No.	Maximum Water Elevation (feet NAVD 88)	Analysis	Factor of Safety
Bottom Ash	Section 1	B-13	103.5	Spencer Model Deep Failure	1.52
Bottom Ash	Section 2	B-12	103.5	Spencer Model Deep Failure	1.52
Bottom Ash	Section 3	B-3	103.5	Spencer Model Deep Failure	1.54

The calculated short-term static factor of safety under maximum surcharge pool loading conditions is greater than 1.40, therefore these safety factors are adequate.
