CCR SURFACE IMPOUNDMENT ANNUAL INSPECTION REPORT

Big Cajun II Power Plant

New Roads, Pointe Coupee Parish, Louisiana

January 2018

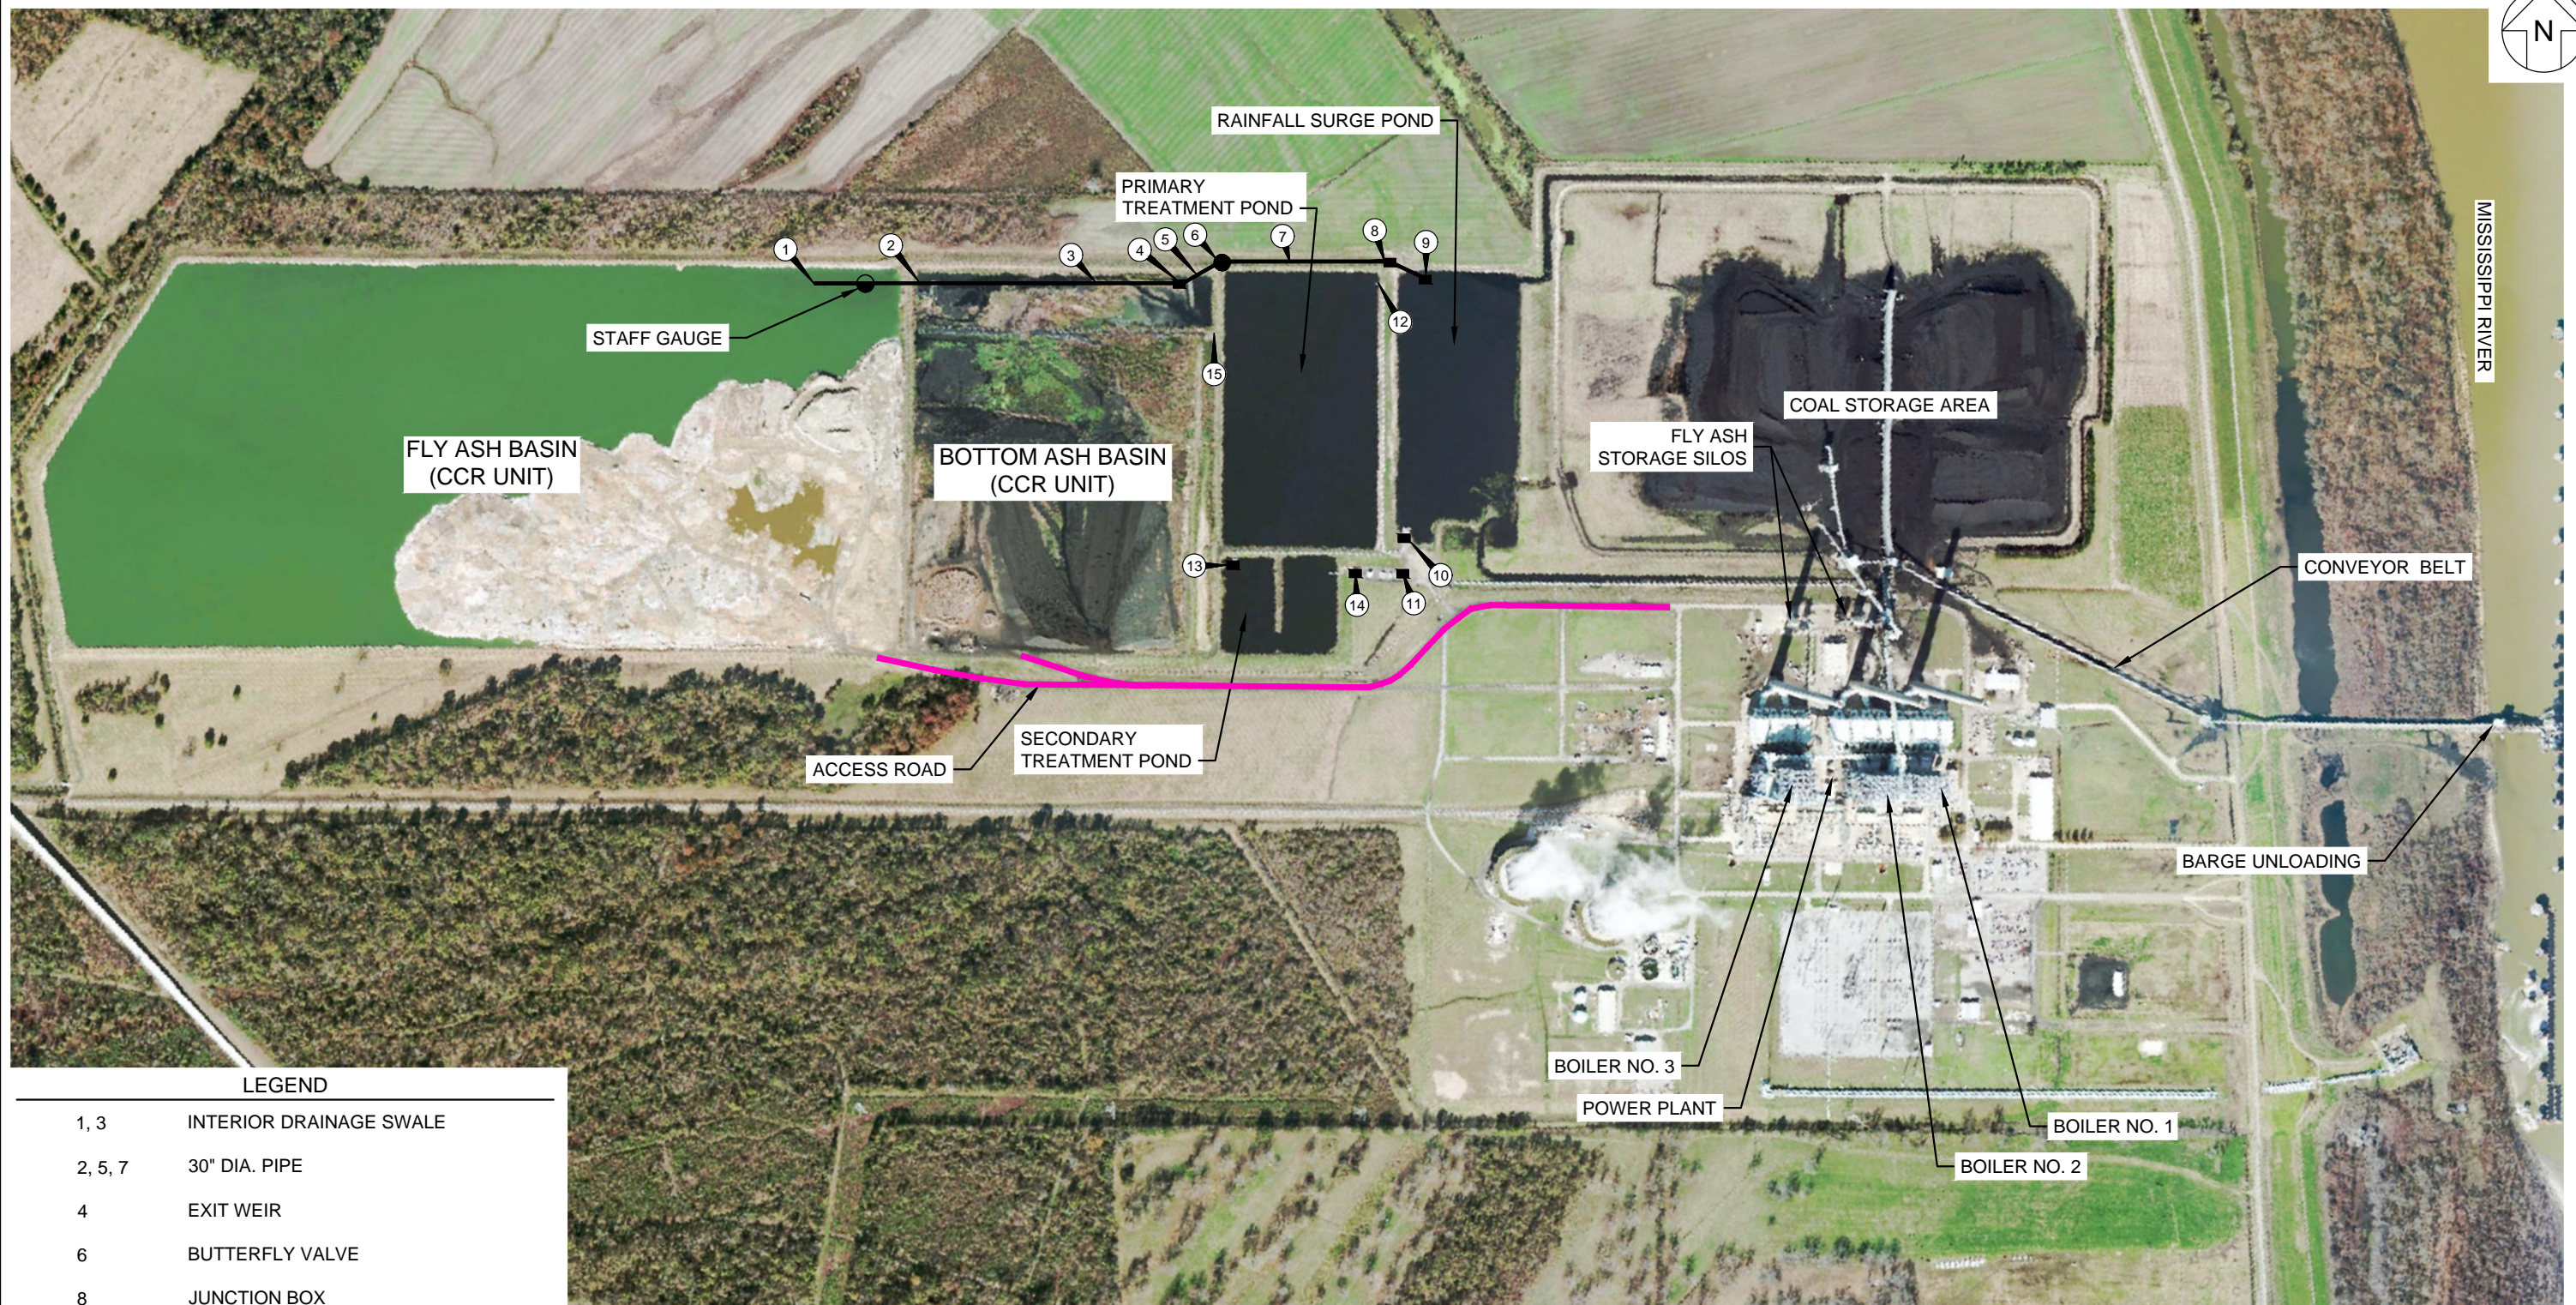
Figure 2: 10/25/2017 Inspection Map

Results of the observed conditions of the Fly Ash Basin and Bottom Ash Basin during the annual inspection were presented previously in Section 3. The conditions are also documented on Figure 2 and on the photographs in Appendix A.

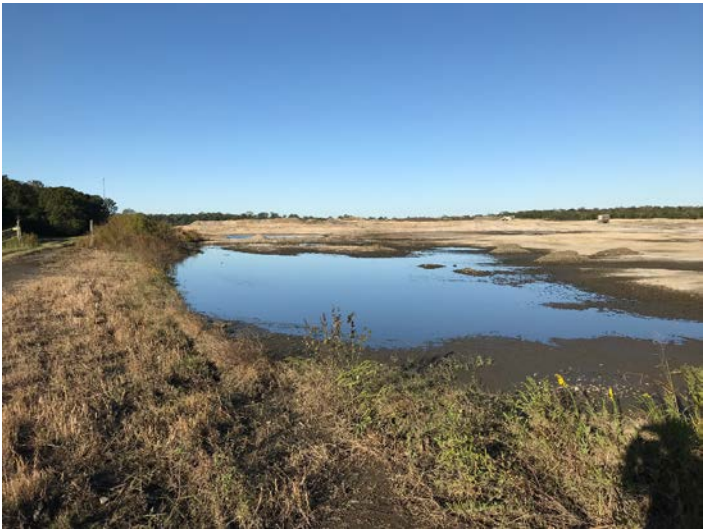
<p>Photograph ID: 1</p> <hr/> <p>Date: 10/25/2017</p> <hr/> <p>Direction: W</p> <hr/> <p>Comments: Fly Ash Basin – southeast corner</p>

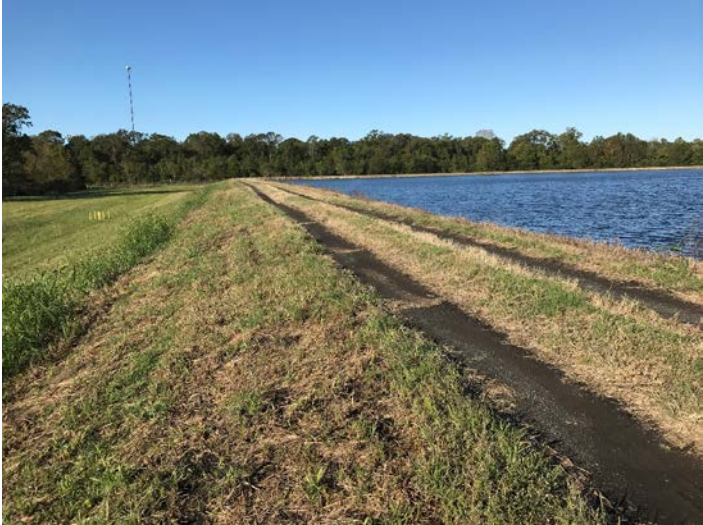
<p>Photograph ID: 6</p> <hr/> <p>Date: 10/25/2017</p> <hr/> <p>Direction: W</p> <hr/> <p>Comments: Fly Ash Basin – south exterior slope and road</p>

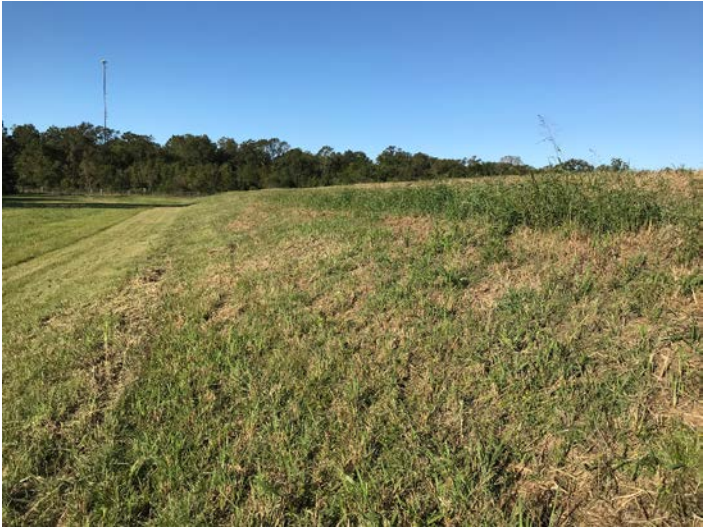
<p>Photograph ID: 7</p> <hr/> <p>Date: 10/25/2017</p> <hr/> <p>Direction: W</p> <hr/> <p>Comments: Fly Ash Basin – south exterior slope</p>

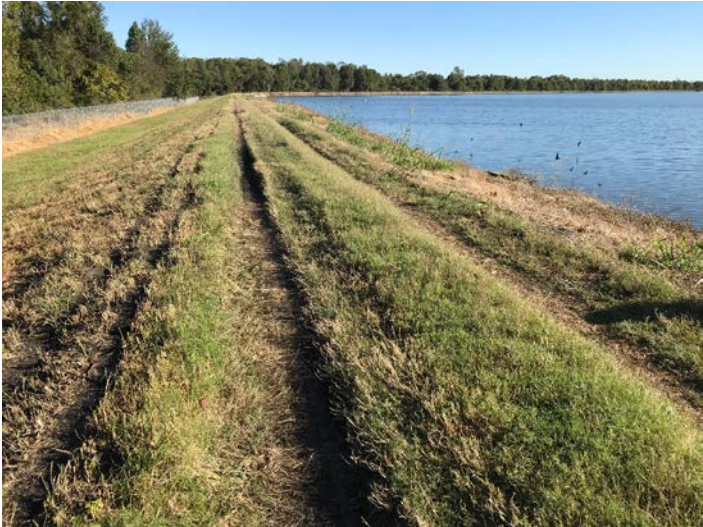
- The perimeter road near the western tip of the Fly Ash Basin showed deeper vehicle ruts (approximately 6-inches) that should be observed for changes and maintained as needed to keep the road accessible. Otherwise, the perimeter road on top of the dike was generally in good condition with no observed signs of problematic desiccation cracking or deformations.

- There were occasional animal burrows observed on the western-facing exterior dike slopes. Overall, vegetation was in good condition, with no noted areas of distress, nor signs of erosion of the exterior dike slopes or seeps exiting the slope.

<p>Photograph ID: 9</p> <hr/> <p>Date: 10/25/2017</p> <hr/> <p>Direction: N</p> <hr/> <p>Comments: Fly Ash Basin – west interior/exterior slopes and road</p>

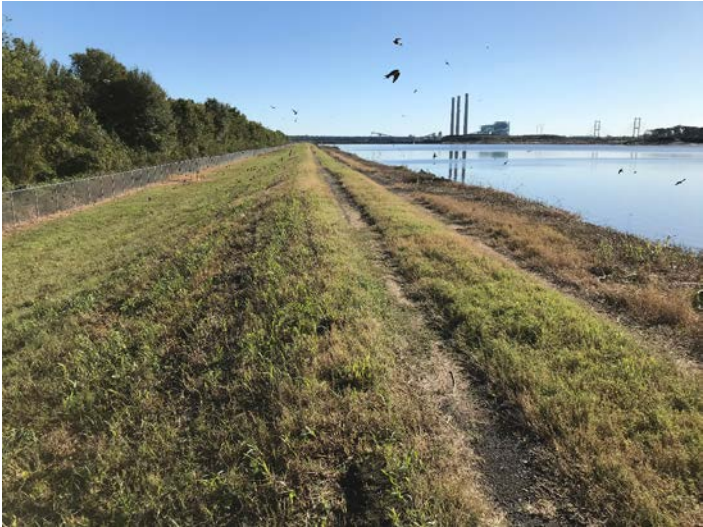
<p>Photograph ID: 10</p> <hr/> <p>Date: 10/25/2017</p> <hr/> <p>Direction: E</p> <hr/> <p>Comments: Fly Ash Basin – north interior/exterior slopes and road</p>

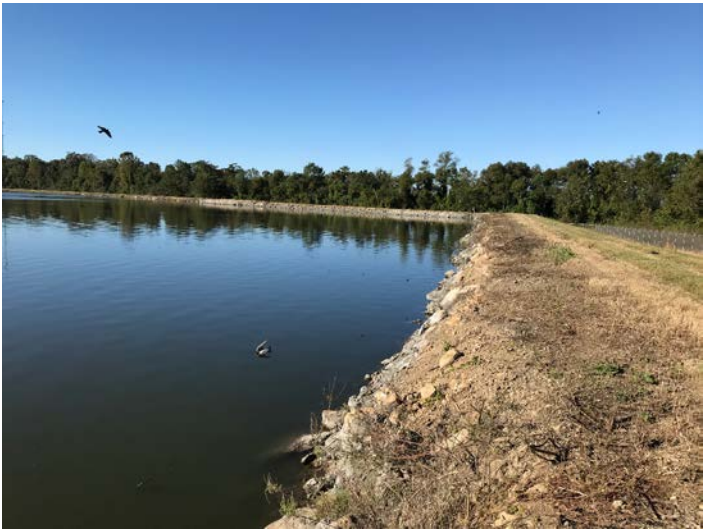
<p>Photograph ID: 11</p> <hr/> <p>Date: 10/25/2017</p> <hr/> <p>Direction: W</p> <hr/> <p>Comments: Fly Ash Basin – north interior slope and road</p>

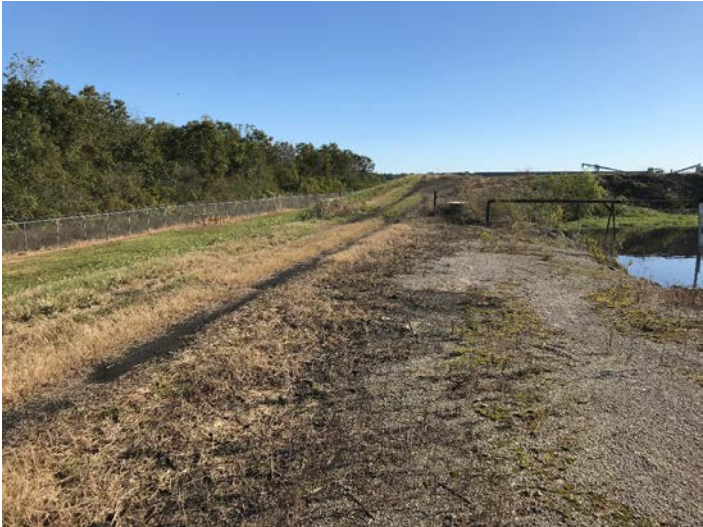
<p>Photograph ID: 13</p> <p>Date: 10/25/2017</p> <p>Direction: E</p> <p>Comments: Fly Ash Basin – northeast corner looking at increased dike height for Bottom Ash Basin</p>

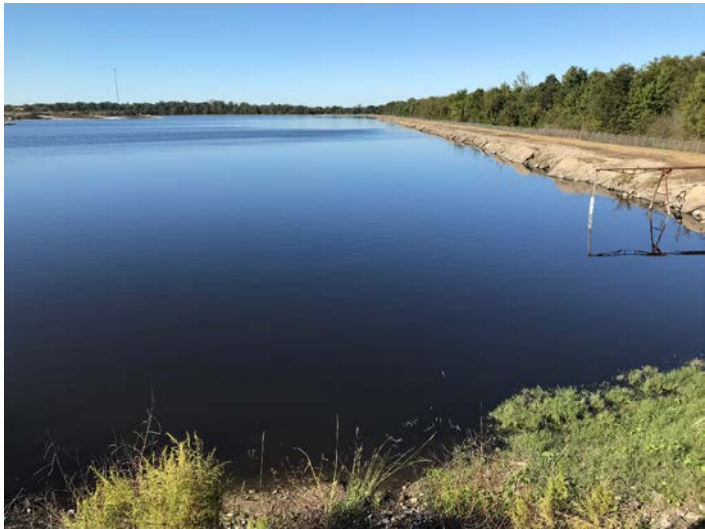
<p>Photograph ID: 15</p> <hr/> <p>Date: 10/25/2017</p> <hr/> <p>Direction: W</p> <hr/> <p>Comments: Fly Ash Basin – northeast corner</p>

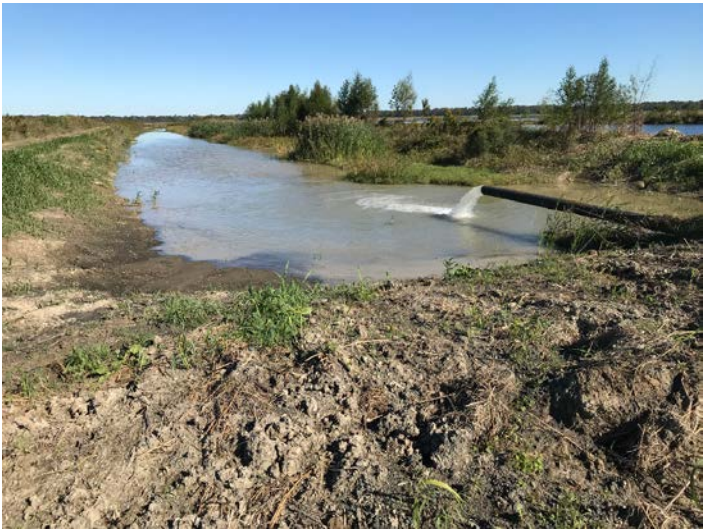
<p>Photograph ID: 17</p> <hr/> <p>Date: 10/25/2017</p> <hr/> <p>Direction: N</p> <hr/> <p>Comments: Bottom Ash Basin – Clarifier underflow discharge at southeastern corner of bottom ash basin</p>

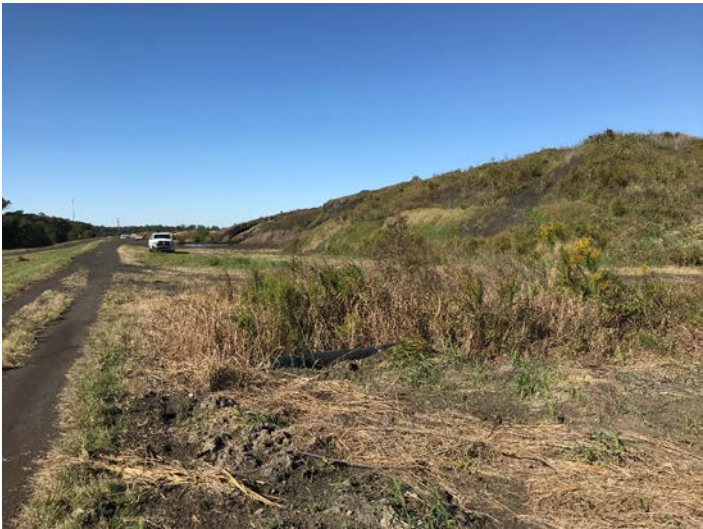
A photograph showing a discharge pipe on the right side of the frame, discharging a stream of water into a larger body of water. The water is a light, milky color. The surrounding area is a mix of dirt, grass, and some brush. The sky is clear and blue.
<p>Photograph ID: 18</p> <hr/> <p>Date: 10/25/2017</p> <hr/> <p>Direction: W</p> <hr/> <p>Comments: Bottom Ash Basin – southeast corner</p>

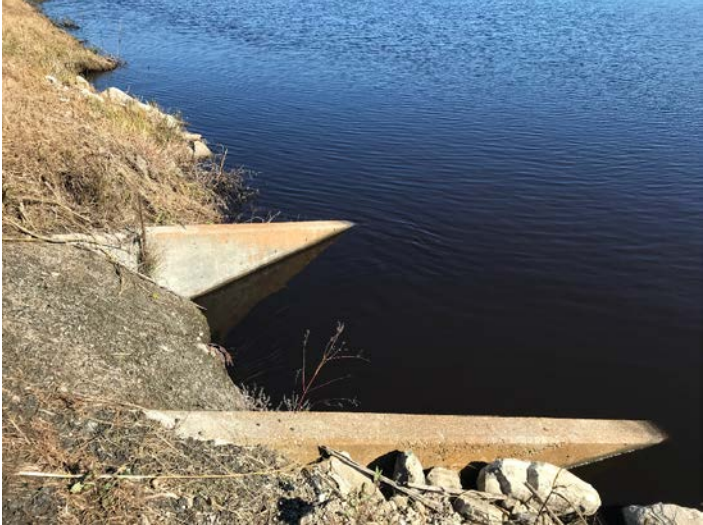
<p>A photograph showing the interior slope of a pond. The foreground is dominated by a dense, tangled mass of dry, brown grasses and weeds. To the right, the water of the pond is visible, with some green vegetation growing along the edge. In the background, a clear blue sky and a line of trees are visible under bright daylight.</p>
<p>Photograph ID: 20</p> <hr/> <p>Date: 10/25/2017</p> <hr/> <p>Direction: N</p> <hr/> <p>Comments: Bottom Ash Basin – showing outlet of overflow weir (pipe) to Primary Treatment Pond</p>

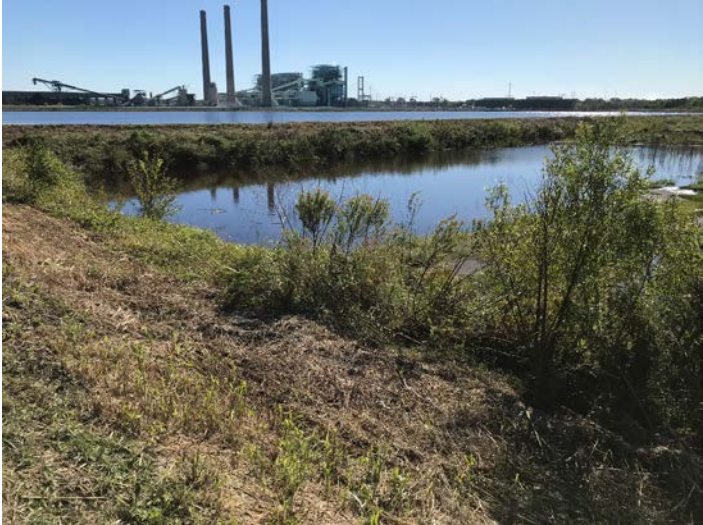
<p>Photograph ID: 21</p> <hr/> <p>Date: 10/25/2017</p> <hr/> <p>Direction: E</p> <hr/> <p>Comments: Bottom Ash Basin (near), Primary Treatment Pond (far), and Power Plant (background)</p>
