# **CLECO POWER LLC** BRAME ENERGY CENTER

# 5-YEAR PERIODIC REVIEW SAFETY FACTOR ASSESSMENT

# **BOTTOM ASH POND**

**OCTOBER 2021**

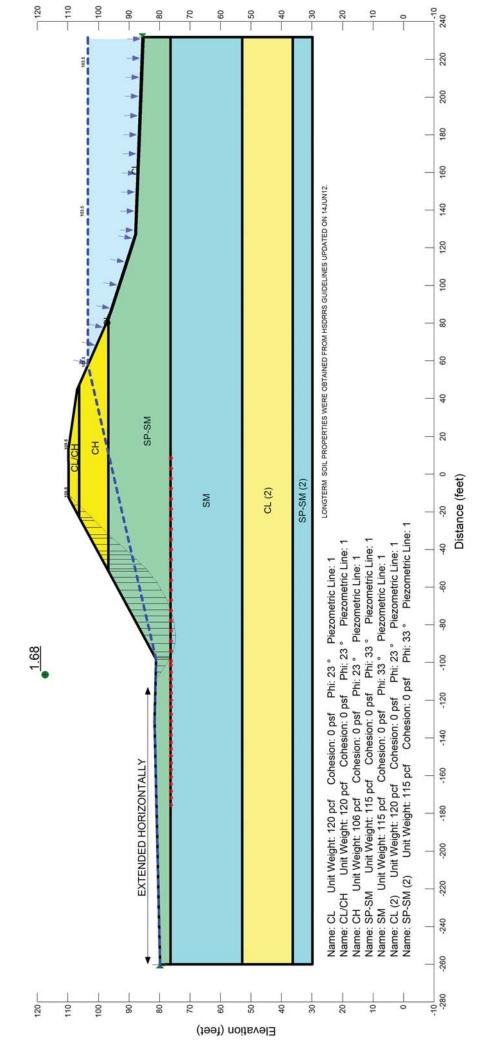
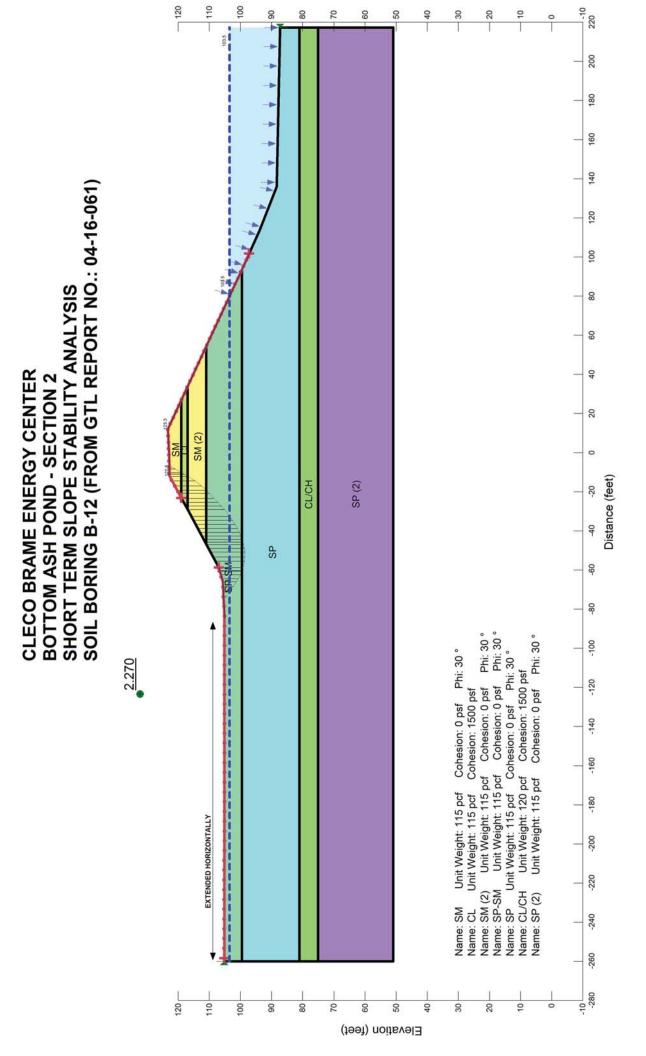
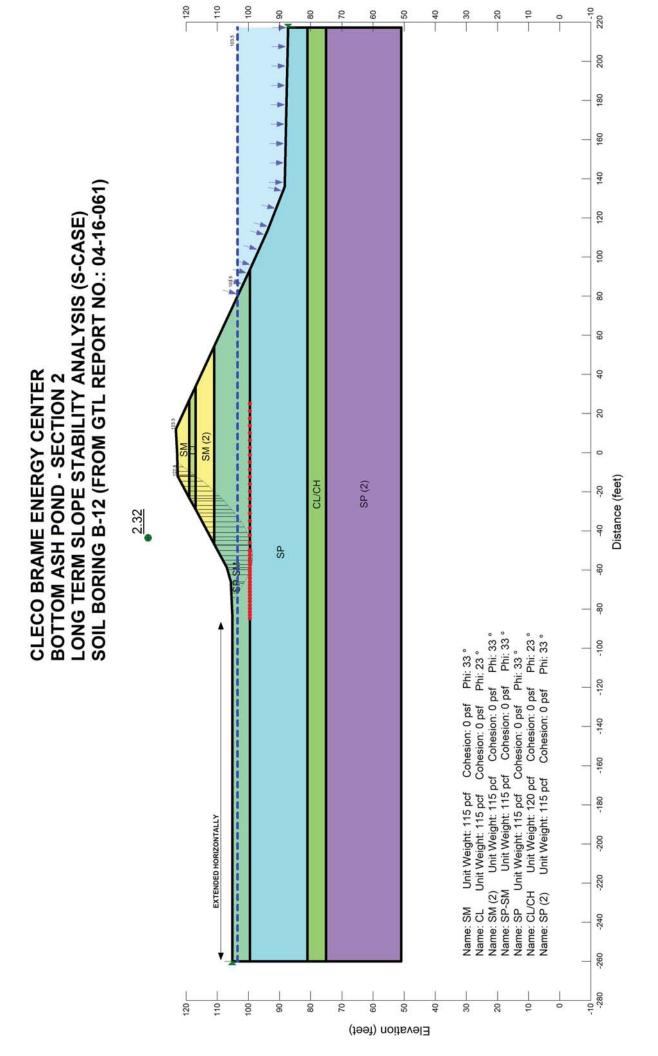
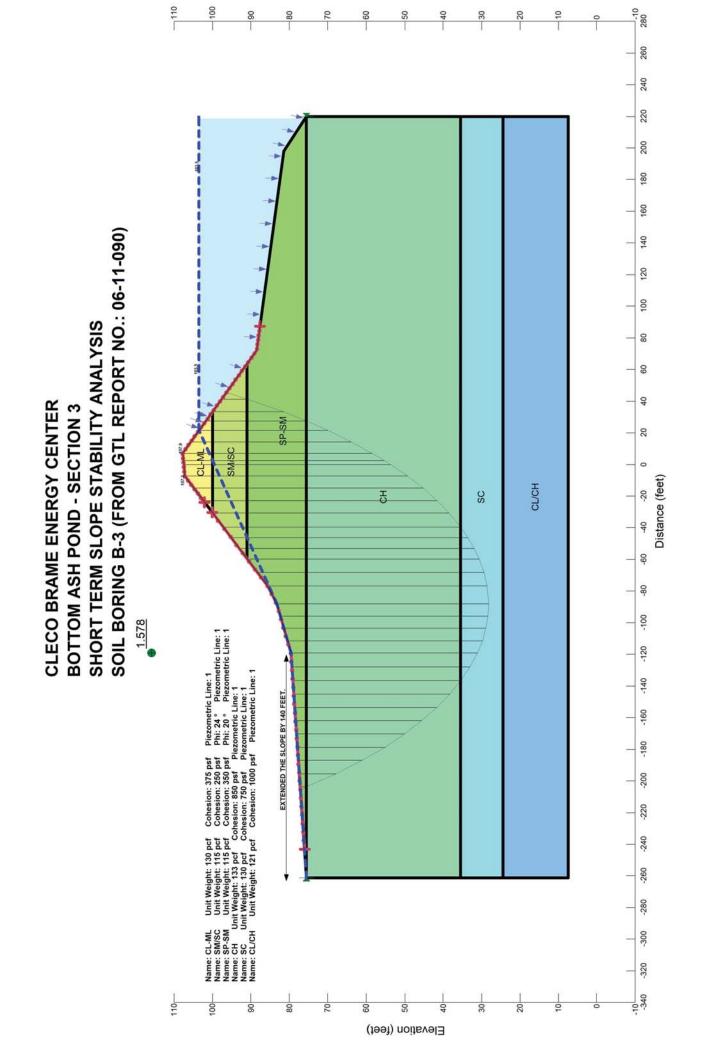
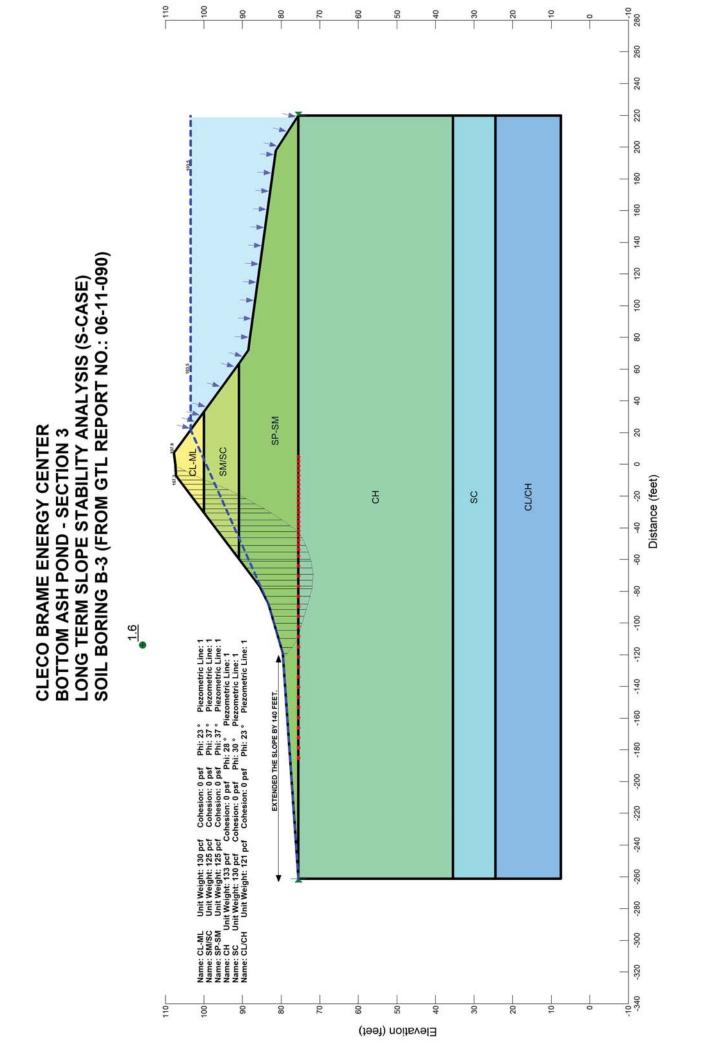
CLECO BRAME ENERGY CENTER BOTTOM ASH POND - SECTION 1 LONG TERM SLOPE STABILITY ANALYSIS (S-CASE) SOIL BORING B-13 (FROM GTL REPORT NO.: 04-16-061)

Pond	Section #	Condition	Flood Side Water Elevation (feet, NAVD88)	Factor of Safety Obtained	Notes
	1	Short Term	103.5	1.53	
Dettern	1	Long Term	103.5	1.68	
Bottom Ash	2	Short Term	103.5	2.27	
Pond	2	Long Term	103.5	2.32	
FUIU	3	Short Term	103.5	1.58	
	3	Long Term	103.5	1.60

Based on the results presented in the above table, all three sections of the Bottom Ash Pond meet minimum required factor of safety with the projected maximum water elevation as shown in above table for both short term and long term conditions. This is based on the soil boring data provided by the client.
