MAY 2017

CLECO POWER LLC
BOTTOM ASH AND FLY ASH SURFACE IMPOUNDMENTS
LENA, RAPIDES PARISH, LOUISIANA

**EMERGENCY
ACTION PLAN**

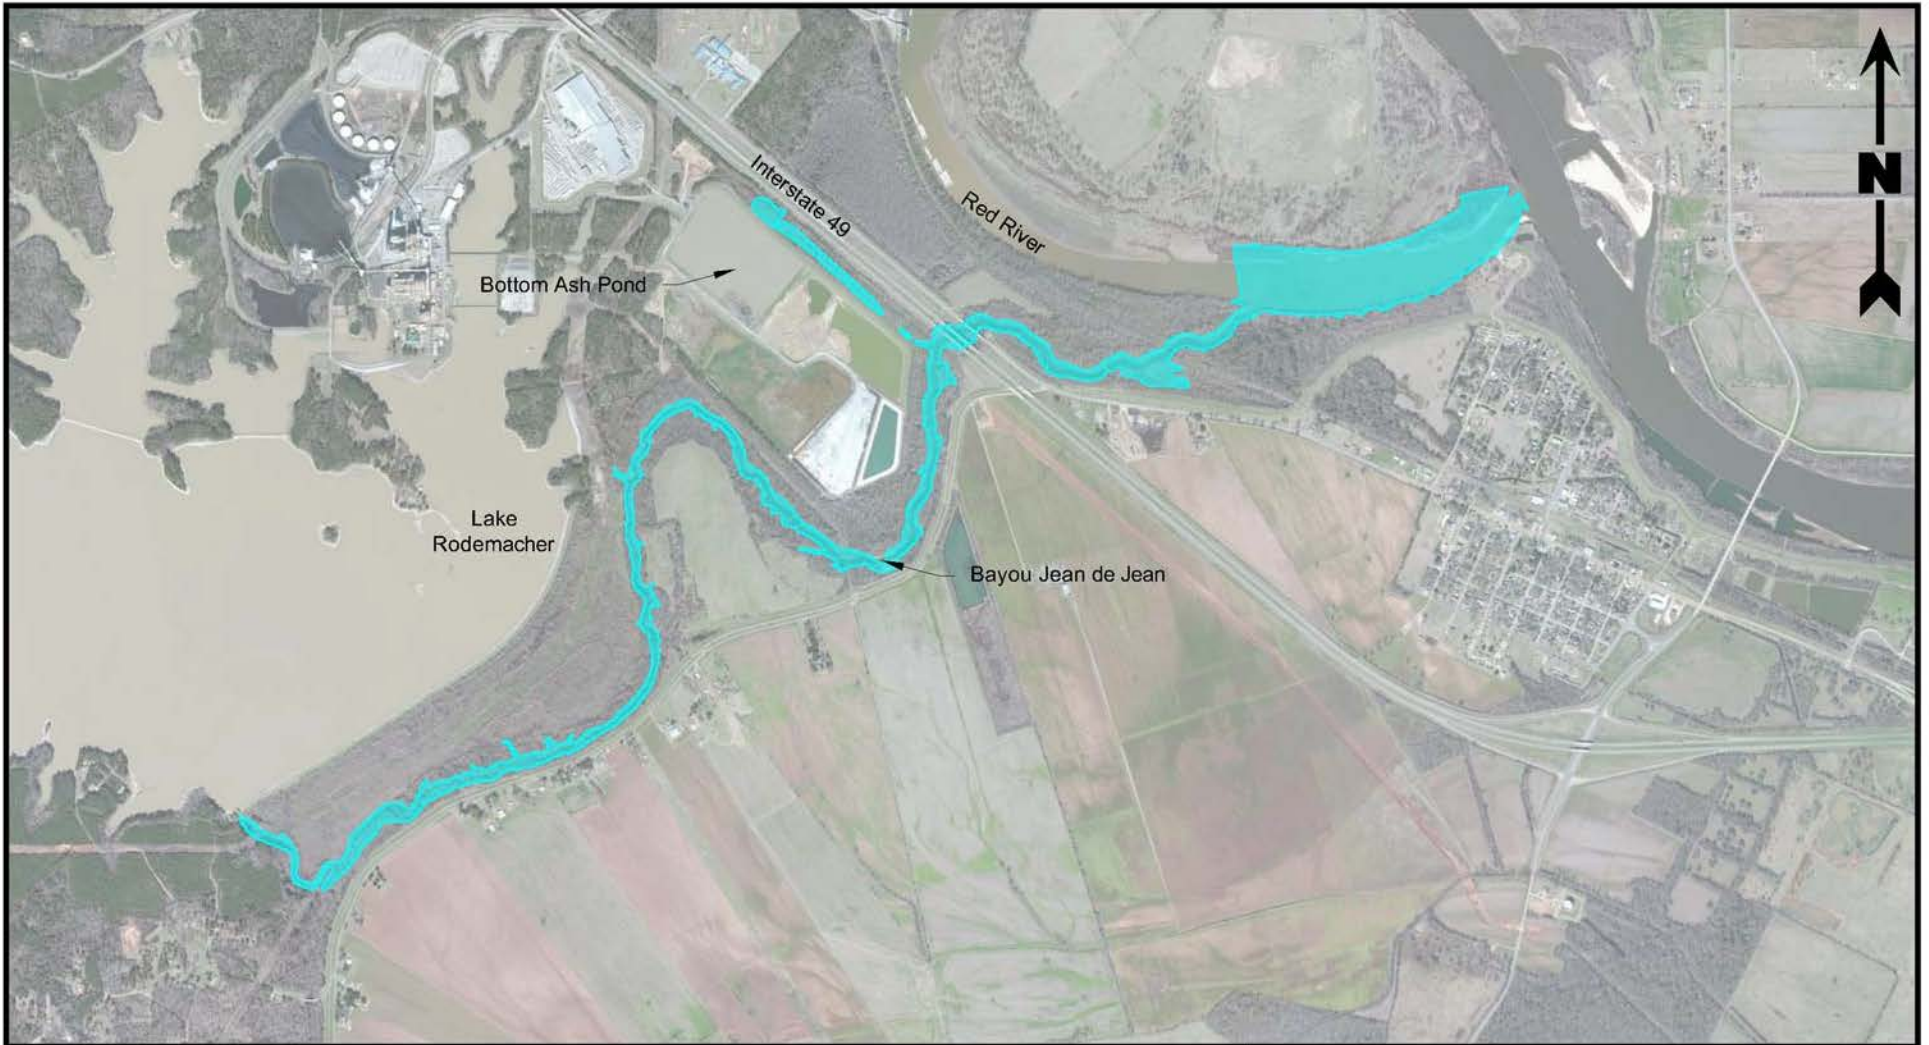
FIGURE 3
BOTTOM ASH POND MOST PROBABLE LOSS

Most Probable Loss (Avg. ELEV. = 75.96')

It should be noted that these models were generated based on a continuous outflow from the pond as this was determined to be the most conservative way to model a levee breach. Real-world scenarios should be less impactful as the flow rate will steadily decrease as the pond empties.

Figure 2 shows the Levee Breach Study Area for the Bottom Ash and Fly Ash Surface Impoundments. **Figure 3** and **Figure 4** depict the Most Probable Loss and the Maximum Loss scenarios for a levee breach failure of the Bottom Ash Surface Impoundment. **Figure 5** and **Figure 6** depict the Most Probable Loss and the Maximum Loss scenarios for a levee breach failure of the Fly Ash Surface Impoundment. It should be noted that these models were generated based on a continuous outflow from the pond as this was determined to be the most conservative way to model a levee breach. Real-world scenarios should be less impactful as the flow rate will steadily decrease as the pond empties.

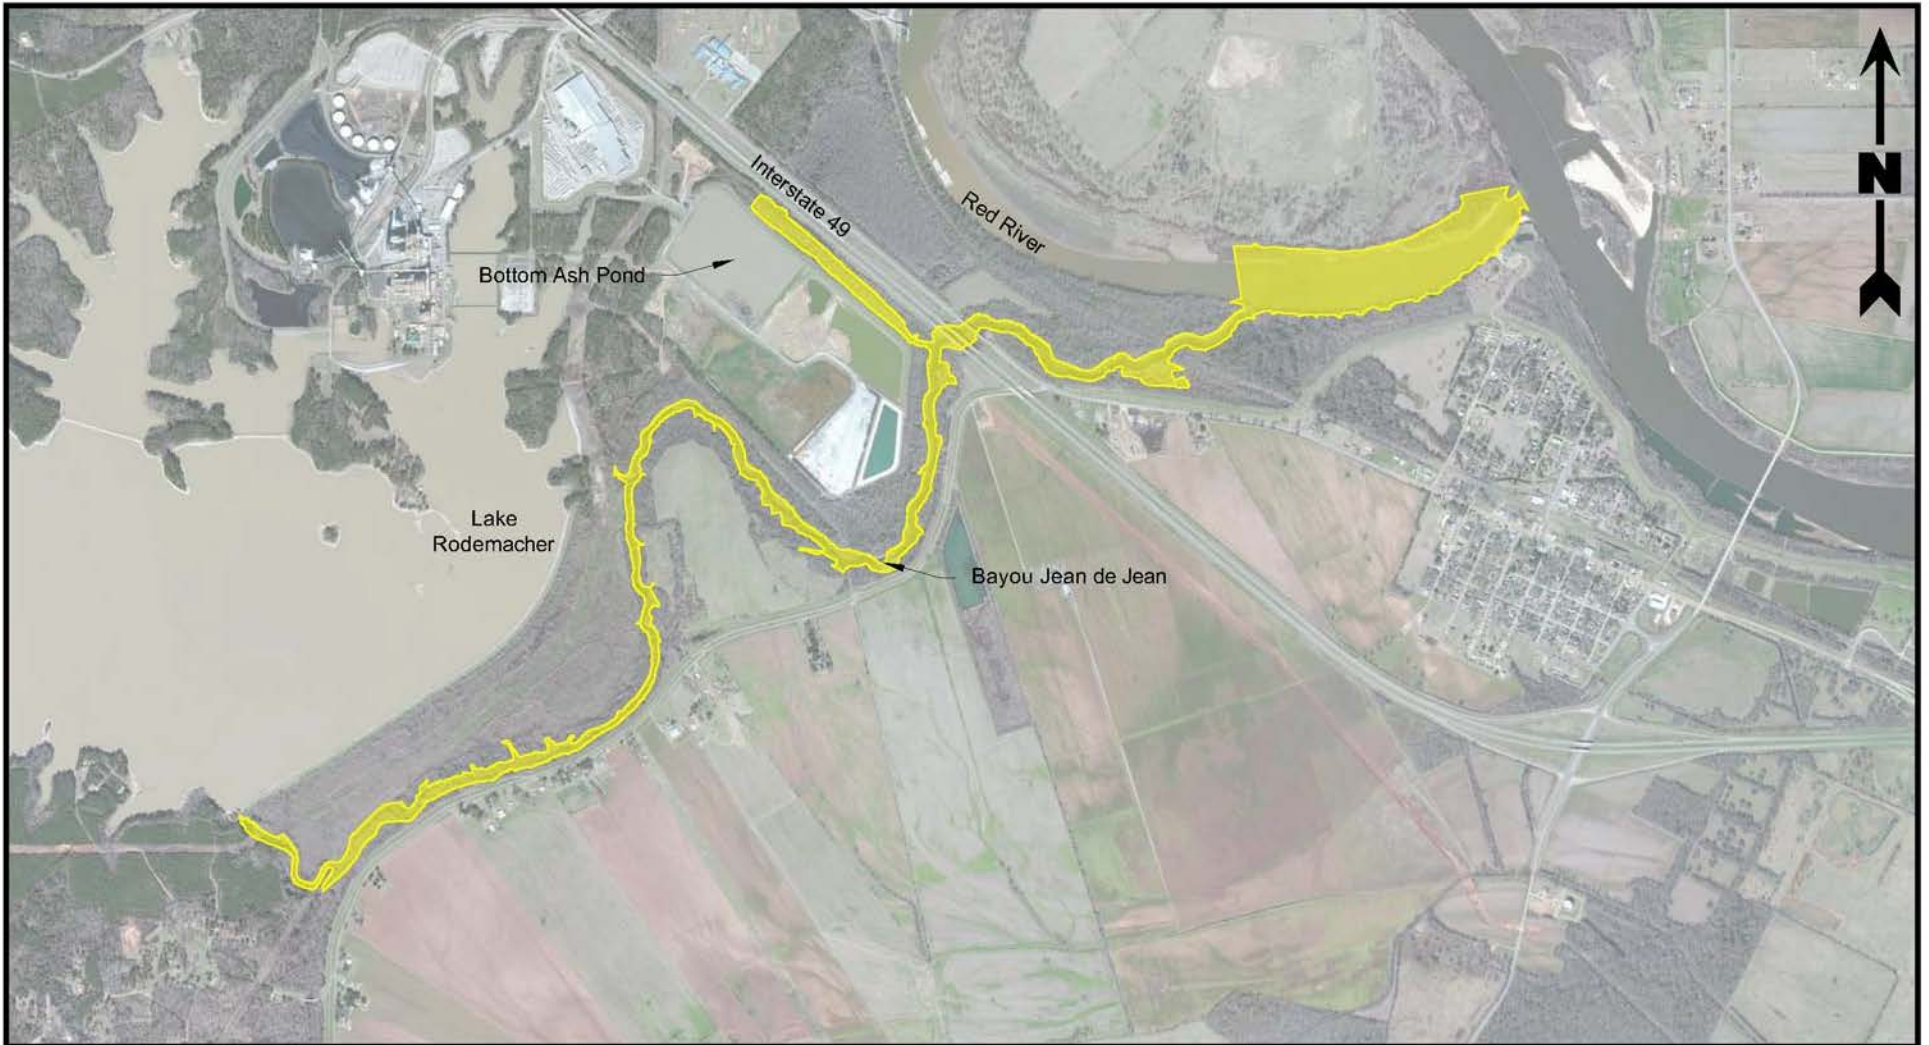
FIGURE 4
BOTTOM ASH POND MAXIMUM LOSS

Maximum Loss (Avg. ELEV = 76.38')

1. This map assumes that the impoundment is at maximum levels which is not normal operation.
2. It should be noted that these models were generated based on a continuous outflow from the pond as this was determined to be the most conservative way to model a levee breach. Real-world scenarios should be less impactful as the flow rate will steadily decrease as the pond empties.

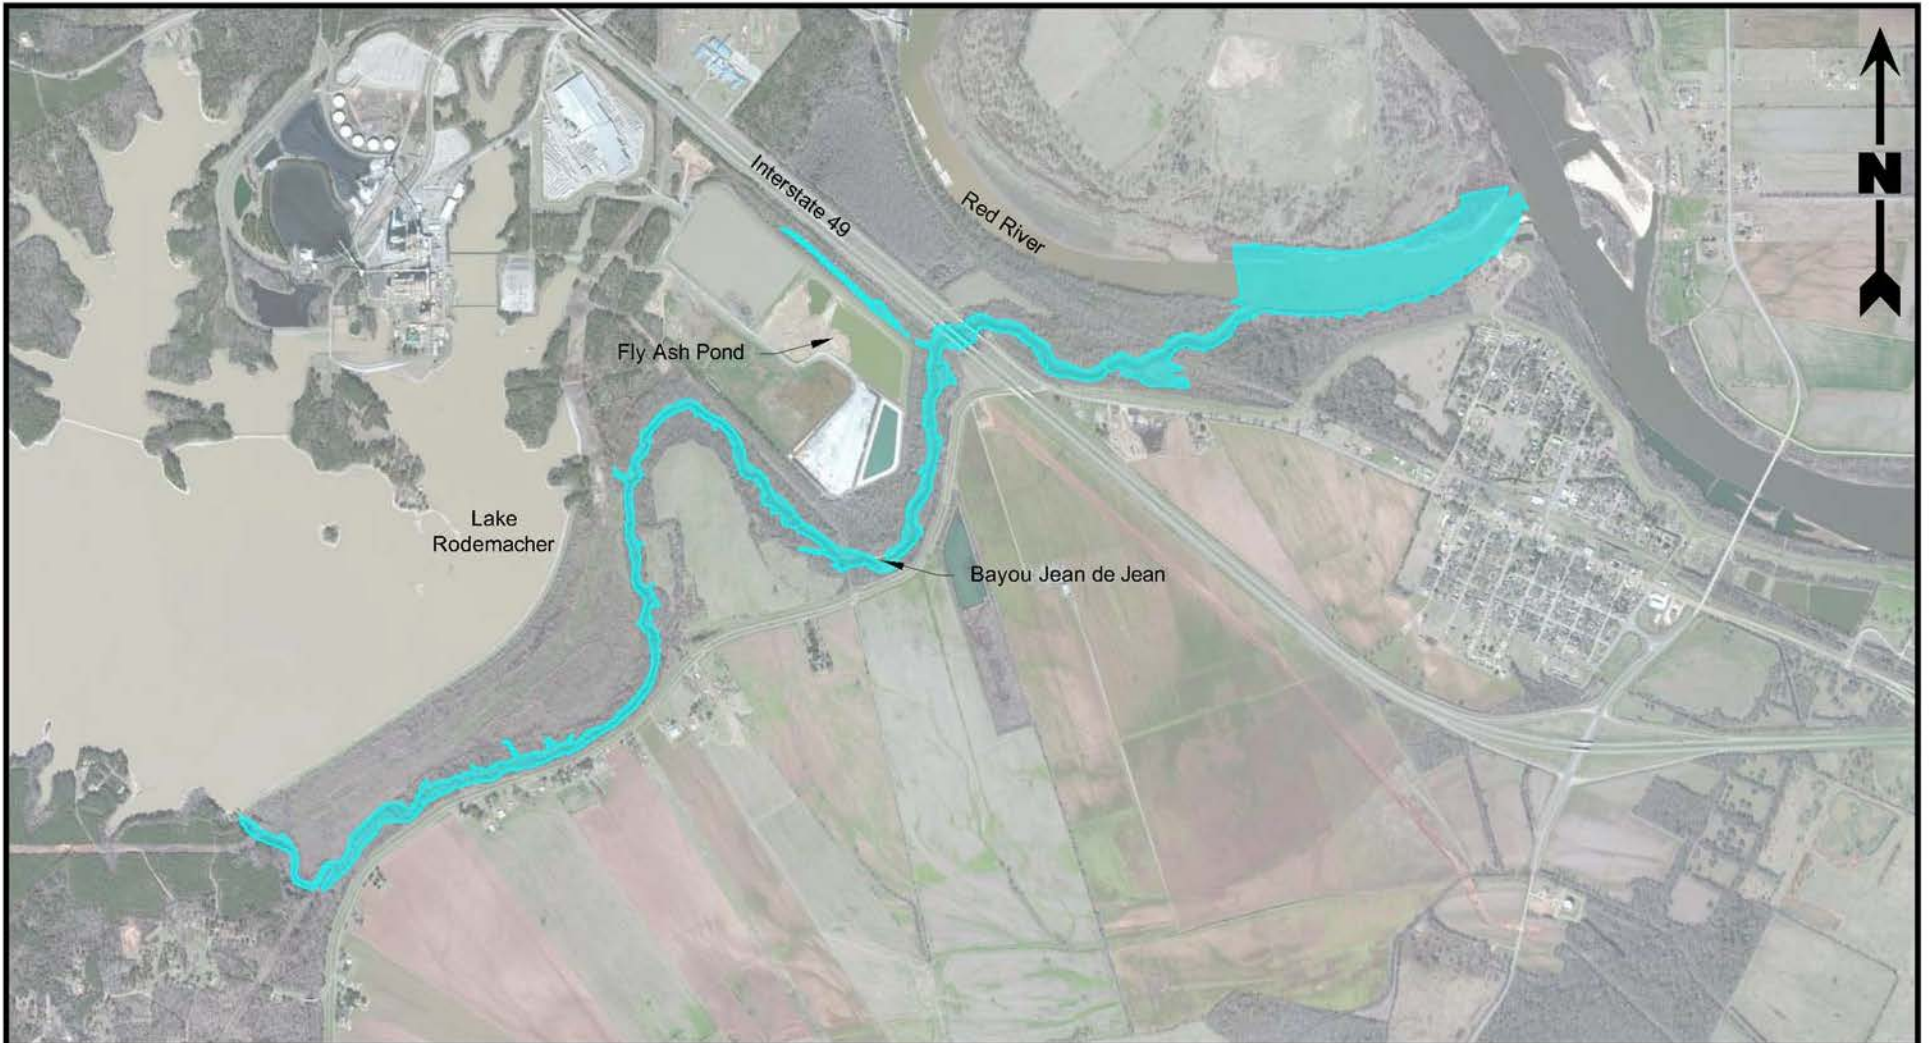
FIGURE 5
FLY ASH POND MOST PROBABLE LOSS

Most Probable Loss (Avg. ELEV. = 75.61')

It should be noted that these models were generated based on a continuous outflow from the pond as this was determined to be the most conservative way to model a levee breach. Real-world scenarios should be less impactful as the flow rate will steadily decrease as the pond empties.

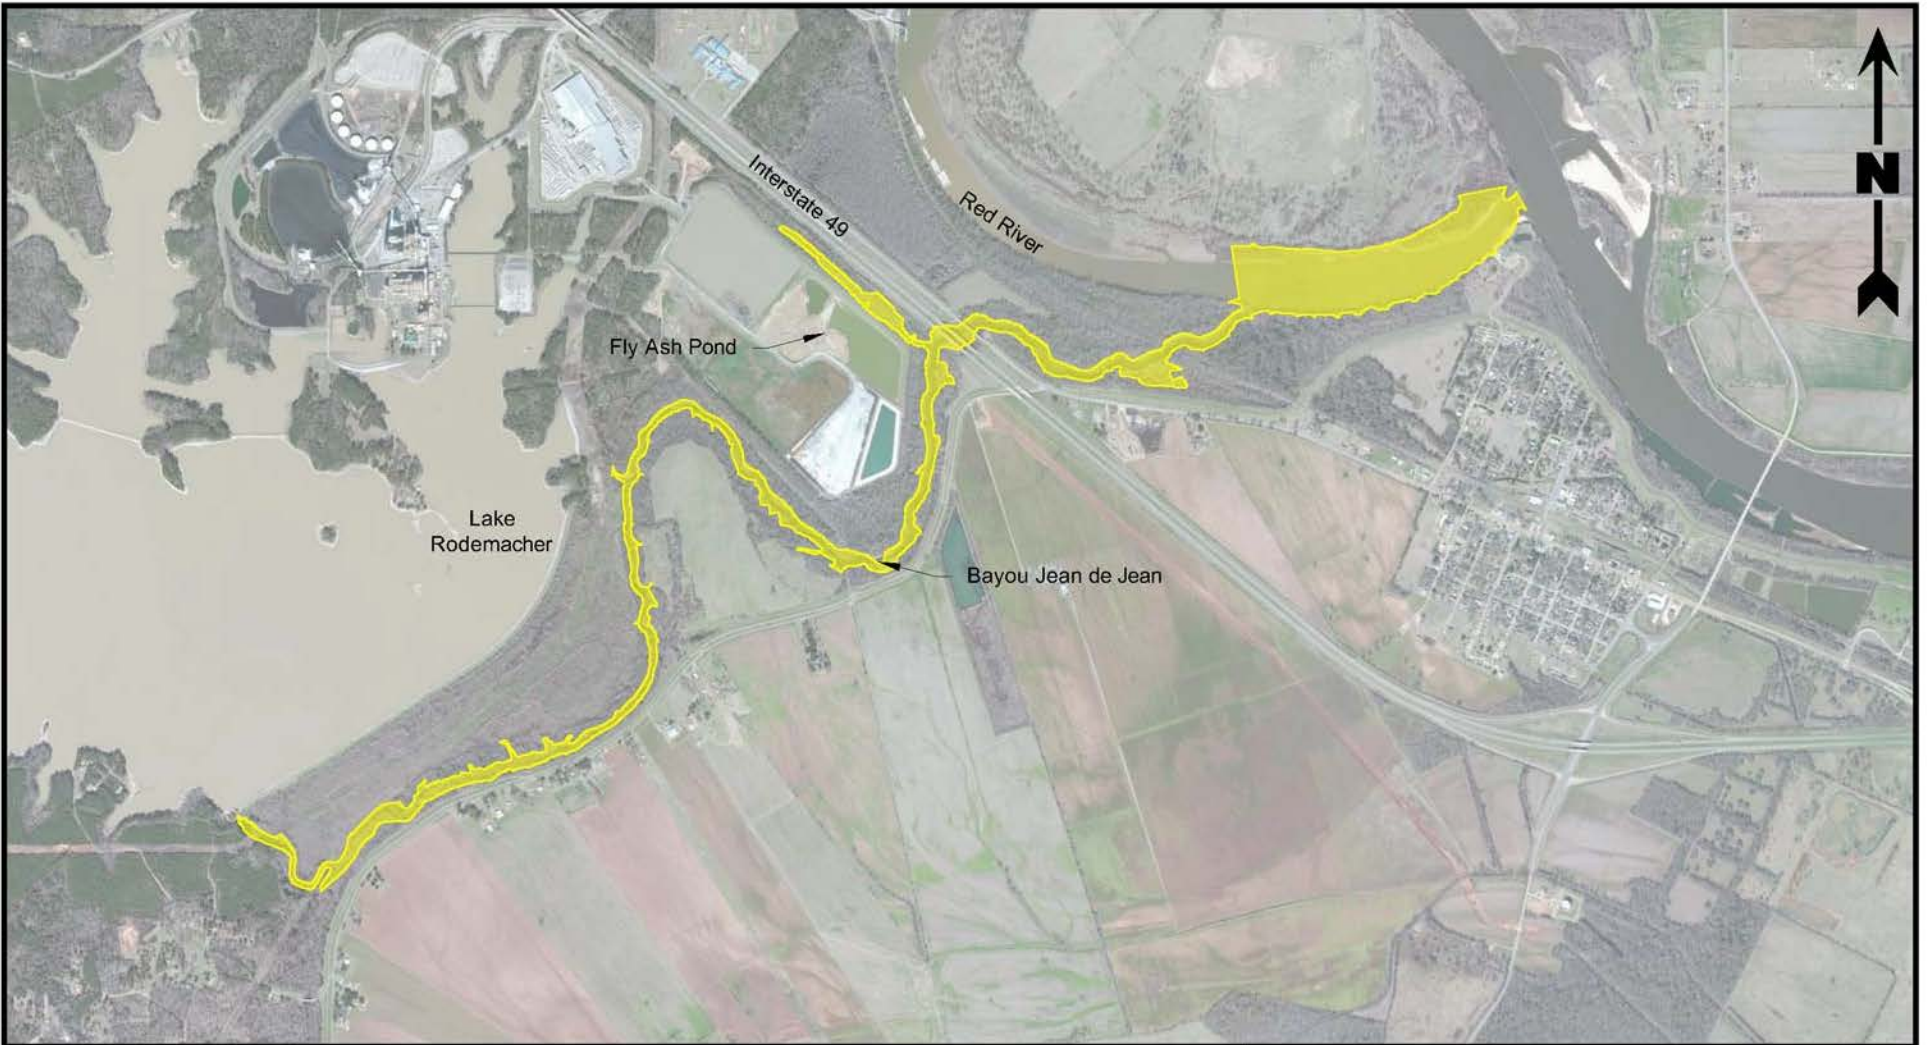
FIGURE 6
FLY ASH POND MAXIMUM LOSS

Maximum Loss (Avg. ELEV. = 76.41')

1. This map assumes that the impoundment is at maximum levels which is not normal operation.
2. It should be noted that these models were generated based on a continuous outflow from the pond as this was determined to be the most conservative way to model a levee breach. Real-world scenarios should be less impactful as the flow rate will steadily decrease as the pond empties.
