CLECO POWER LLC BRAME ENERGY CENTER

UNSTABLE AREAS ASSESSMENT

FLY ASH POND

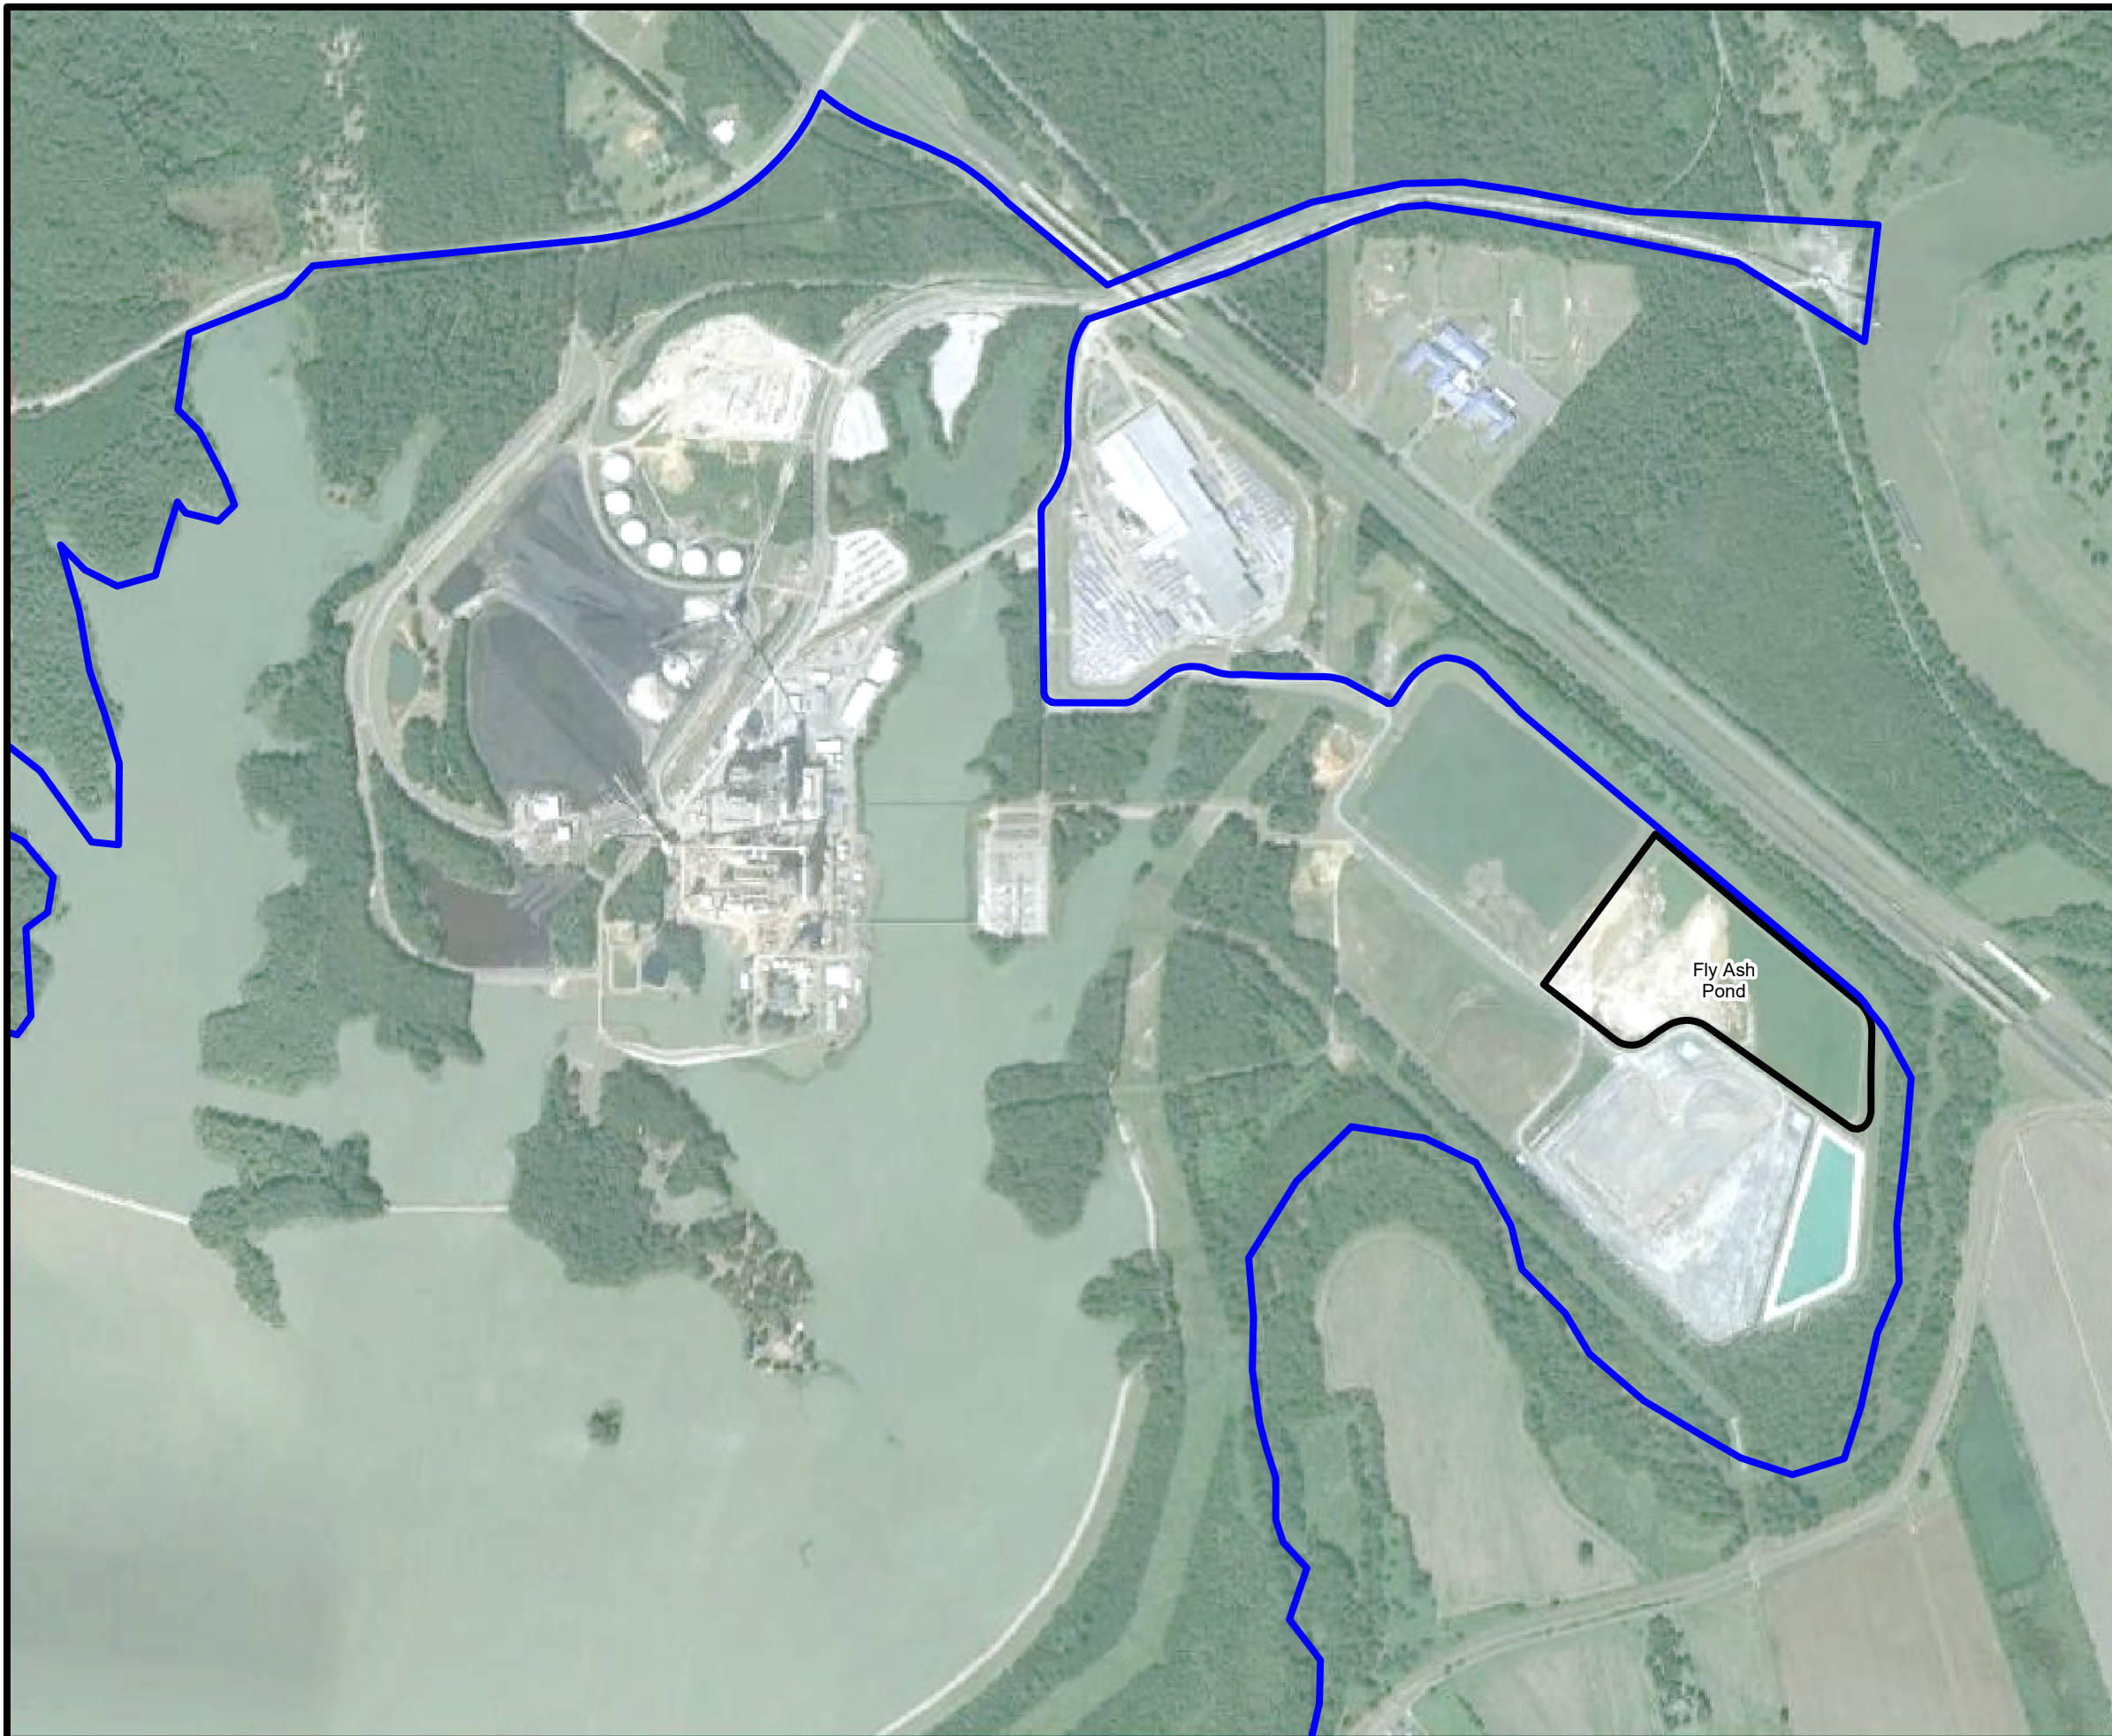
FIGURE 2
SITE MAP

This unstable area assessment pertains to the Fly Ash surface impoundment (Pond) utilized for the Unit 2 coal-fired generation unit. A site map for the Fly Ash Pond is included as **Figure 2**. For an existing CCR surface impoundment, the unstable areas assessment must be completed no later than October 17, 2018.

Base map comprised of Google Earth aerial imagery from 10/03/14.
