DOLET HILLS POWER STATION

5-YEAR PERIODIC REVIEW

HAZARD POTENTIAL CLASSIFICATION

ASH BASIN No. 1

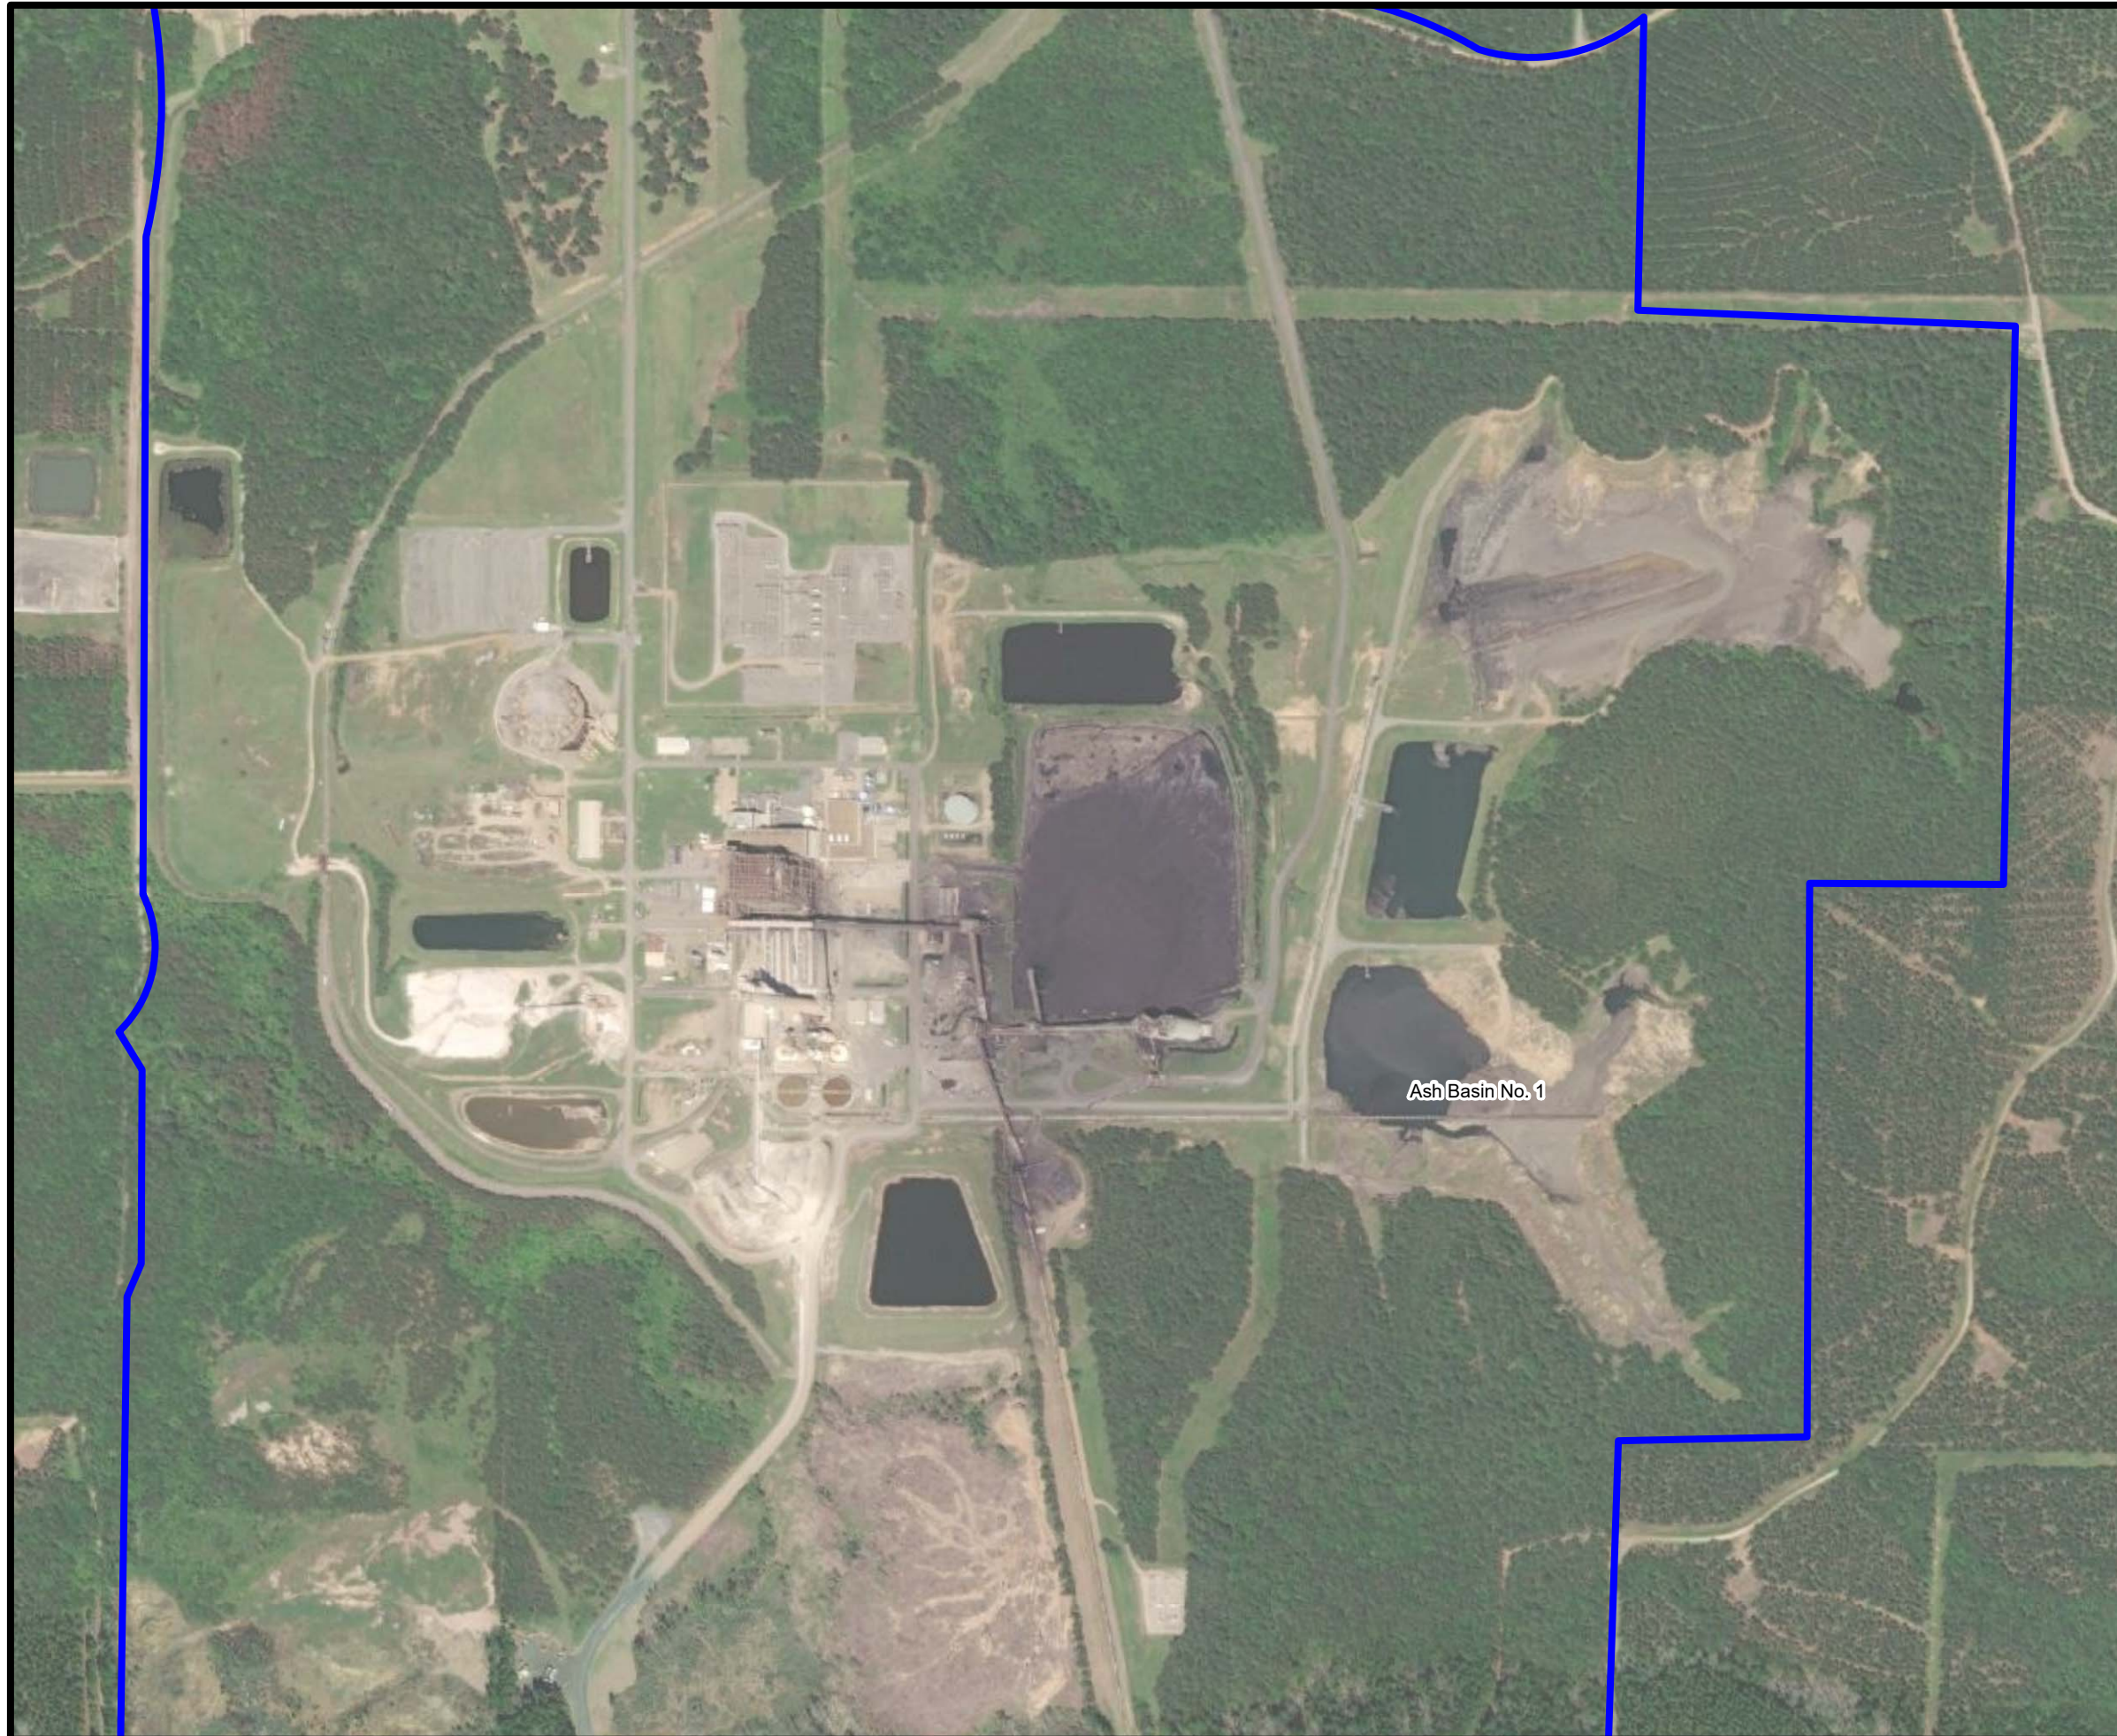
FIGURE 2
SITE MAP

Site Map

This 5-year periodic review for the hazard potential classification assessment pertains to Ash Basin No.1 that is utilized for the coal-fired generation unit. The Cleco Dolet Hills Power Station is located approximately 8 miles southeast of Mansfield, DeSoto Parish, LA. A site location map showing the Dolet Hills Power Station is included as **Figure 1**. The Ash Basin No.1 is shown in **Figure 2**.

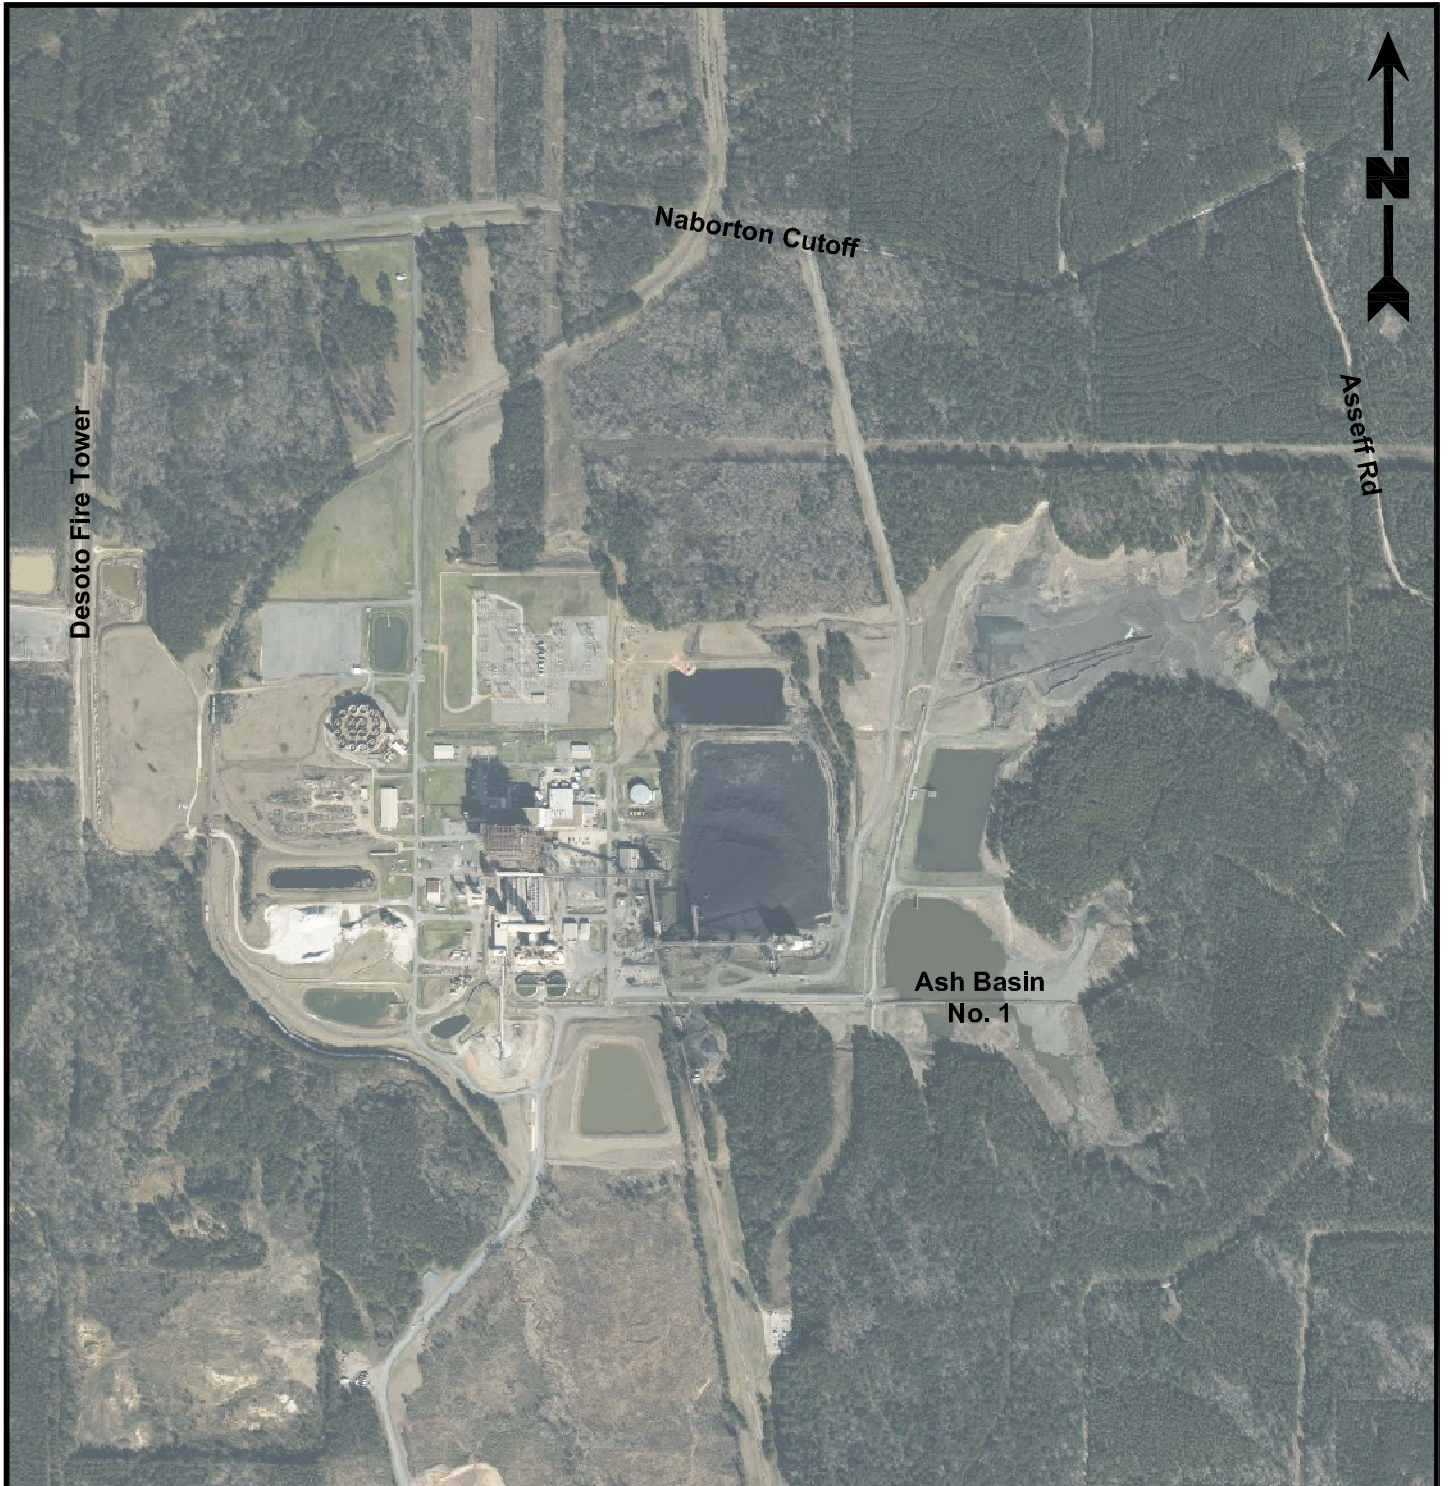
FIGURE 1
LEEVE BREACH STUDY AREA

Ash Basin No. 1 Levee Breach Study Area

The proposed project is located on Federal Emergency Management Agency (FEMA) map panel 0325C in Desoto Parish which is bound by Bayou Pierre on the east, US 84 on the north, LA 509 on the west, and Par Rd 140 on the south. The study area is presented in **Figure 1**.
