# CLECO POWER LLC DOLET HILLS POWER STATION

## FLY ASH/SCRUBBER SLUDGE LANDFILL MANSFIELD, LA

## **2019 Annual Groundwater Monitoring Report for the Coal Combustion Residuals Rule**

January 2020

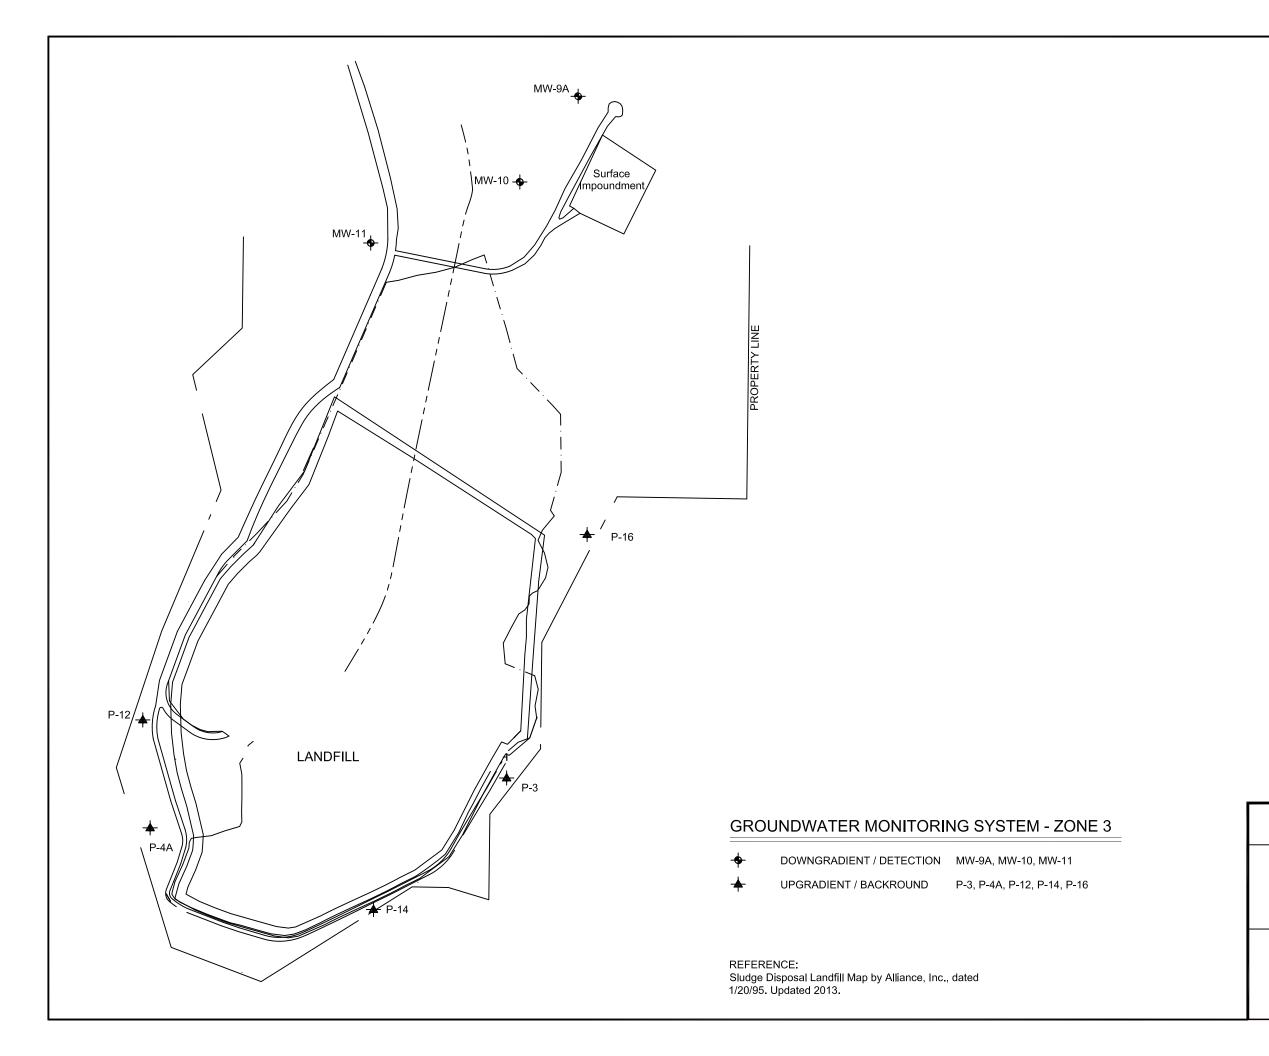
## **Monitoring Well Location Map**

As required by the CCR Rule part §257.90, DHPS has a groundwater monitoring well system to evaluate the groundwater quality conditions near the landfill. The monitoring system consists of monitoring wells installed previously to conduct groundwater monitoring required by DHPS's LDEQ approved solid waste permit. A total of eight monitoring wells have been installed per applicable portions of §257.91. The uppermost water bearing zone that is laterally continuous beneath the landfill is referred to as Zone 3. Locations of the monitoring wells can be found on Figure 2, and a table of monitoring well construction details can be found in Table 1.

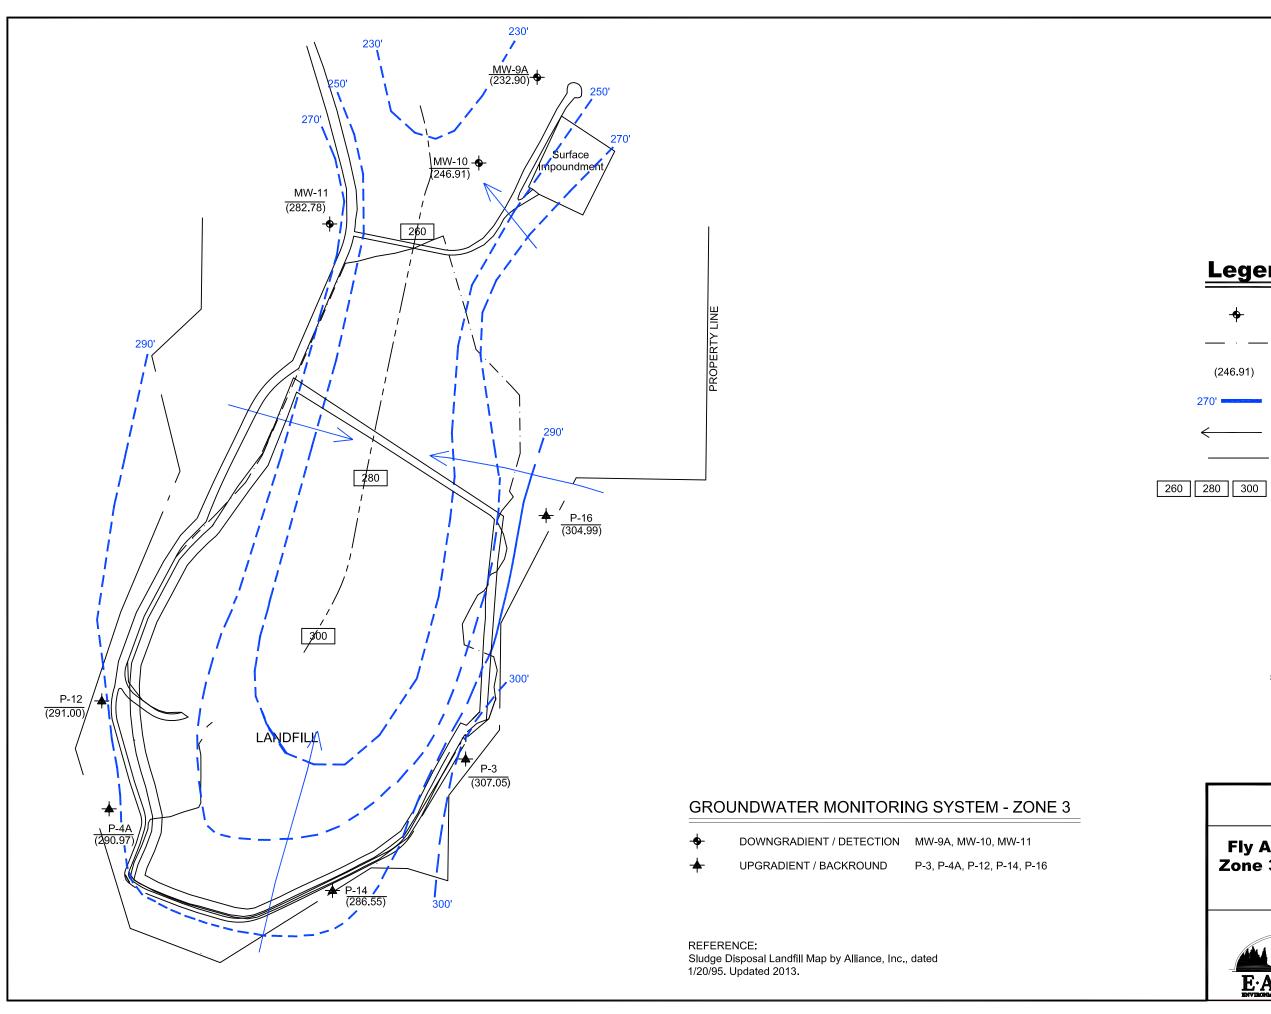
## Fly Ash / Scrubber Sludge Landfill **Zone 3 Potentiometric Surface Map March 2019**

Potentiometric surface maps were prepared to evaluate groundwater flow in Zone 3 (Figures 3 through 6). The potentiometric surface maps prepared for Zone 3 indicate that groundwater in Zone 3 flows to the north, converging toward the stream and mimicking the topography of the site. Based on soil borings completed for solid waste permitting activities for Cleco's surge ponds and other surface impoundments to the north, Zone 3 is not laterally continuous in areas north of the landfill and its surface impoundment. Field mapping and observations at the facilities have identified that groundwater drains to land surface in outcrop areas of Zone 3 and is directed to the stream in the base of the valley. Elevations of the stream bed have been incorporated into the potentiometric surface maps for Zone 3. These elevations were obtained from a detailed site topographic survey of the Fly Ash/Scrubber Sludge Landfill, dated April 3, 1995. This pattern of groundwater flow is consistent in the potentiometric surface maps, indicating little significant fluctuation in groundwater flow.

| Date | Hydraulic Gradient<br>(feet/feet) | Estimated Groundwater<br>Flow Velocity<br>(feet/day) | | |
|---|---|--|--|--|
| March 2019 | 0.003 to 0.03 | 0.0015 to 1.5 | | |
